SECTION 3 – UNDERSTANDING THE SITE

3.0 UNDERSTANDING THE SITE

This chapter describes the current condition of the Pittville Park. For ease of reference the site has been divided into character areas. See Fig 1.3

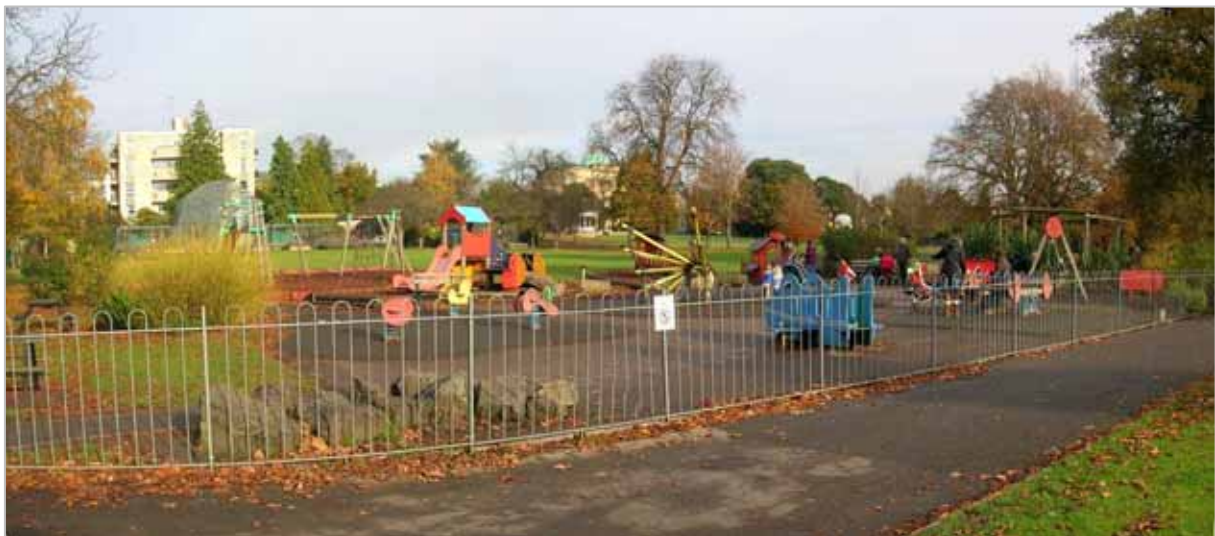
2007 Fenced play area

The play area has a bitmac and wet pour surface which is functional and safe but contributes little to the play value for the area. Some of the markings on the surface have become faded and worn so that they can no longer be distinguishable. The fenced area is accessed via two self closing gates; one is located to the south, adjacent to the toilet block and the other to the north west adjacent to the aviaries.

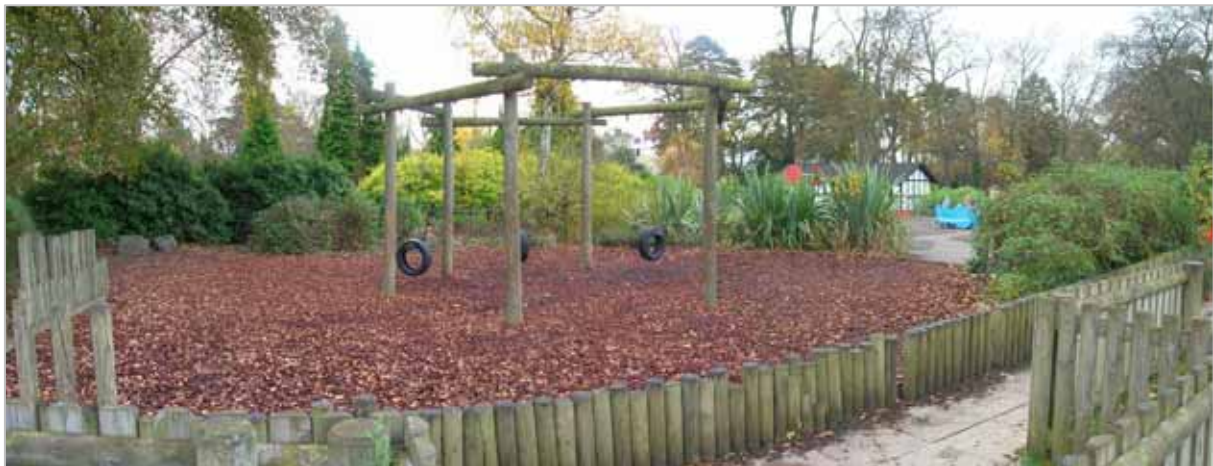
2007 Equipment for older children

The surfaces within this area, whilst safe are becoming worn and are beginning to deteriorate. Grassed surfaces adjacent to the equipment is wearing, despite the provision of grass-crete.

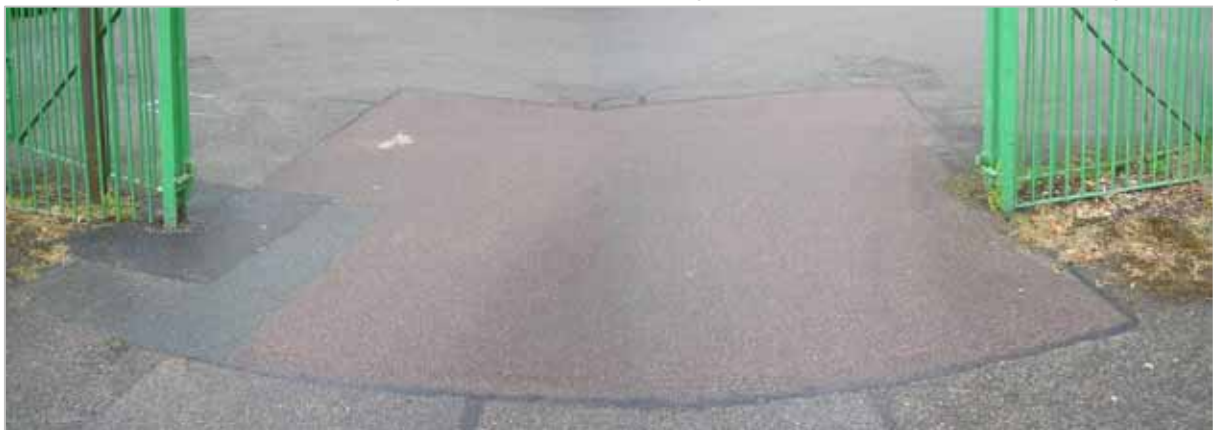
The gateway ironwork is showing signs of deterioration and gives a visual appearance of neglect. To the north and south, the bitmac road surface runs under a section of the ironwork. A lack of pedestrian or vehicular traffic here has enabled the colonisation of moss and weeds which continue to grow unchecked, adding to the visual appearance of neglect.

2007 East Approach Drive gateway

The bitmac surface between the gates has been repaired and replaced several times and the resulting 'patchwork' of colours again detracts from the visual appearance of this gateway space.

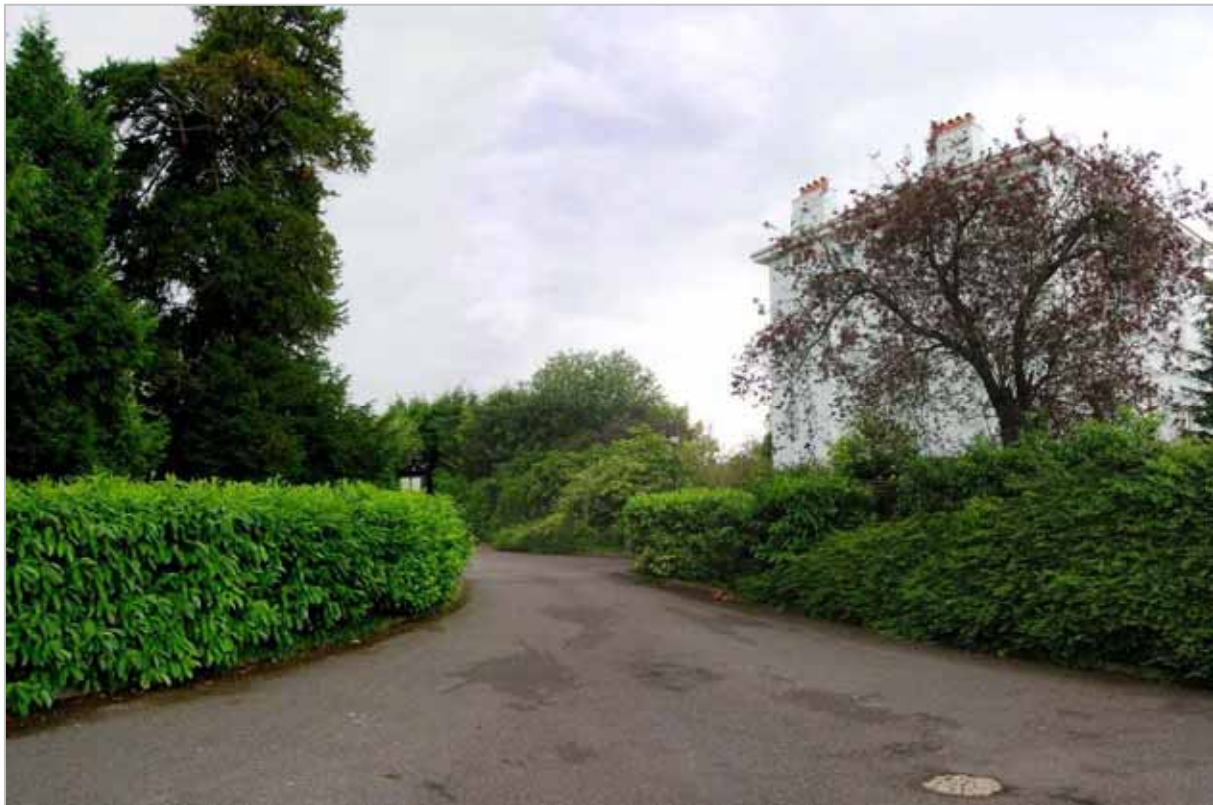
2007 Pinch point towards the car park

Sadly, this eastern gateway space does little to announce the arrival to the magnificent building of the Pump Rooms. There have been plans to replace the gates and railings at this eastern gateway and the latest design by Claire Stenson with help from Jeremy Jefferies is included within this conservation management plan at Appendix 6.

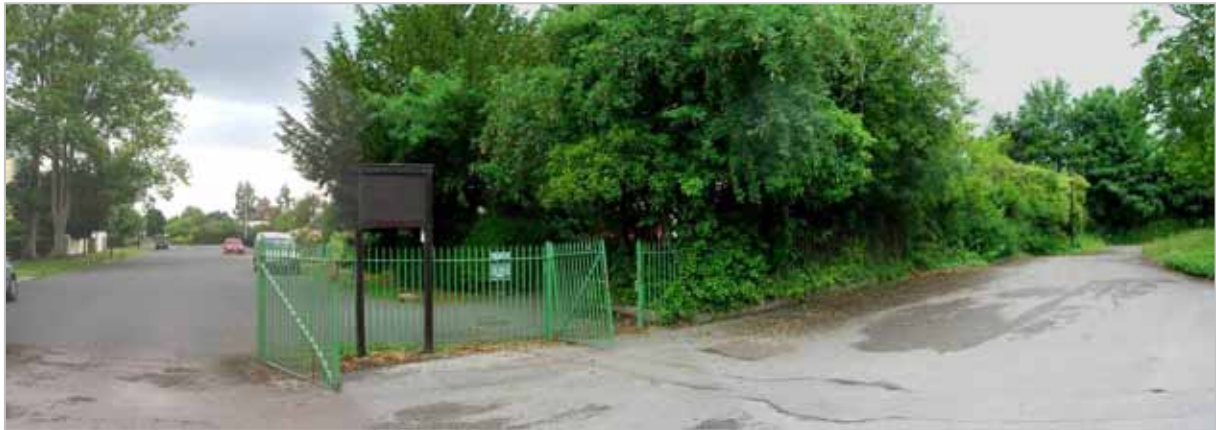
The gateway is defined by green iron railings and gates in the same style as those found throughout Pittville Park. The ironwork is showing signs of deterioration and wear and detracts from the visual qualities of this gateway space.

The hard, bitmac surface runs up to and under the majority of this ironwork and as a result of little wear from pedestrians and vehicles, has been colonised by moss and weeds along with leaves and litter. This adds to the visual appearance of deterioration and neglect.

The hard, bitmac surface level is such that the gates have worn a groove into the surface with the process of opening and closing. The bitmac surface is also showing signs of deterioration and has been removed, repaired or replaced in sections.

2007 Ironwork at the western gateway

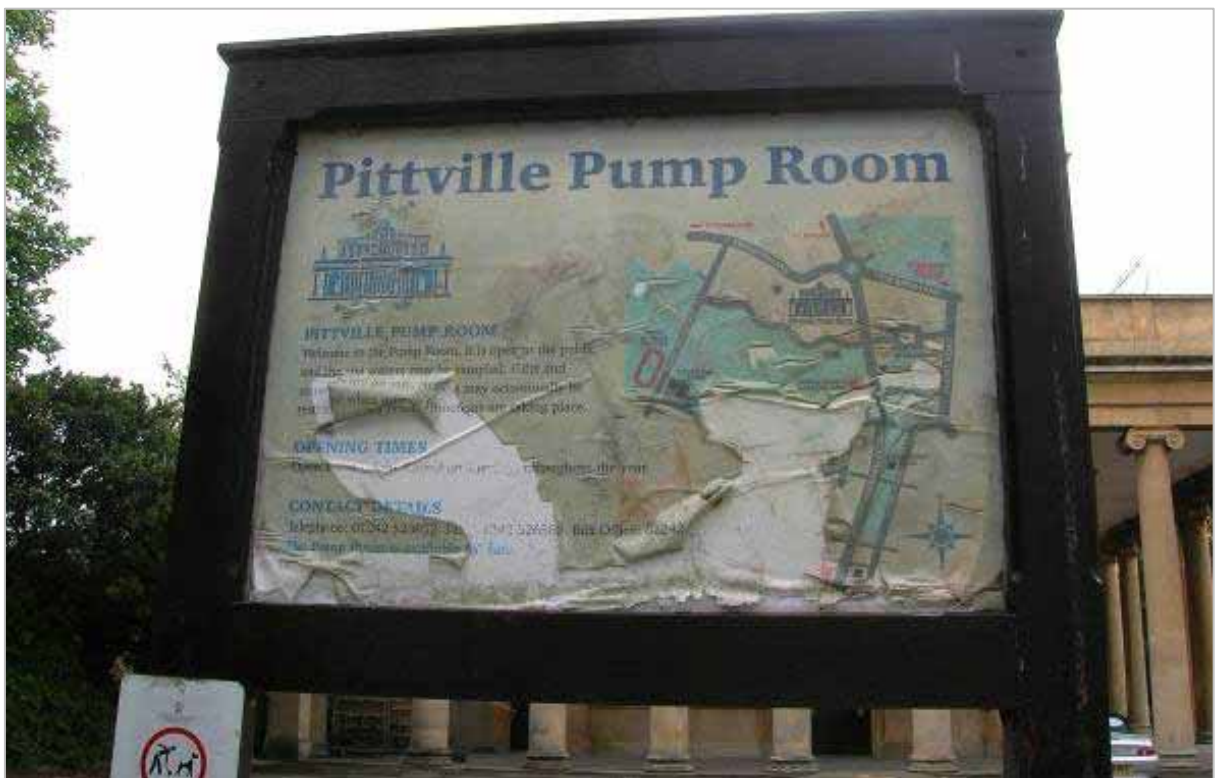
A brown wooden sign is positioned close to the ironwork to announce the arrival at the Pump Rooms. The information displayed on the sign is dated and worn and gives the visual appearance of neglect. The sign would be difficult to read if arriving by car.

2007 Gateway signage

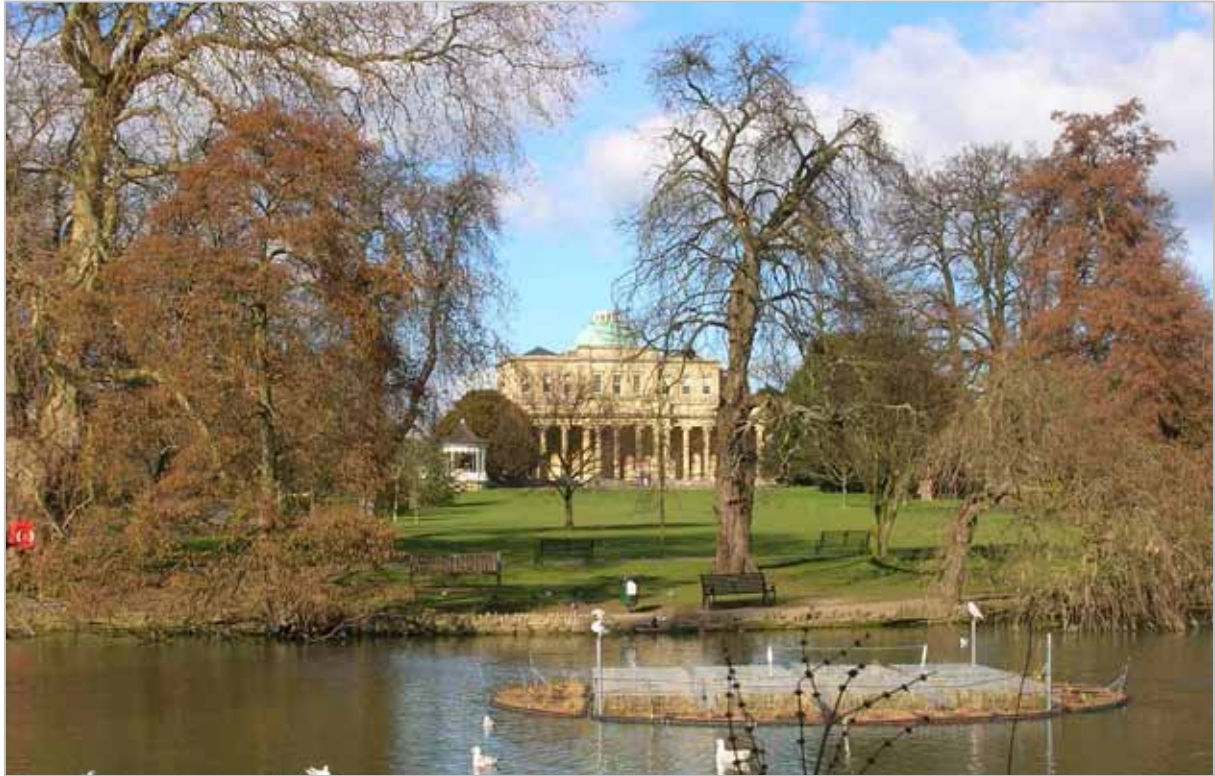
The path continues to run almost parallel with the lake for around most of the northern edge, occasionally circling around mature trees which have been allowed to grow into the lakeside. From the southern shore, the vista towards the Pump Room has become partially blocked by mature trees.

2007 Pittville Pump Room becoming obscured by trees

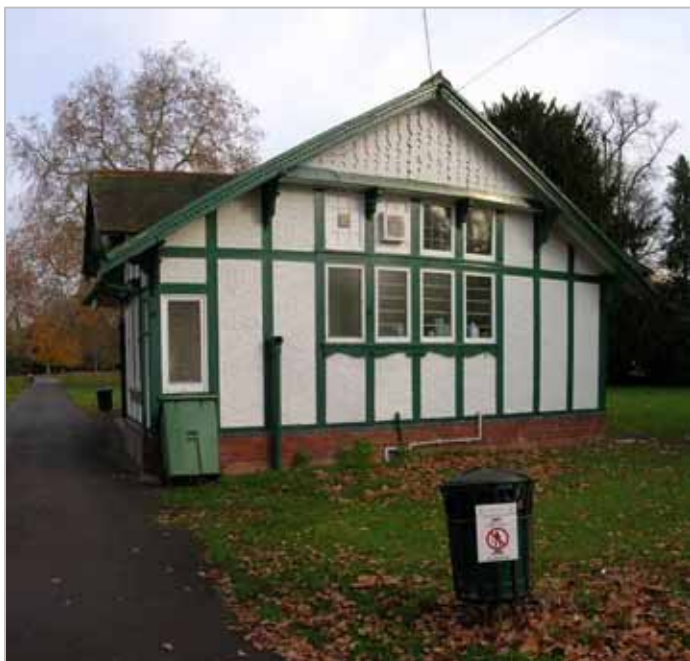
There are a number of rubbish bins and a wheelie bin located close to the Chalet which are unsightly and detract from the architectural style of the building and the landscape setting.

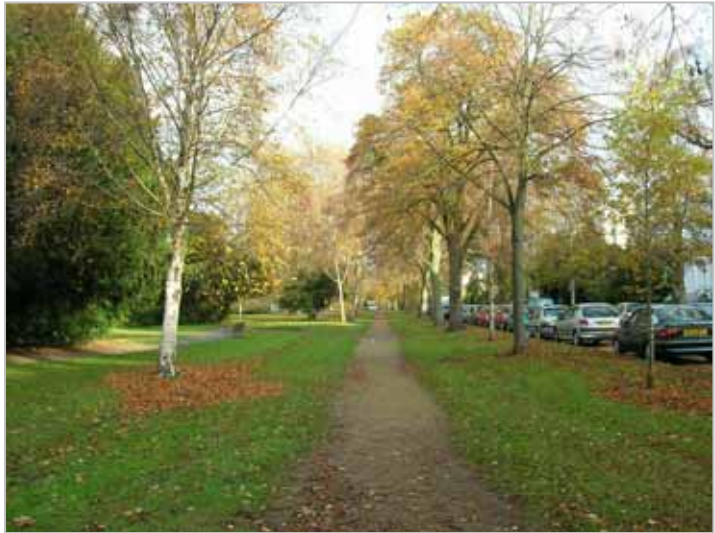
To the west there is also a hard surfaced bitmac footpath which runs parallel to the A435 Evesham Road. This hard surfaced path is repeated to the north, running parallel with Central cross Drive and in the south, running parallel with Wellington Road. In places tree roots are distorting the bitmac surface, which may prove to become a tripping hazard in the future and contributes to an untidy and neglected atmosphere.

2007 Informal path adjacent to Pittville Lawn

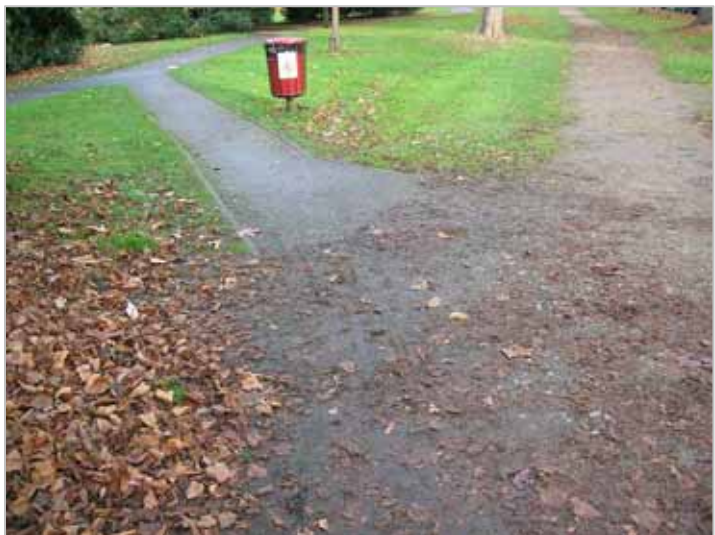
To the east however, there is an informal path with a compacted gravel surface which runs parallel with Pittville Lawn. This informal path is showing signs of deterioration, especially at the junctions with roads and hard surfaced footpaths.

2007 Path deterioration

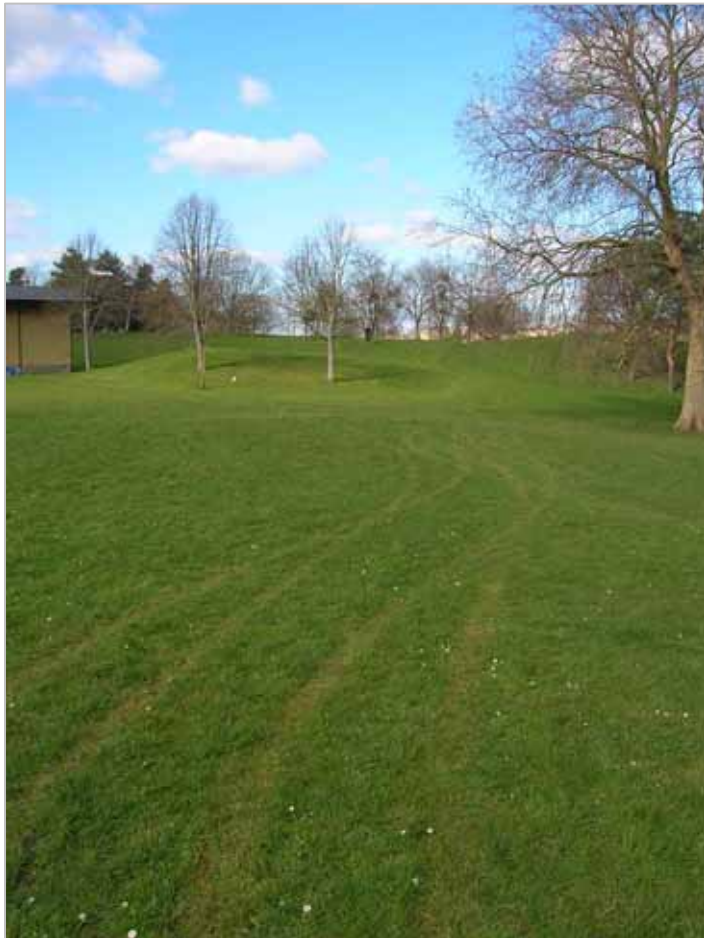
A bollard has now been installed into the centre of the footpath close to the bridge which crosses Wyman's Brook. This measure is already proving inadequate as motorbikes can still pass by easily on the footpath and cars are now being driving across the grass adjacent to the Leisure @ Cheltenham sports centre.

2007 Tyre tracks in the grass close to the western lakeside made by unauthorised vehicles

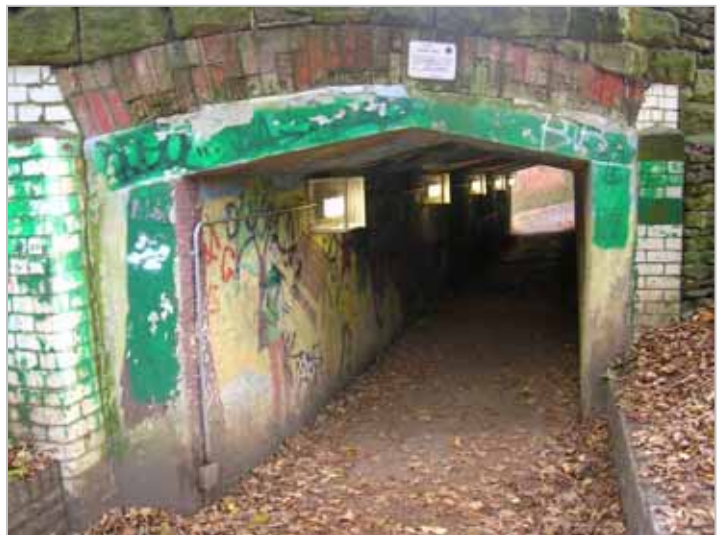
The subway was originally decorated with glazed tiles and later rendered with concrete. Artwork had been painted on the walls, however this is now mostly covered with graffiti, looking very neglected.

2007 Subway current visual condition

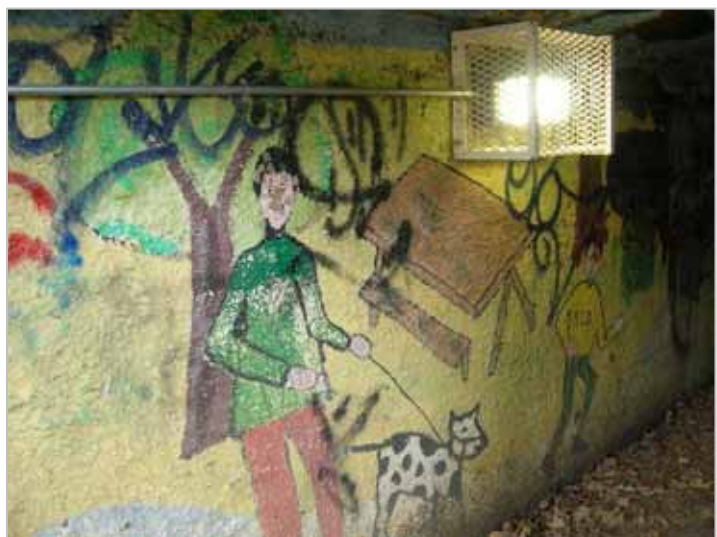
The lighting units within the subway are low and covered with a large square mesh box which is situated at around eye / forehead level and could potentially be a major hazard.

The lighting within the subway is poor and on darker days is barely adequate to light the passage.

2007 Subway art work and lighting

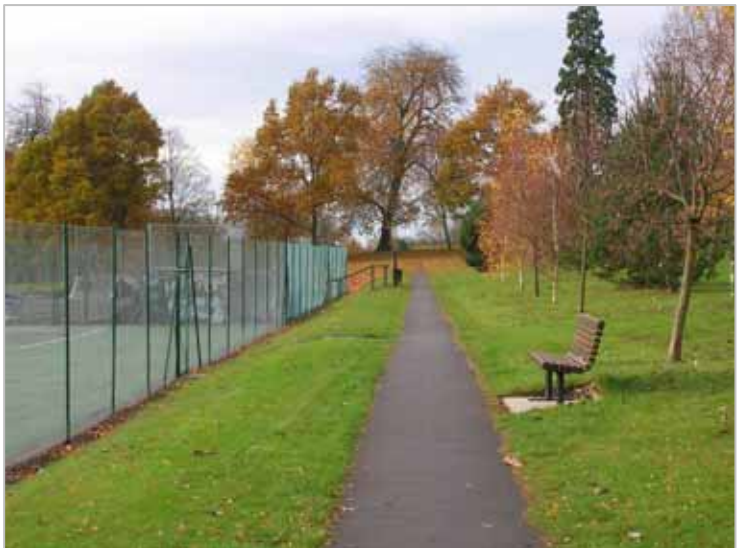
There is one bench sited adjacent to the footpath to the north of the tennis courts. One other base for a bench is sited adjacent to the skateboard park, however the bench is missing.

2007 Bench facing the tennis courts (above) and missing bench (below)

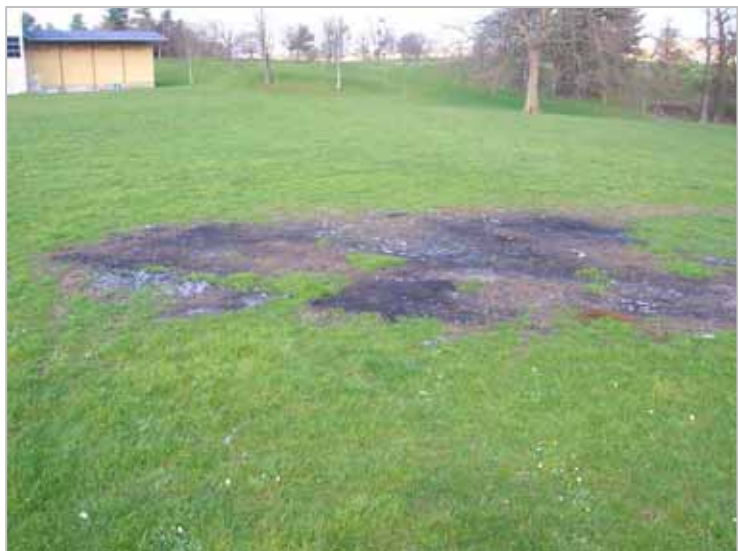
The landscape surrounding this play area, within this character area should provide a stimulating, natural environment for play, however consultation with park users and nearby residents has discovered that there is an element of fear and uncertainty in allowing children free access to this play area and surrounding landscape. This is due to the frequent misuse of Pittville Park by unauthorised vehicles, motorcycle riders and joy riders, who enter the park, drive at speed and then burn out stolen vehicles.

2007 Remains of a burnt out car

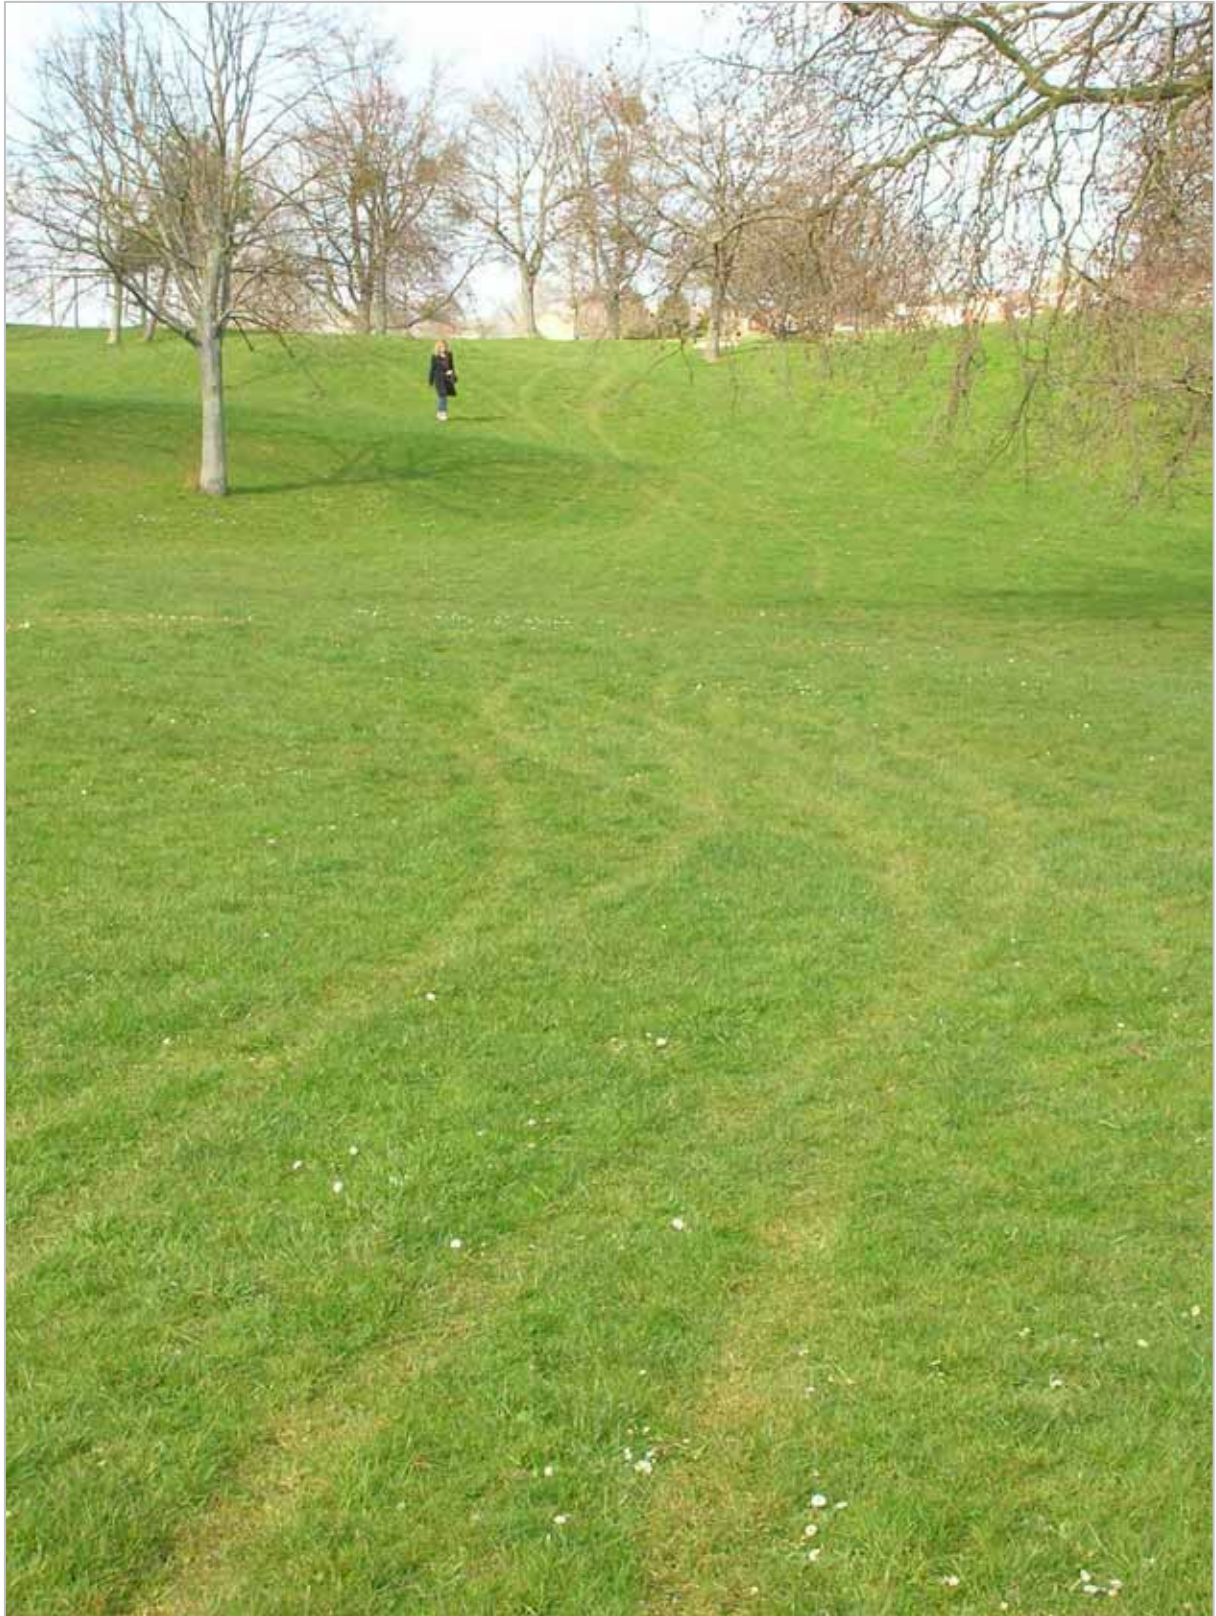
On site visits tyre tracks were observed in the grass within this character area. It is understood that unauthorised vehicles are driven into the park off Tommy Taylor's lane and along the hard, bitmac surfaced footpath, turning south and crossing the bridge over Wyman's Brook before heading for the Agg Gardner recreation ground. A bollard has been installed into this footpath on the bridge however, vehicles continue to enter the park and now drive straight across the hill adjacent to the Leisure @ Cheltenham sports centre.

2007 Tyre tracks made by unauthorised vehicles

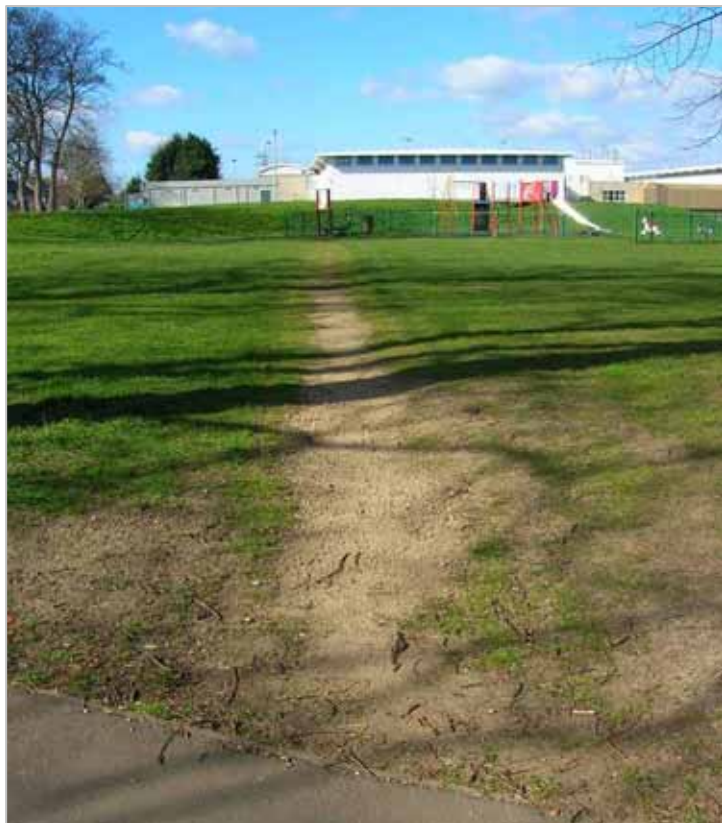
The footpath leading to the Children's Play area is well worn, with the gravel surface long disappeared and now appears as a desire line which leads from the main footpath is an indication that this is a well used route.

2007 Desire line to Children's Play area

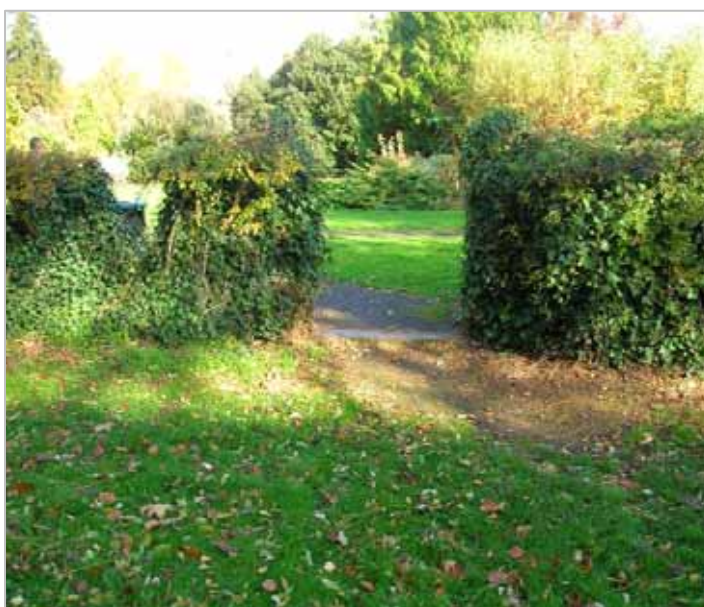
Access into Wellington Square is via gateways to the north, south, east and west sides. The gateways are defined by open sections of the hedge, by iron railings with gate missing and iron gates. The ironwork is in decline and is in need of renovation or replacement. The lack of unity in the gateway treatment also adds to the appearance of neglect.

2007 Wellington Square gateway with missing gate

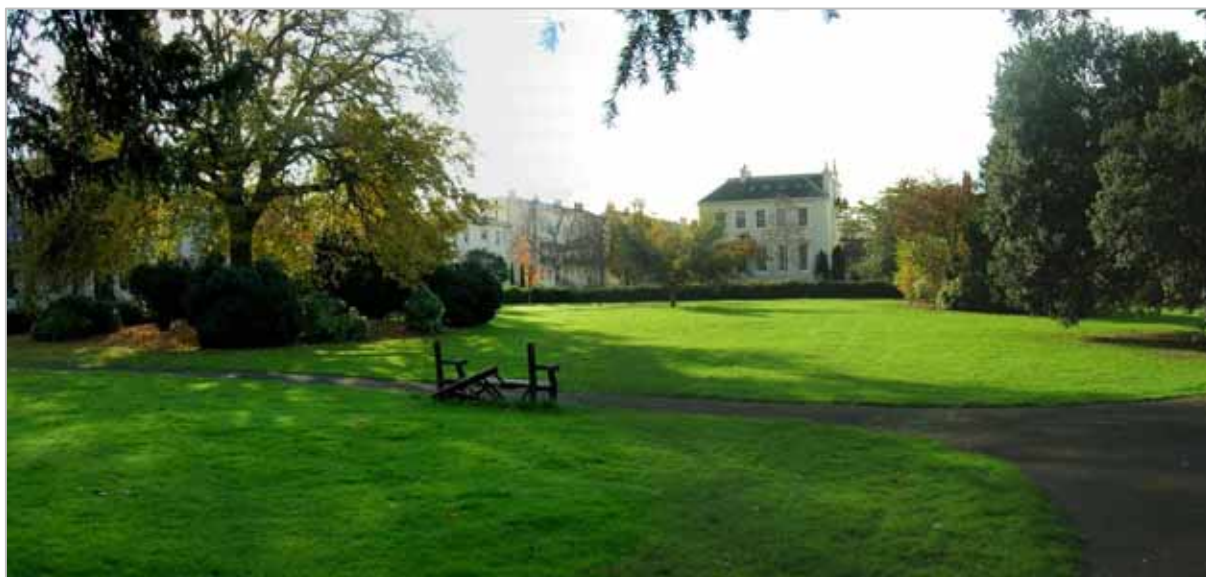
Within this distinctive green space there is little seating provision. On the occasion of site visits in November 2007, this single bench was damaged.

2007 Wellington Square broken bench
