ARBORICULTURAL SURVEY AND STATEMENT

OAKLEY FARM, CHELTENHAM

OUTLINE PLANNING
APPLICATION FOR
RESIDENTIAL
DEVELOPMENT AND
ASSOCIATED
INFRASTUCTURE

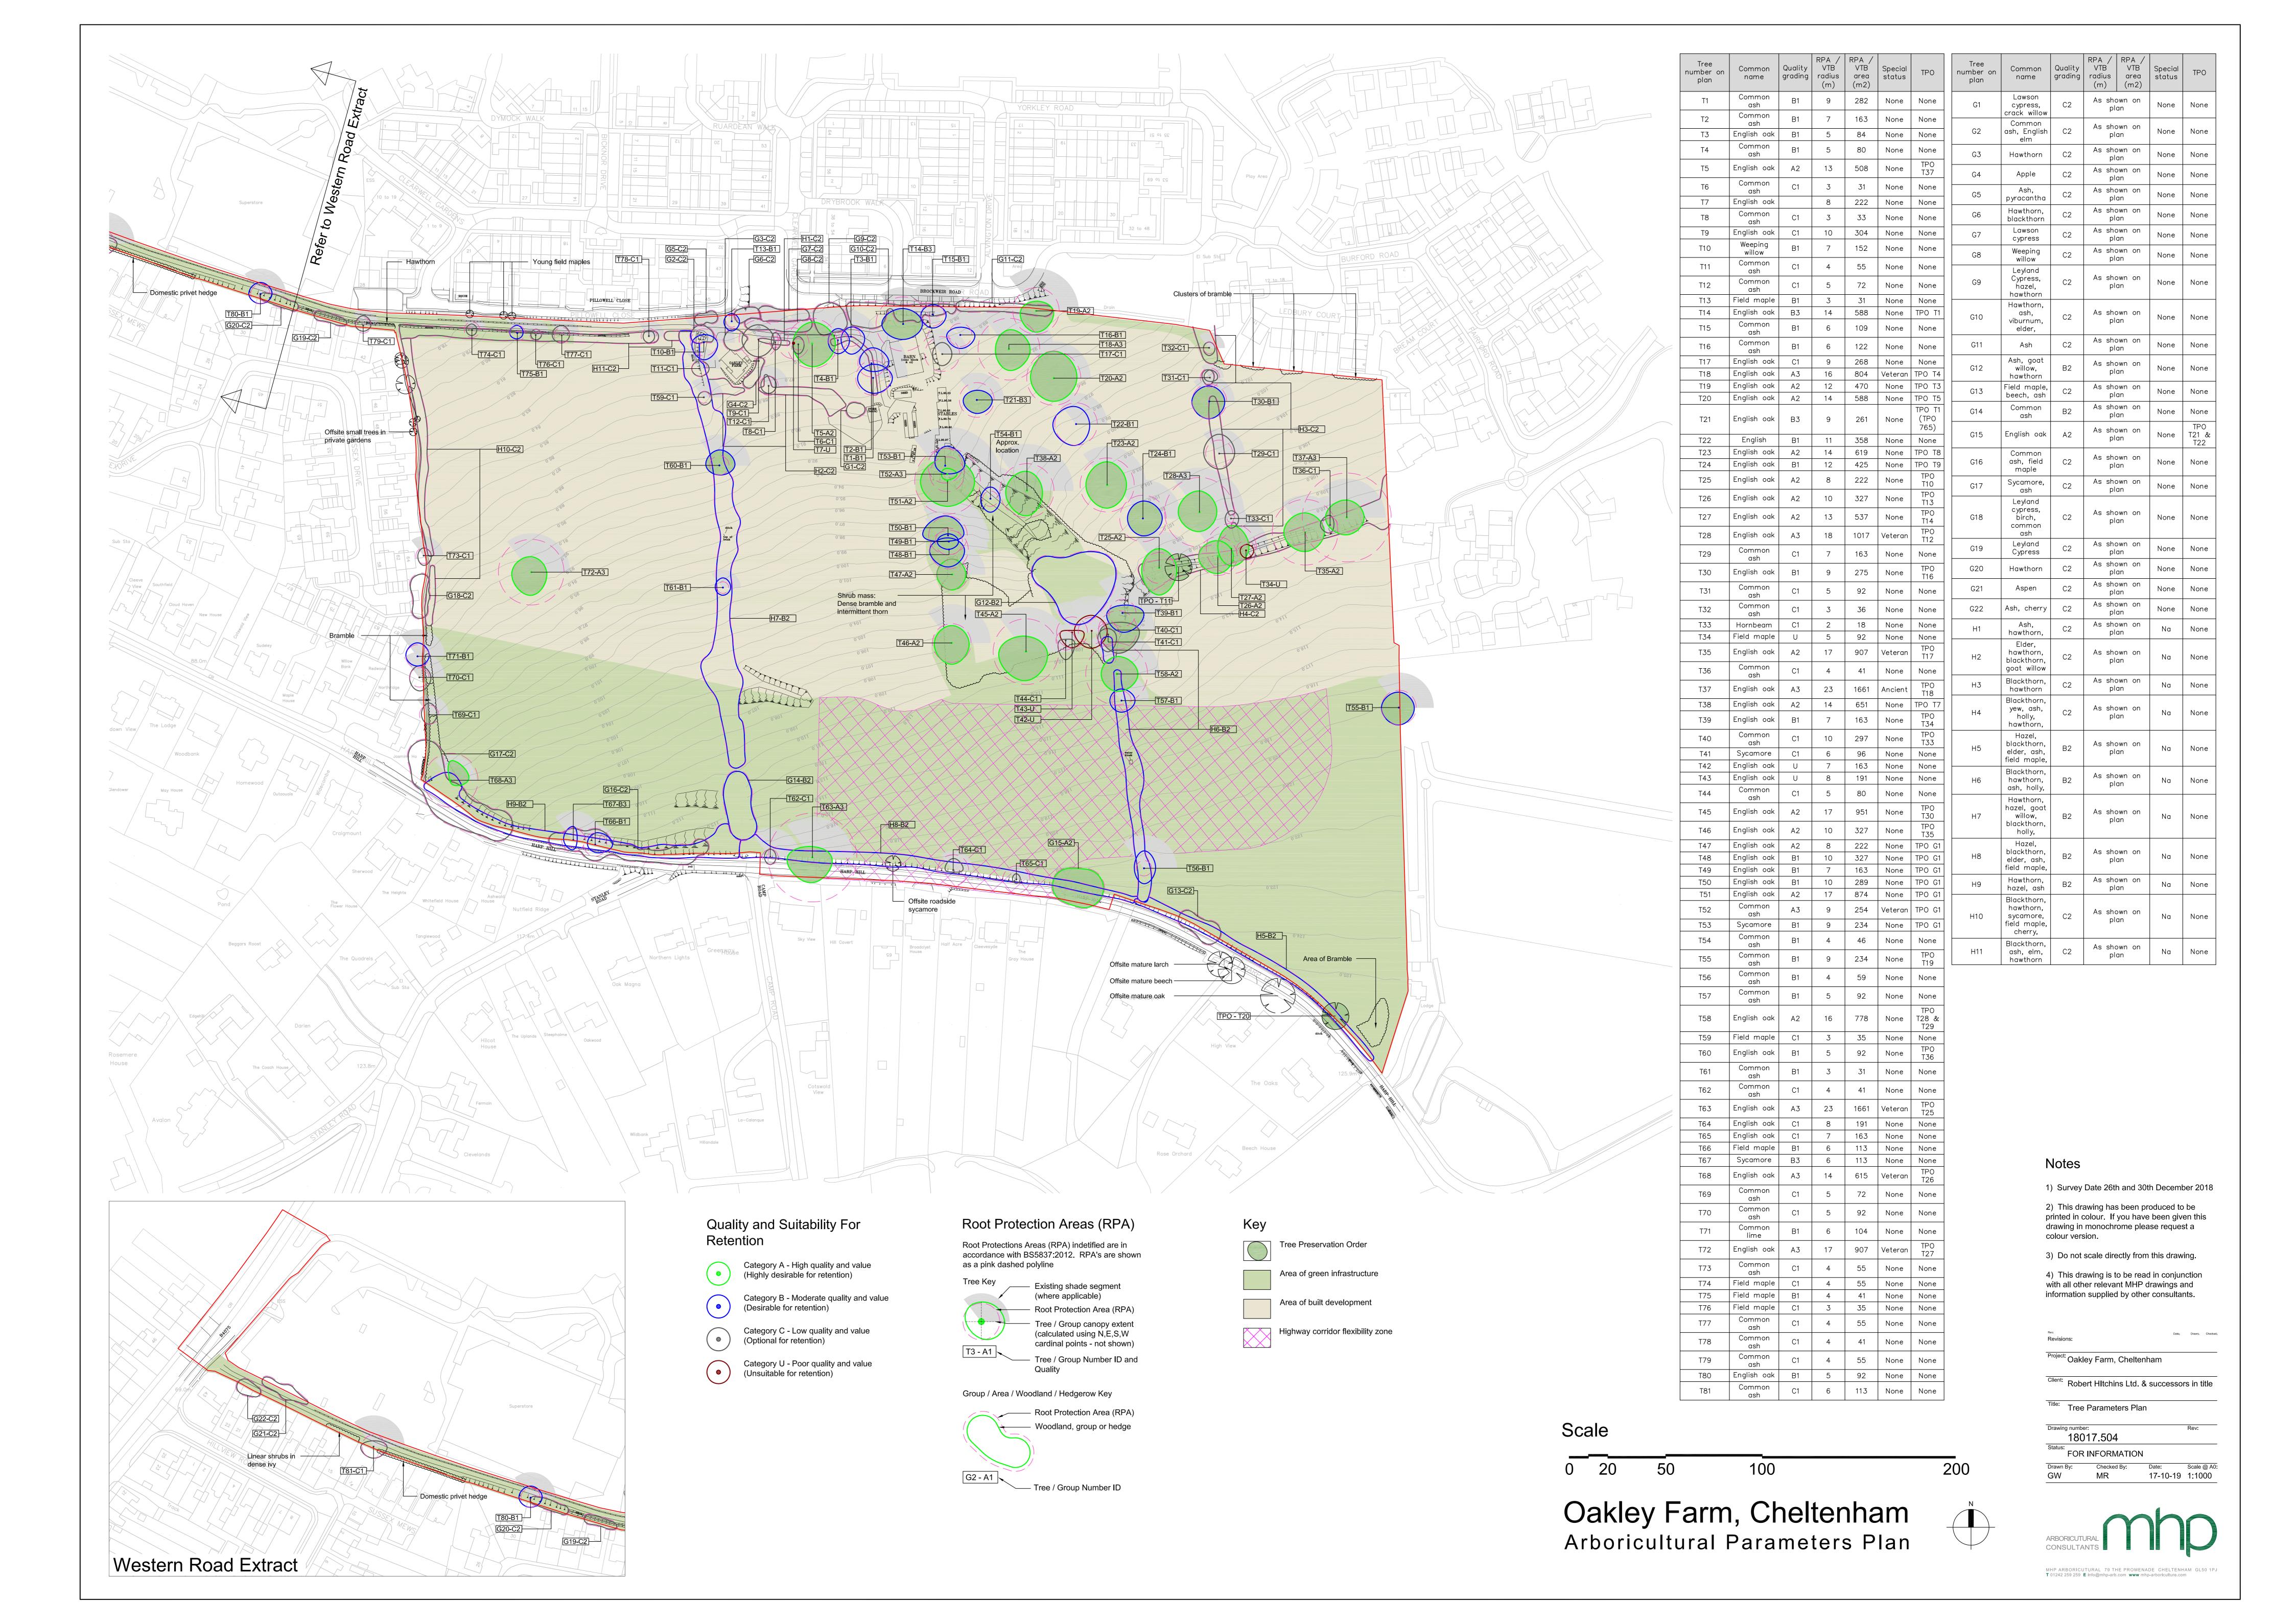
APPENDIX 2 – TREE SURVEY AND CONSTRAINTS PLAN WITH GREEN INFRASTRUCTURE PARAMETERS

3.1.1 The constraints posed by the surveyed arboricultural features on site are shown on the Tree Survey and Constraints Plan at **Appendix 2**. This plan also shows the green infrastructure parameters that have been set in relation to the planning proposals.

- 4.1.2 Overlay with the Tree Survey and Constraints Plan shows that there are various significant trees, tree groups and hedges within the built development parameters area and the highway corridor flexibility zone. However, there is also considerable space between many of the trees and on this basis I can infer that a considered design process with appropriate arboricultural input can achieve a sustainable and harmonious relationship between new built form and existing trees.

- 4.1.3 In due course, as detailed proposals come forward, I anticipate that further details setting out tree protection measures will be required in order demonstrate with enough clarity that the proposals can be achieved without harm being caused to significant trees.
