Cheltenham Borough Council Planning Policy Team Local Plan Draft Document May 2017

Map 2. The boundary of the St Paul's Conservation Area and proposed removal;

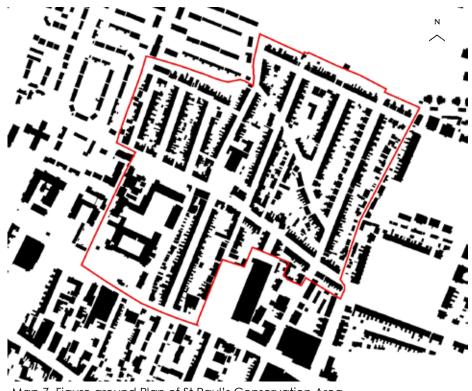
Map 7. Figure ground Plan of St Paul's Conservation Area

3.1.1 The planform of the Conservation Area encompasses the majority of the area of St Paul's, predominantly encompassing 19th century narrow residential streets which run on a north-south axis in a slight irregular grid pattern. Swindon Road and St Paul's Road are wider and run on an east-west axis, with artisan terraces running to the north and south.

3.1.2 The majority of which are located on the front of the pavement with no garden (Fig.3.1). Buildings located on Marle Hill Parade, Marle Hill Road and St Paul's Road are set back behind small frontages. Service and narrow back lanes running

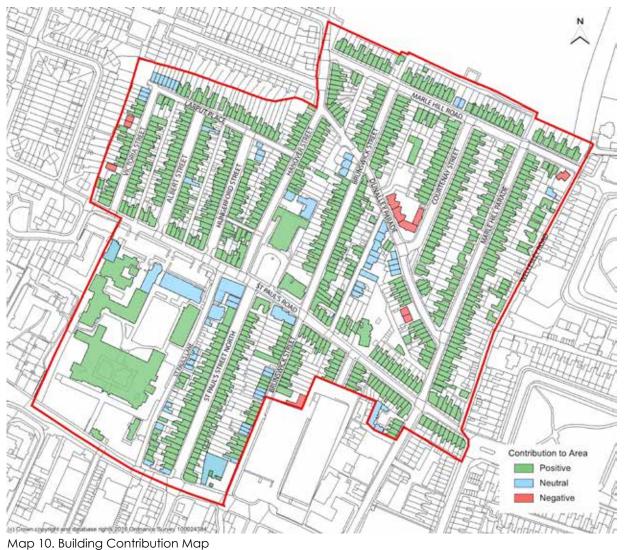
5.1.3 Whilst artisan terraces offer a degree of uniformity there are subtle differences between the roads due to the gradual development of the area. Victoria Street, for example consists of a wide range of materials, including stucco, red brick and checkerboard bricks, where houses were often built as pairs within the terrace by individual builders.
