The Poets Conservation Area

Character Appraisal and Management Plan

Cheltenham Borough Council
Planning Policy Team
Local Plan Draft Document
May 2017

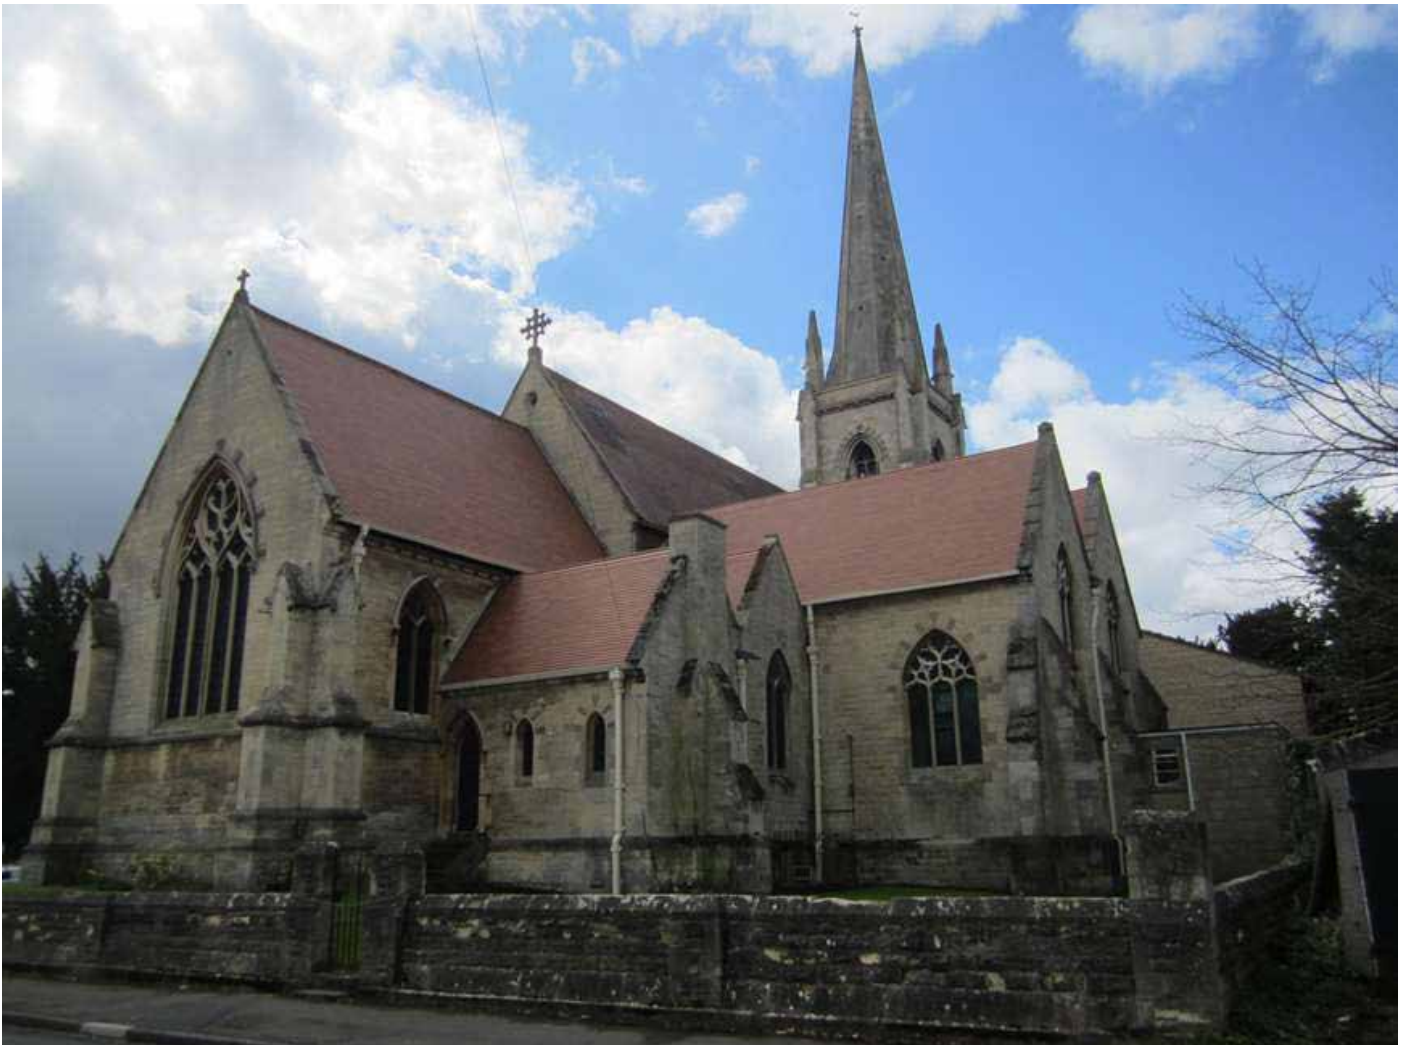
Fig.2.1 St Mark's Church, where the areas name originates from

2.2.1 The area of St Marks began development in the mid-19th century, and included the building of St Mark's Church, designed by John Middleton between 1860 and 1866, of which the area is named after (Fig.2.1). Other significant developments include two large residential properties, The Granley and Hillfield circa 1860-70, and properties to the east of the conservation area along Church Road.

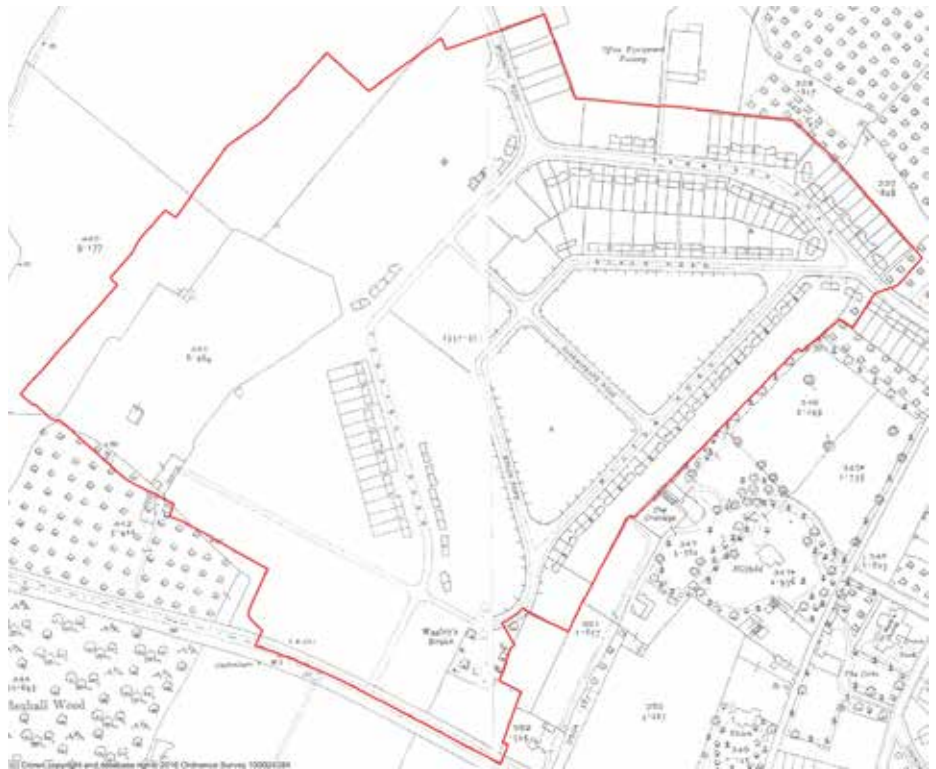
Map 4. 1923 OS Map demonstrating initial development under the 1919 Housing Act

2.2.4 The estate was built in three distinct phases under individual housing acts (Map 5). Funded by the 1919 Housing Act the initial plans for 50 houses at the Libertus Road end of the estate were approved in November 1919 and in April 1920 the mayor cut the first sod for Cheltenham's first council housing estate. These were designed by Chatters, Smithson and Rainger and built by A. C. Billings, with 10 houses on Libertus Road ready

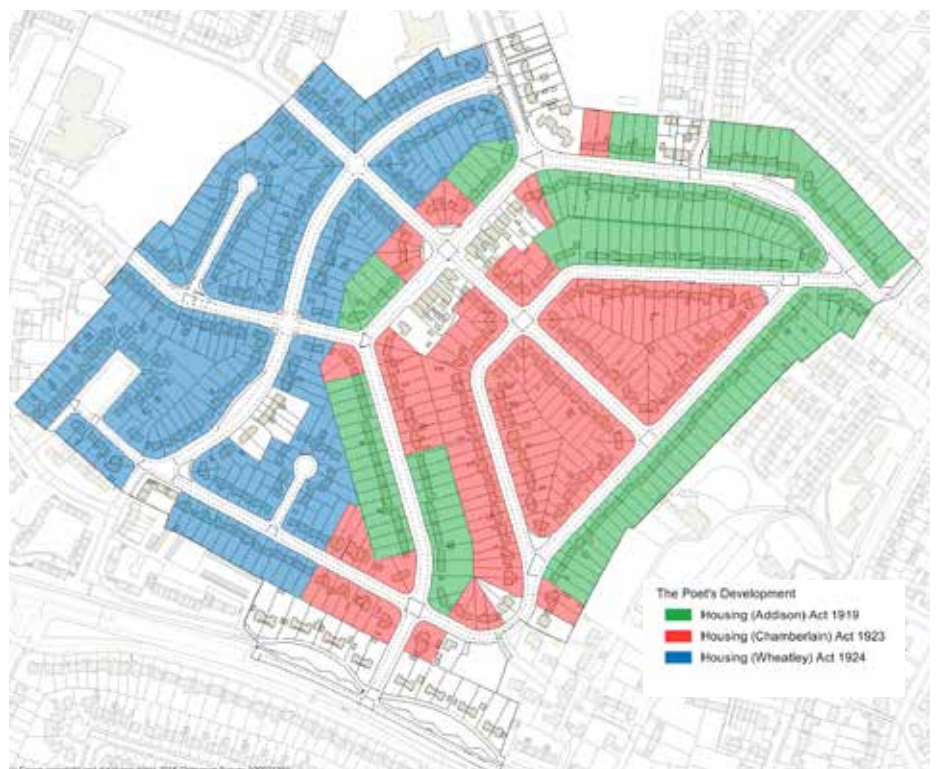
Map 5. Development stages of the St Mark's Estate

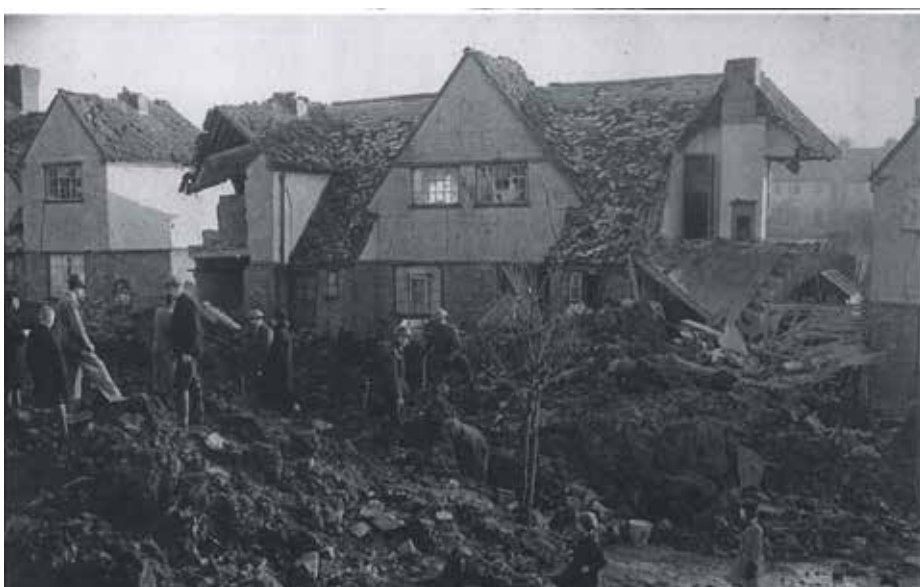
Fig.2.3 Bomb damage, Kipling Road

2.2.9 On December 11th 1940 during World War Two six houses were destroyed due to a bomb and a number neighbouring houses damaged. In their replacement in the 1950s a terrace of four and a pair of semi-detached houses were constructed. It appears as if considerable damage was done to neighbouring properties due to likely replacement roofs and unusual window features on the houses neighbouring the bomb sites when compared to the rest of the estate.

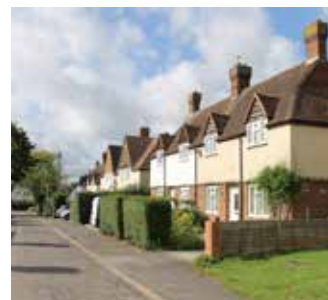
Fig.3.1 Regular rhythm of houses

3.1.2 The street layout and the relationship of built form to open spaces form a key characteristic of the area with development following a regular building line throughout the estate (Fig.3.1). Plot sizes are regularly shaped and generous, with a low density of 12 houses per acre, all featuring small gardens at the front but substantial plots to the rear. New developments on Guinevere Way (former Spirax Sarco site) fail to respect the density.

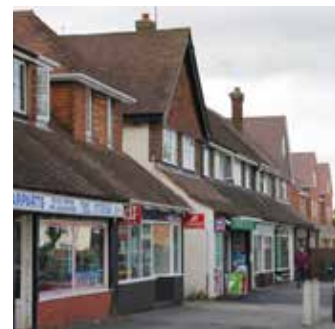
Fig.3.2 Shops, Tennyson Road located at the heart of the area

of the road with a wide pavement. These shops date from the early 1930s and have a historically important function.

3.3.2 In the centre of the conservation area on Tennyson Road the shops have a greater massing than the rest of the estate, where there is a small terrace with shops at the ground floor and residential above (FIG 3.3).

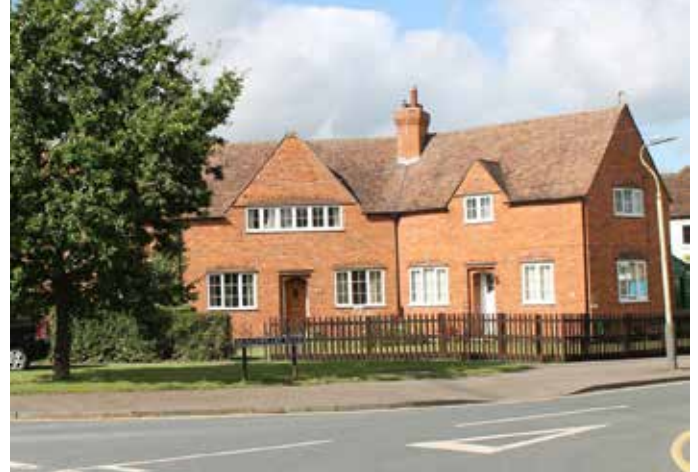
Fig.4.1. Prominent open corner plot Tennyson Road

4.1.2 Areas of grass are still common at corner plots such as Tennyson Road and Byron Road (Fig 4.1 & 4.4) and where the road meanders for example through Kipling and Tennyson Road. These features are important, however are increasingly being replaced with asphalt to enable the creation of drives, which has a detrimental impact on the green space throughout the area.

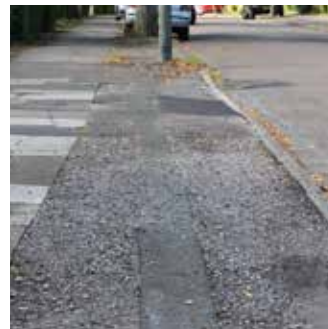
Fig.4.2 Poor quality foot-paths

4.1.6 Generally the footpaths are in a poor condition, with slabs largely uneven and in many cases due to tarmacking up to the tree this has resulted in considerable lifting and damage from the tree roots (Fig 4.2). The paths would have originally been gravel, and today resin bound gravel would be a more suitable treatment, particularly surrounding trees.

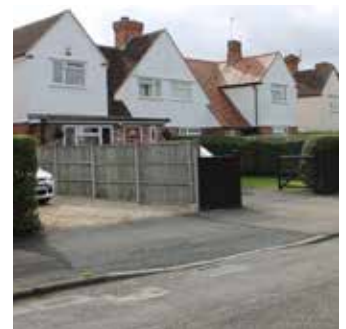
Fig.4.3 Loss of paving slabs

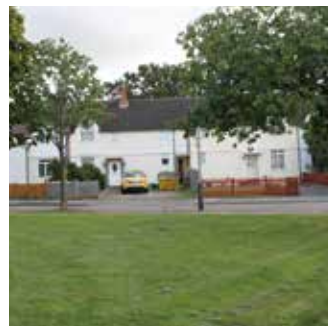
Fig.4.4 Open corner plot Byron Road

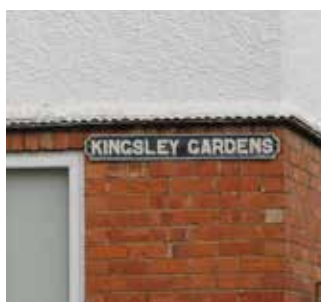
Fig.4.7 Historic street signs

4.1.8 There are a number of historic street plates on houses in Byron Road and Wordsworth Avenue that have been retained, these make a positive contribution to the area (Fig.4.7).

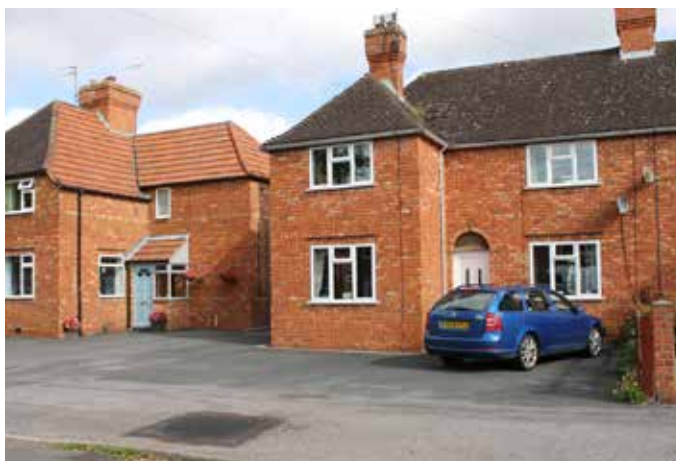
Fig.4.10 Loss of front gardens

4.3.1 When the houses were built no provisions for parking were made, as a result over the years drives have been added in an ad-hoc manor. Today private drives are a mixture of tarmac, brick, gravel and paving slabs. A significant proportion have resulted in the total loss of front gardens which have a detrimental impact on the uniformity of the street scene (Fig.4.7).

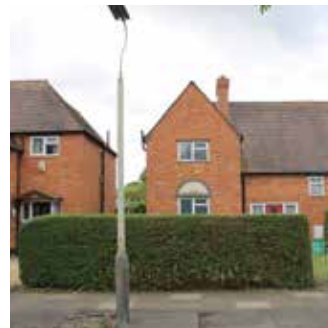
Fig.4.12 Original style Privet Hedge

4.4.1 Privet Hedges play a significant role within the conservation area forming a visually attractive and historic boundary treatment (Fig.12, 13 &14). Generally they are well maintained, but the introduction of drives in many cases has resulted in the partial and in certain cases the complete loss of original boundary treatments. This is a particularly evident on Shelley Avenue where very few properties have any boundary treatments as a result of the introduction of parking.

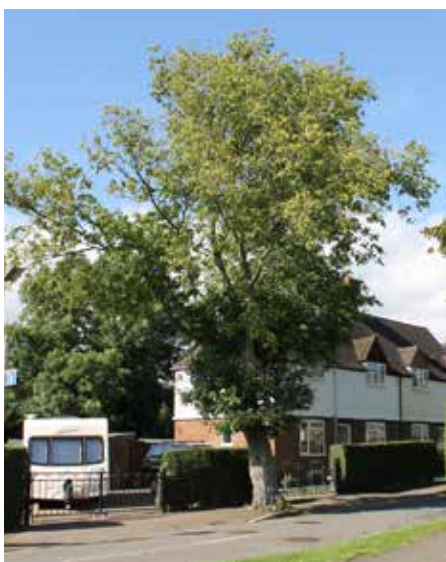
Fig.4.11 Box-elder

4.5.1 Trees play a fundamental role in the setting of the Poet's Conservation Area, with tree lined avenues being a key characteristic of the garden suburb principle which the estate is based on. There were intended to be three types of trees within the estate; Black locust (Fig.4.18), Cherry (Fig.4.15) and Box-elder (Fig.4.11).

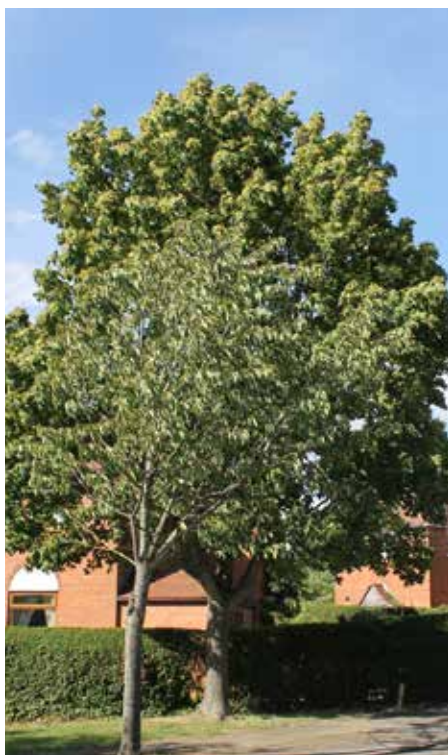
Fig.4.15 Cherry and Norway Maple

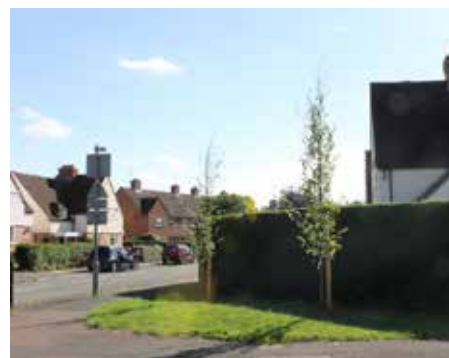
Fig.4.17 Hornbeam Frans Fontaine

4.5.4 There is evidence of tree replacements carried out by Amey on behalf of Gloucestershire highways, however a significant proportion of new trees have been with species which are largely alien to the estate such as Hornbeam (*Frax Fontaine*) (Fig.4.17) and Himylian

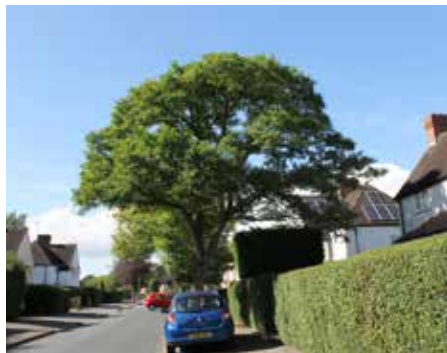
Fig.4.18 Black Locust

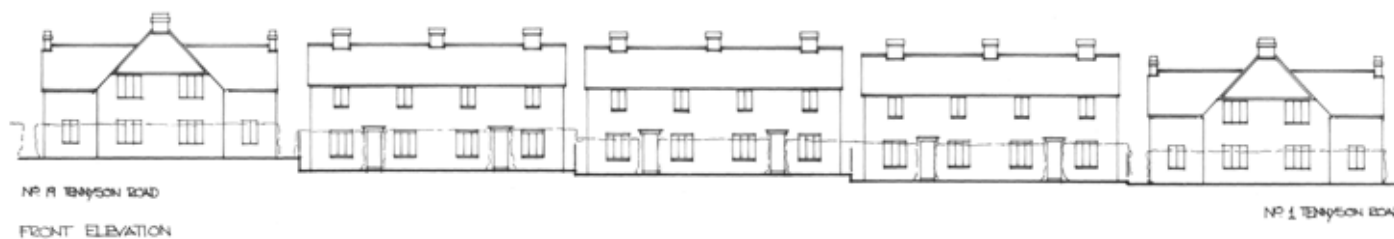
Fig.5.1 Front elevations of houses on Tennyson Road. Reproduced with permission from Harvey Faulkner-Aston

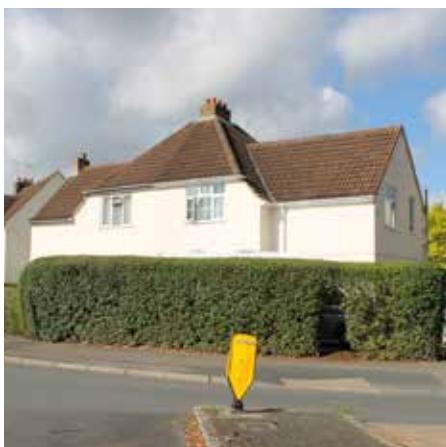
Fig.5.7 Corner plot with projective bay

5.4.1 Houses are predominantly semi-detached with a rectangular planform. Variation to the initial development is introduced on corner plot buildings by the formation of a front and rear projective bay (Fig.5.4). Houses generally follow a uniform building line, however some are set back slightly (Fig.5.5). Properties are generally constructed of block work and rough-cast render, although in recent years a number have been re-rendered with smooth render which alters the character (Fig.5.4). There is a mixture of brick and blockwork stepped chimneys. Most designs incorporate a pre-cast concrete corbelled porch canopy over the main entrance. Windows would originally have been steel or timber casements.

- Corbelled Porches
- Stepped Chimneys (Fig.5.3 & 5.6)
- Projecting Bays (Fig.5.6 & 5.7)
- String course (Milton Road) (Fig.5.3)
- Cast Iron Rainwater Goods
- Plain Gables (Fig.5.7)

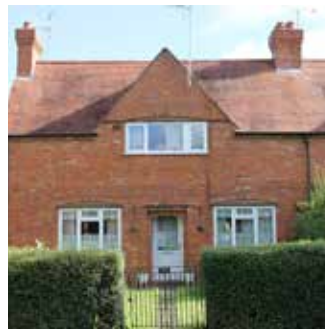
Fig.5.10 Arts and crafts inspired house

5.4.7 Rendered infill panels, with tile surround are a feature over ground floor windows on a proportion of houses. Relieving arches with tile keys are also another common arts and craft detail (Fig.5.10 & 5.18). However, a significant number have been lost as a result of replacement windows.

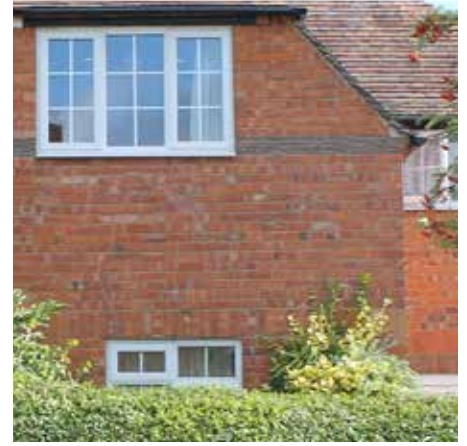
Fig.5.16 Horizontal tile creasing

- Rendered infill panels with tile surround above windows (Fig.5.13)
- Full width string courses of horizontal laid tiles (tile creasing) (Fig.5.16)
- Recessed porches (Fig.5.20 & 5.1)
- Cast iron rainwater goods
- Soldier courses above windows
- Stepped chimneys (Fig.5.19)
- Plain gables (Fig.5.18)
- Catslide, Hipped and Gabled Roofs
- Relieving arch (Fig.5.18)

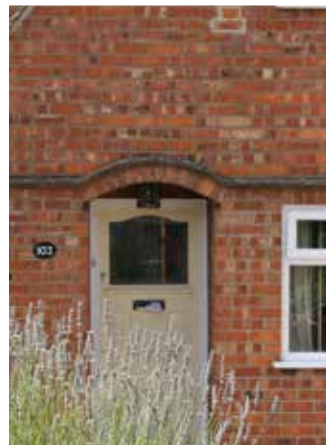
Fig.5.20 Recessed porches

5.4.8 Slightly recessed porches are found on the majority of houses, however with the replacement of original doors with modern uPVC alternatives this feature is being lost.

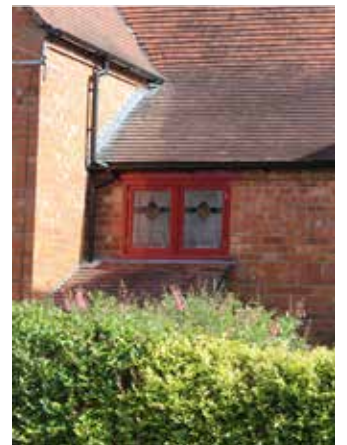
Fig.5.22 Art-nouveau windows

5.4.10 Windows would originally have been timber casements with glazing bars, but almost all have been lost. It is likely that a number of houses on Spencer Avenue had art-nouveau inspired designs on windows above the porches, of which today there are two surviving examples (Fig.22).

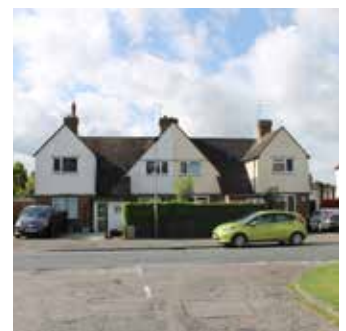
Fig.5.24 Mismatch of colour

5.4.13 The majority of houses built in this phase of construction conform to the pattern of red brick construction to the ground floor and roughcast rendered blockwork to the first floor. The lack of cohesive colour scheme today harms the uniform character of the conservation area, and is particularly damaging with semi-detached houses painted different colours (Fig.5.24). It is likely that the render would originally of been painted white. Furthermore, there is a great deal of staining on paint due to lack of maintenance (Fig.5.29). Spenser Road and Avenue are the exception, with brick houses throughout and mark a stage of transition from the 1923 to 1924 Housing Act.

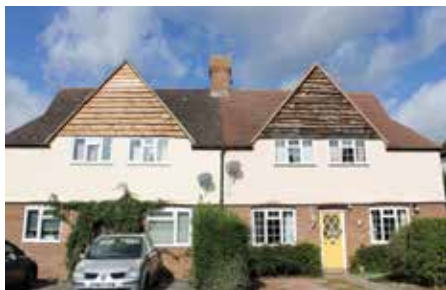
Fig.5.28 Horizontal boarding on gables

5.4.15 Gables and generally plain, with the exception of Shelley Avenue which is the only street on the estate to feature wavy horizontal boarding to the first floor gables (Fig.2.28). Poor quality replacements are becoming increasingly common which harm the character and appearance of the conservation area and should be avoided.

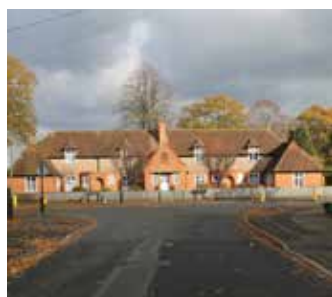
Fig.5.38 Jesse Mary Chambers Almshouses

5.5.1 Two storey construction, with hipped roofs and low eaves levels commencing at one and half-storey height (Fig.5.38). The ground floors are of exposed brickwork, with the first floor walls of natural colour render. The roof is made of clay tiles, and unlike many properties all original timber doors and windows are retained.

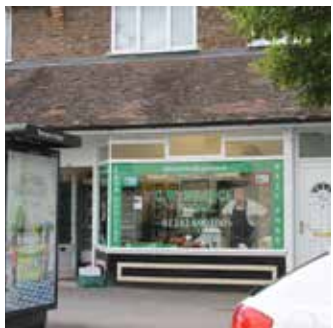
Fig.5.37 1930s shop-front

5.4.19 The buildings vary in form, comprising of several semi-detached and a long terrace, all having domestic accommodation above. Several contain their original shop fronts, and these should be retained (Fig.5.37). Vertical tile hangings have been incorporated into the design, predominantly on first floor elevations.

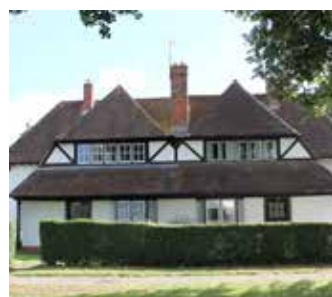
Fig.5.39 1 & 3 Brooklyn Road

5.5.2 Semi-detached houses. C1925, by Chatters, Smithson & Rainger (Fig.5.39). Two storeys, rendered and half-timbered with prominent roof slopes and hipped gables of red clay tile and a tall central chimney.

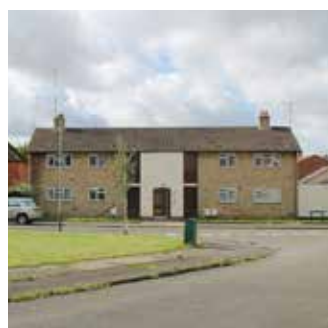
Fig.5.40 Unsympathetic flats, Spenser Road

5.7.1 There is a poor quality block of flats and two bungalows on the corner of Spenser Road and Wasley Road. The size, scale and foot print of the development is out of character with the area. Furthermore, new developments on Tennyson Road do little to enhance the area, due the excessive massing and the introduction of alien boundary wall treatments.

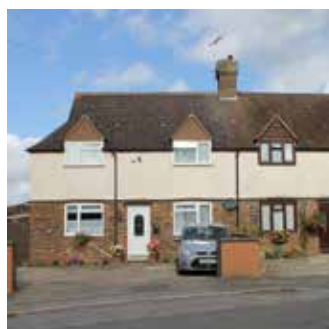
Fig.6.3 Loss of architectural features

- Loss of historic architectural features (Fig.6.3)
- Alterations to external finish such as cladding or smooth render
- Inconsistent colours
- Re-pointing of walls with cement
- Replacement of original doors and windows with uPVC
- Poor quality new developments
- Poor maintenance (Fig.6.1)

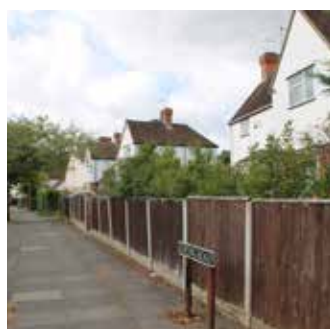
Fig.6.2 Loss of original boundary treatments

- Loss of front gardens and original boundary treatments (Privet Hedges) (Fig.6.2 & 6.4)
- Loss and poor maintenance of trees
- Loss of grass verges
- Poor street signs and furniture and loss of historic fabric
