Prestbury Conservation Area

Character Appraisal and Management Plan

Cheltenham Borough Council
Planning Policy Team
Local Plan Draft Document
May 2017

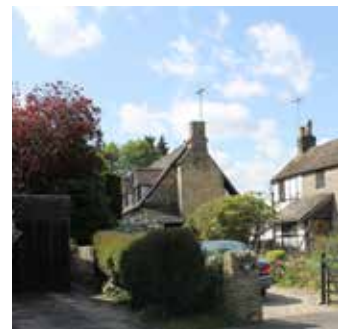
Fig.3.1 Houses following the original Burgage plot boundaries

development. The size and shape of the plots along The Burgage are determined by the historical pattern of the burgage plots; which are long and narrow and have resulted in houses in close proximity to each other (FIG 4.1 POINT A & FIG.3.1.). Many front directly on to the pavement or have narrow enclosed frontage strips.

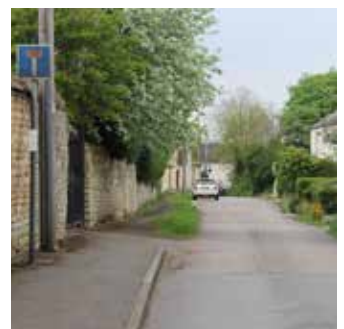
Fig.3.2 Long views evident on Lake Street

3.1.2 Road layout varies throughout, with Mill Street having a gentle, winding form. Deep Street and High Street have a more exaggerated curved form as they merge with one another. The form of these roads creates a series of staggered views and interest as new views and spaces are experienced along the route. In comparison, The Burgage, Lake Street and Bowbridge Lane are straight, which permit long views though the village (FIG.3.2).

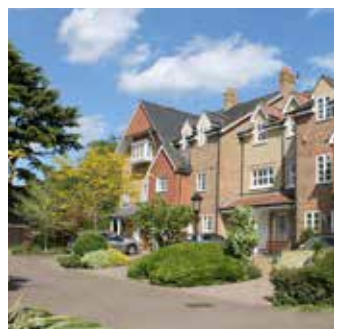
Fig.3.3 Morningside Close

3.1.5 Housing from the latter half of the 20th century as found in Idsall Drive and Morningside Close, has been more densely developed on smaller, compact plots (MAP 8. POINT C & FIG.3.3). These properties were frequently built in the grounds of earlier buildings.

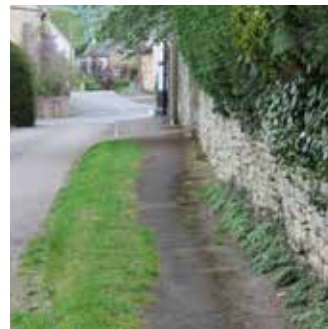
Fig.4.2 Grass Verges Lake Street

4.1.5 The condition of the asphalt footways within the conservation area is generally good and the grass verges on Mill Street and Lake Street make a valuable contribution to the area and should be retained (Fig.4.2). Within the Conservation Area there are several locations where the footways are in need of attention, particularly in the High Street and at the junction of The Burgage and New Barn Lane. The Conservation Area is poorly provisioned with dropped kerbs to assist users of mobility scooters. However, this is soon to be addressed with funding from Highways Local. The roads

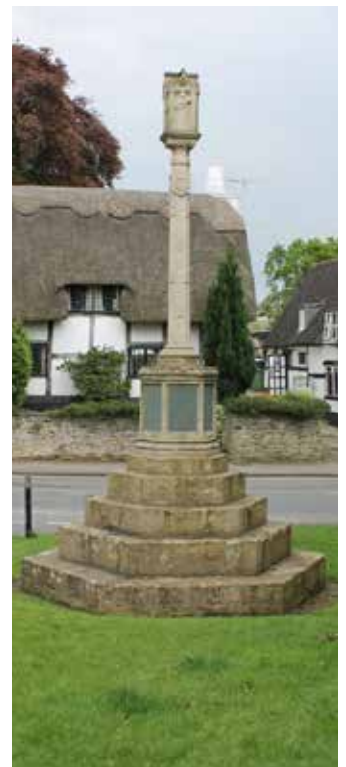
Fig.4.5 Open space surrounding the War Memorial

4.3.1 Historic street furniture plays an important role in enhancing the conservation area. Of particular prominence is the Grade II telephone box located on the High Street (FIG.4.9) and the locally listed GR post box on Southam Road (FIG.4.10). The war memorial by John Coates Carter, 1920 on High Street considerably adds to the character of the street (FIG.4.5).

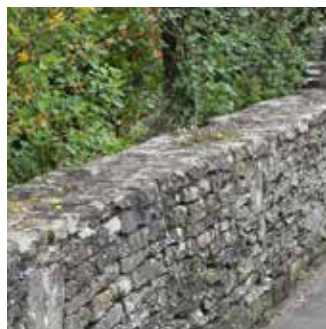
Fig.4.8 Cotswold Stone Wall

4.2.1 Traditional and historic boundary treatments of Cotswold stone and brick are common throughout the conservation area and form important features of the streetscape (FIG.4.8 & FIG. 4.11). Many of these are low set and therefore allow full appreciation of buildings, landscaping and features behind. A wall of particular prominence is the locally listed, approximately 2m high wall running along Southam Road and to the north of High Street.

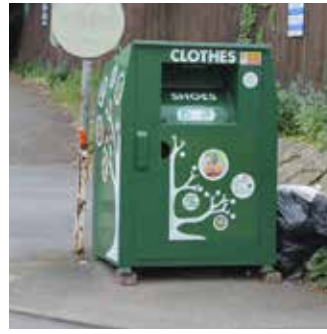
Fig.4.11 Charity bin, High Street

bins on the pavement in both the Burgage and within the The Kings Arms site on the High Street adds to visual clutter and harms the character of the area (Fig.4.14 & Fig.4.15). The poorly placed charity clothes recycling bin on High Street is similarly harmful (Fig.4.11).

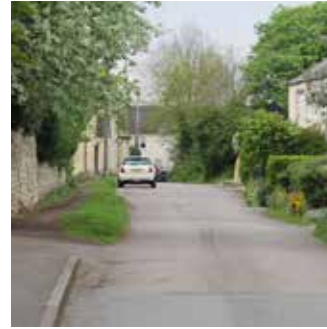
Fig.4.13 Lack of street furniture, Lake Street

4.3.3 Overall, street furniture is generally of good quality; and the lack of street furniture in Mill Street, The Burgage and Lake Street (FIG.4.13) creates a sense of space which enhances their rural character.

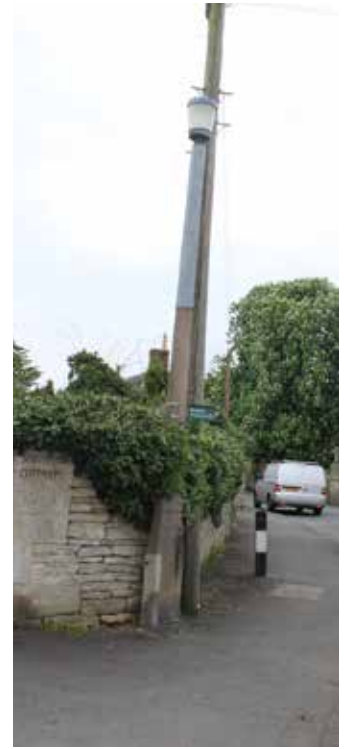
Fig.4.12 Street lighting and clutter

4.3.4 Streetlighting is functional in design, and while set back from the road does not enhance the character and appearance (FIG.4.12).

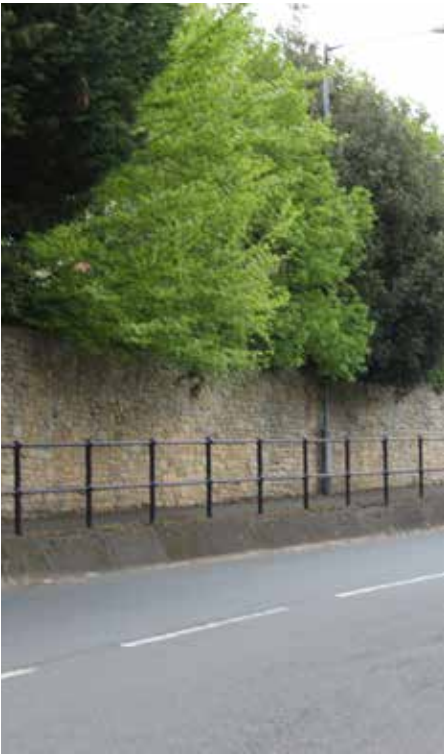
Fig.4.16 Large tree groups, Idsall Dr

5.4.3 Mature trees are evident throughout the conservation area. Of particular note is the substantial row of trees along the eastern boundary of Capel Court and includes plane, horse chestnut, lime and holm oaks. In addition to the mature yew trees that are found growing within the churchyard of St Mary's Church (Fig.4.20) and form an attractive feature. Significant tree groups are also present adjacent to St Mary's Church and Idsall Drive (Fig.4.16).

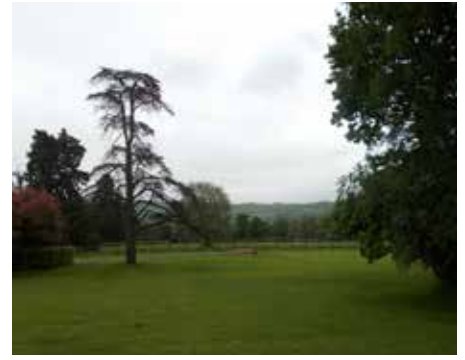
Fig.4.18 Large trees, The Hayes

5.4.2 The extensive grounds of The Hayes forms an impressive setting for the early 19th century manor house (Fig.4.18). Large wellingtonia and other substantial mature trees including poplar, cedar, hornbeam and horse chestnut grow in the lawns. The grounds, accompanied by the sweeping drive convey a sense of importance, status and grandeur of the buildings.

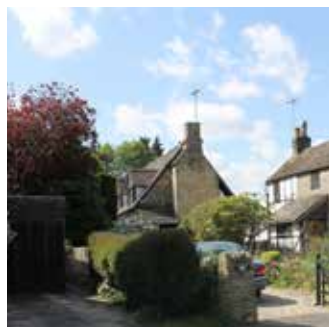
Fig.5.1 Burgage Close

5.3.2 The Burgage is wide and straight' the west side characterised by modest cottages and houses from the 17th and 18th centuries. These generally follow a uniform building line, fronting the road, with the exception of Burgage Close (Fig.5.1) and three 20th century detached houses set back from the road. House types vary from detached, semi-detached and terraced properties.

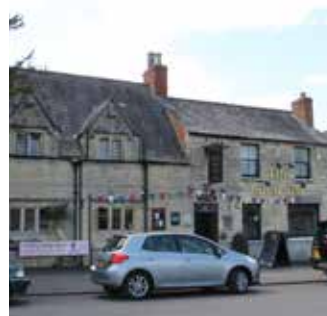
Fig.5.2 The Royal Oak

5.3.3 The Royal Oak forms an important landmark building The Burgage, dating from the 17th century with a coursed limestone façade it features prominently in the streetscape (Fig.5.2).

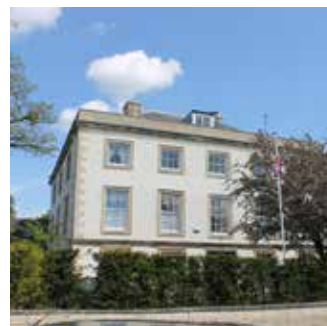
Fig.5.3 Prestbury House

5.3.4 The east side of The Burgage contains Prestbury House which dates from the early 18th century (Fig.5.3). Today it is mostly pebble dashed with exposed quoins and continues to form an important element in the street. The adjacent 18th century, predominantly brick stables, also makes an important contribution (Fig.5.4).

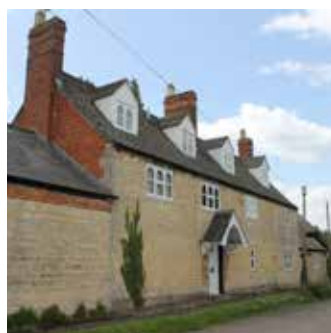
Fig.5.6 Lake House, Lake Street

5.3.8 Lake House features prominently within the street, and is a large 18th century house with 19th century gothic wood windows and with its striking chimneys forms a significant feature in the street (Fig.5.6).

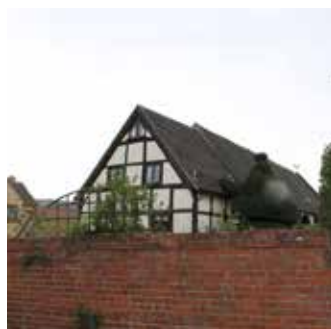
Fig.5.7 Tythe Barn

5.3.9 This forms one of the entrances to the conservation area, and includes predominantly 20th century developments of substantial houses of stone construction which make a neutral contribution to the area. However, the 18th century Tythe Barn can clearly be seen from this road and helps to provide a clear gateway into the conservation area (Fig.5.7).

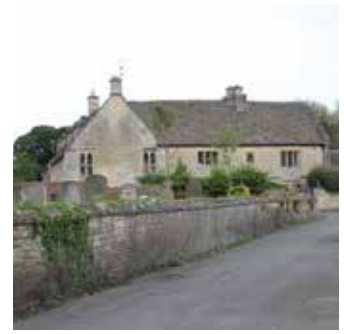
Fig.5.11 The Priory

5.3.14 Surrounding the church there are a number of particularly significant buildings including The Plough and The Priory (Fig.5.11), both Grade II

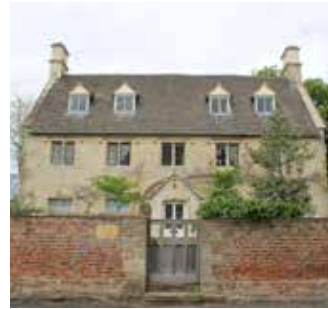
Fig.5.12 The Cottage/Monks Grange

listed. The Cottage a mid C17 house of coursed squared and dressed limestone is notable for its large massing and prominent positioning off Mill Street (Fig.5.12)

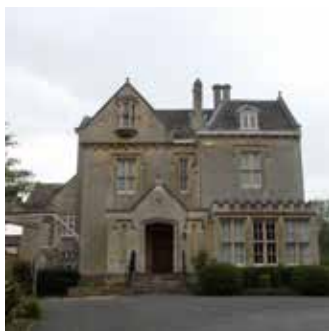
Fig.5.13 The Hayes

5.3.15 The Hayes (Prestbury Manor House) can clearly be seen from the surrounding fields and roads and forms a key feature at the entrance to the conservation area (Fig.5.13) It dates from the 19th century and constructed in a Tudor Gothic style. The surrounding open fields significantly contribute to the setting of the building and the conservation area.

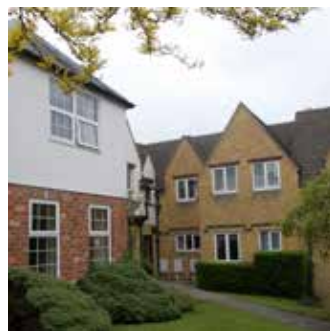
Fig.5.14 Development at the rear of The Hayes

5.3.16 There has been subsequent development over the course of the 20th century behind the house, largely in a Cotswold architectural style (Fig.5.14). This development is mostly subservient in scale and appearance to The Hayes, however the associated rendered car park building detracts from the conservation area.

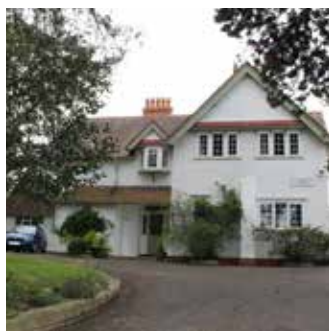
Fig.5.15 Lynworth House, High Street

5.3.19 The massing varies considerably along the street, with closer and more compact properties towards the centre. The eastern end of the street has larger detached houses from the 19th and 20th century set within extensive gardens (Fig.5.15).

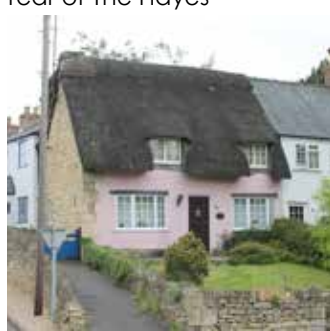
Fig.5.16 18th Century Cottage, 38 High Street

5.3.20 The road contains a number of cottages and houses dating from the 18th century (Fig.5.16), some of which are timber framed, in addition to the 17th century Bakery Stores (Fig.20). It also has a variety of higher status buildings such as the ashlar faced Mansard House (Fig.5.17) and stuccoed Georgian House (Fig.5.18). The Kings Arms makes a significant contribution to the road with its partial timber framed panels and striking red brick facades making an important contribution (Fig.5.19).

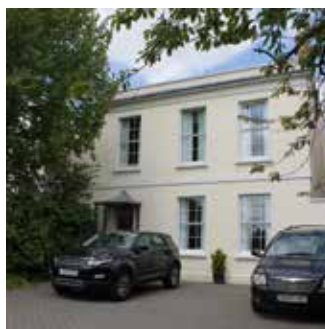
Fig.5.25 Regency Houses, Prestbury Road

5.3.24 Prestbury Road heads towards Cheltenham and contains a number of Regency buildings, and forms an interesting entrance to the conservation area (Fig.5.25).

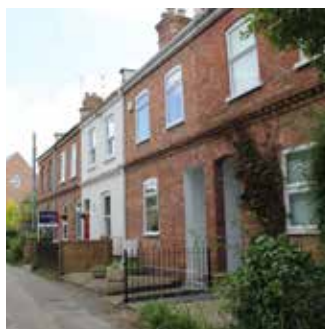
Fig.5.27 Victorian Cottages, Blacksmith Lane

5.3.26 Consists of 6 Victorian brick terrace houses, all with uPVC windows all of architectural merit (Fig.5.27).

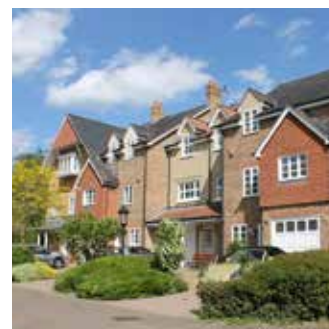
Fig.5.28 Morningside Close

5.3.28 A late 20th century of houses of which are largely out of proportion with the area and are therefore negative to the conservation area (Fig.5.28).

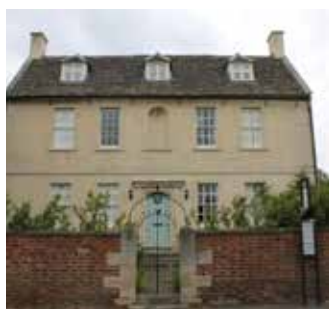
Fig.5.23 Three Queens

5.3.22 As with High Street, there is a mixture of cottages and higher status buildings, including two timber framed thatched cottages (Fig.5.22) and a row of stone cottages dating from the 17th and 18th century which make an important contribution to the street. The Three Queens (Fig.23), which is fronted in Ashlar forms a significant element of the street, along with the 19th century United Reform Church which

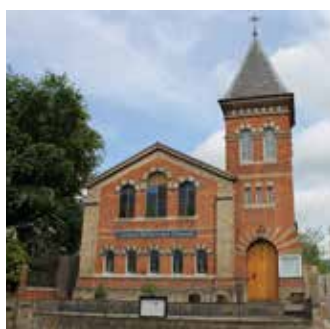
Fig.5.24 United Reform Church

is one of the landmark buildings on one of the approach roads into the village core (Fig.5.24).
