### **7.1.5 Conclusion on Contamination**

## **7.2 Final Conceptual Site Model & Risk Assessment**

Grovefield Way, Cheltenham

NEW BMW MINI DEALERSHIP GROVEFIELD WAY, CHELTENHAM.

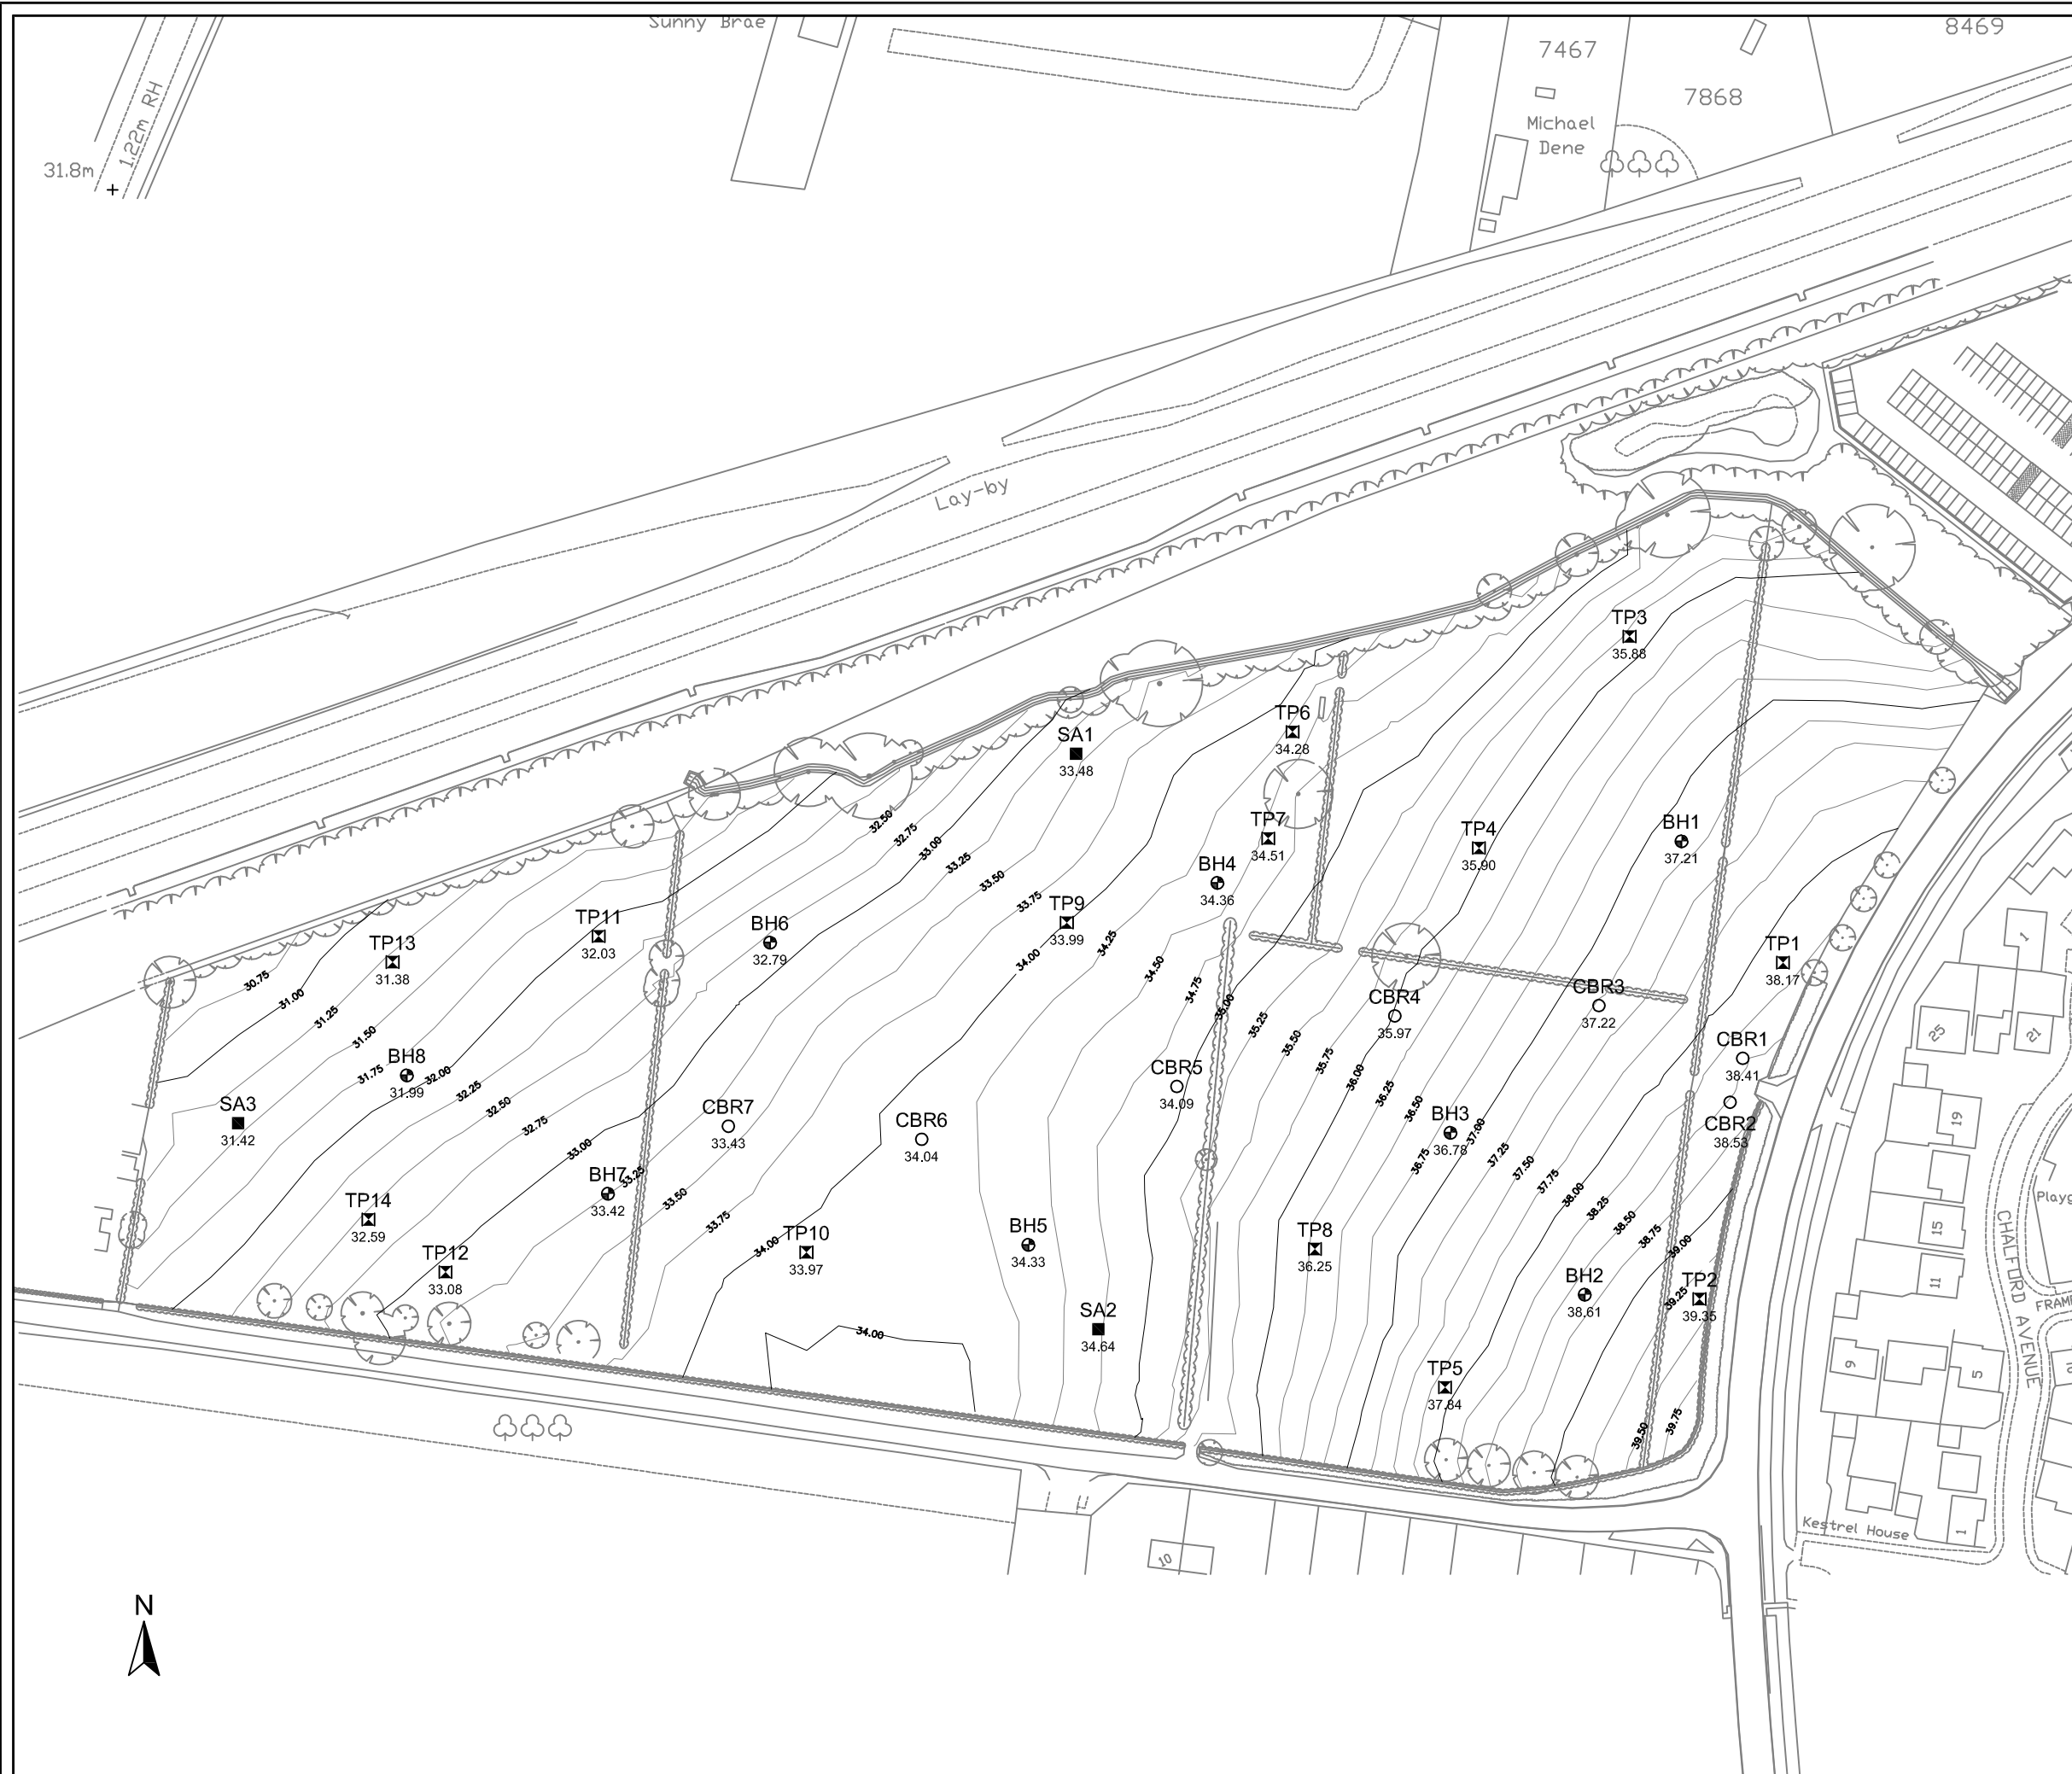
**LEGEND**

- BH Borehole
- TP Trial Pit
- CBR CBR Test
- SA Soakaway
