# Grovefield Way, Cheltenham

## Interpretative Report on Site Investigation

Project No: 731988

Client: Hinton Properties (Midlands) Limited

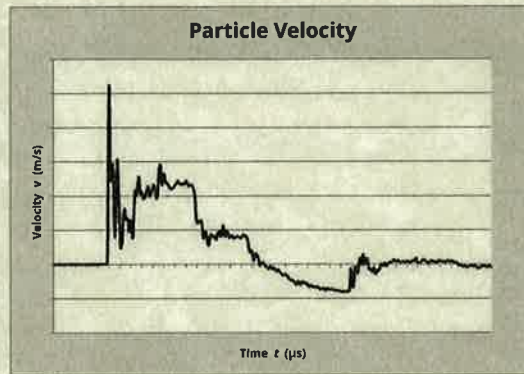
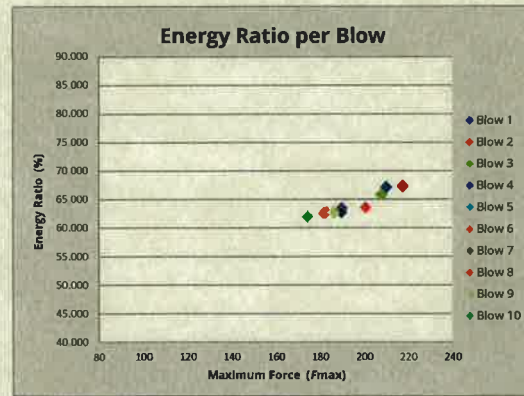
### Characteristics of the instrumented rod

Diameter:  $d_r = 0.052\text{ m}$   
 Length of the instrumented rod:  $0.558\text{ m}$   
 Area:  $A = 11.61\text{ cm}^2$   
 Modulus:  $E_a = 206843\text{ MPa}$

$E_{meas} = 0.304\text{ kN-m}$   
 $E_{theor} = 0.473\text{ kN-m}$
