PHASE 2 GROUND INVESTIGATION REPORT FOR OAKLEY FARM, PRIORS ROAD, CHELTENHAM, GLOS GL52 5AQ

PREPARED FOR ROBERT HITCHINS LIMITED

Report No. 4360/2

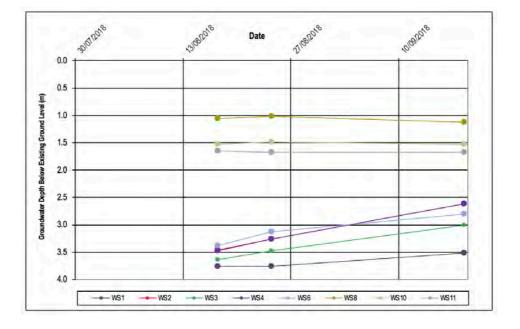
FIG 2: GROUNDWATER OBSERVATIONS

- **3.18** All boreholes were dry during drilling, which in this Practice's experience is typical of the low-permeability CMF, however subsequent monitoring of those boreholes installed with standpipes (response zones of between 1.0m and 4.0m depth) indicated that groundwater does percolate slowly through the subsoil (most likely through fissures) and standing levels are shown in Figure 2 below.

- **3.20** The above would suggest that whilst in the short-term groundwater is unlikely to be encountered within newly excavated foundation or service trenches, the CMF does allow groundwater permeation, albeit at a slow rate due to the low permeability, therefore it is likely to be encountered within excavations (particularly deeper excavations) that are left open for any great period. As always, the groundwater level is of course subject to seasonal fluctuation according to prevailing weather conditions, and the situation encountered and described above could potentially change in the future, especially in a period of seemingly ever-apparent but unpredictable climate change.

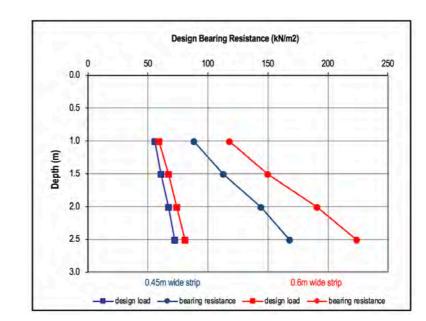
FIG 4: DESIGN BEARING RESISTANCE -v- DEPTH

4.13 Using a characteristic SPT N₆₀ value of 12 at 1.0m depth, based on a conventional two-storey residential line load of 45kN/m, the design bearing resistance (bearing capacity) for a standard 0.6m wide strip foundation is estimated to be approximately 118kN/m², which exceeds the likely bearing pressure and confirms suitability. Similar calculations demonstrate only marginal suitability for 0.45m wide foundations at this depth (bearing capacity of 88kN/m²), indeed this continues with greater depth. Design bearing resistance is plotted against depth in Figure 4 below, so that values can be assigned to any other depths as necessary due to tree influence.

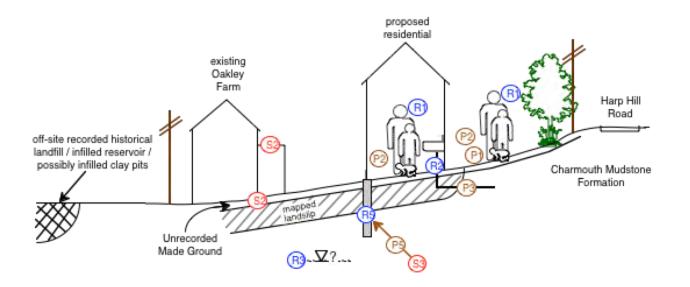
FIG 5: REFINED CONCEPTUAL SITE MODEL (NTS)

6.1 In view of the above discussions the preliminary conceptual site model has been refined as shown in Figure 5 and Table 8 below.

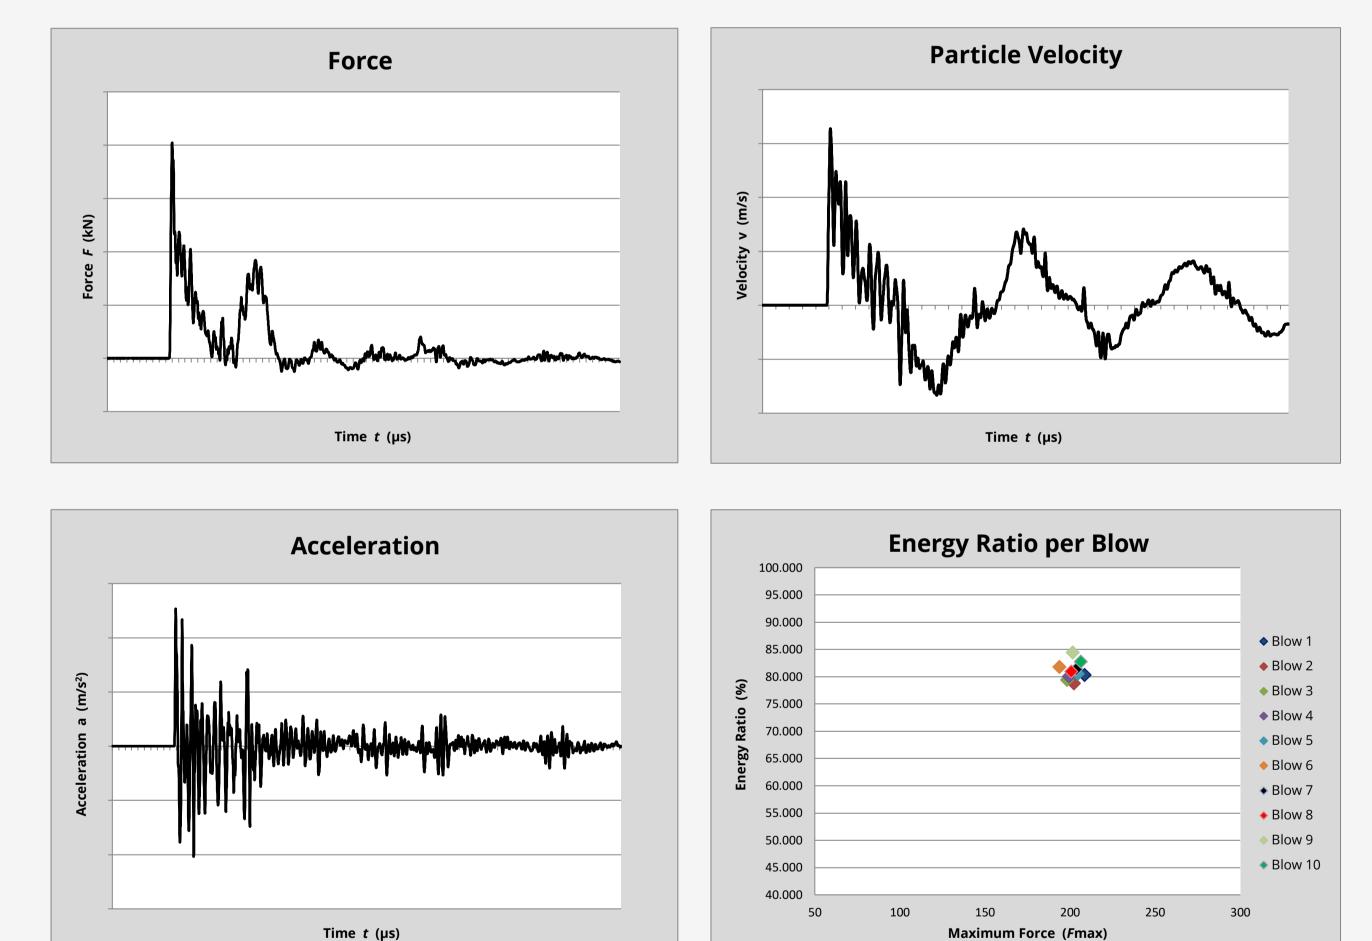
Characteristics of the instrumented rod

Diameter	<i>d</i> _r = 0.052 m
Length of instrumented rod	0.558 m
Area	A = 11.61 cm ²
Modulus	<i>E_a</i> = 206843 MPa

Observations: 1. E meas = 0.382 kN-m **E**_{meas} Energy Ratio = *(E*_r) 80.75% E theor = **0.473** kN-m \pmb{E}_{theor} © Copyright 2018
