GEO-ENVIRONMENTAL DESK STUDY REPORT FOR LAND NORTH OF HARP HILL, CHELTENHAM

Report No. 4360

GEO-ENVIRONMENTAL DESK STUDY REPORT FOR
LAND NORTH OF HARP HILL, OAKLEY, CHELTENHAM
PREPARED FOR ROBERT HITCHINS LIMITED

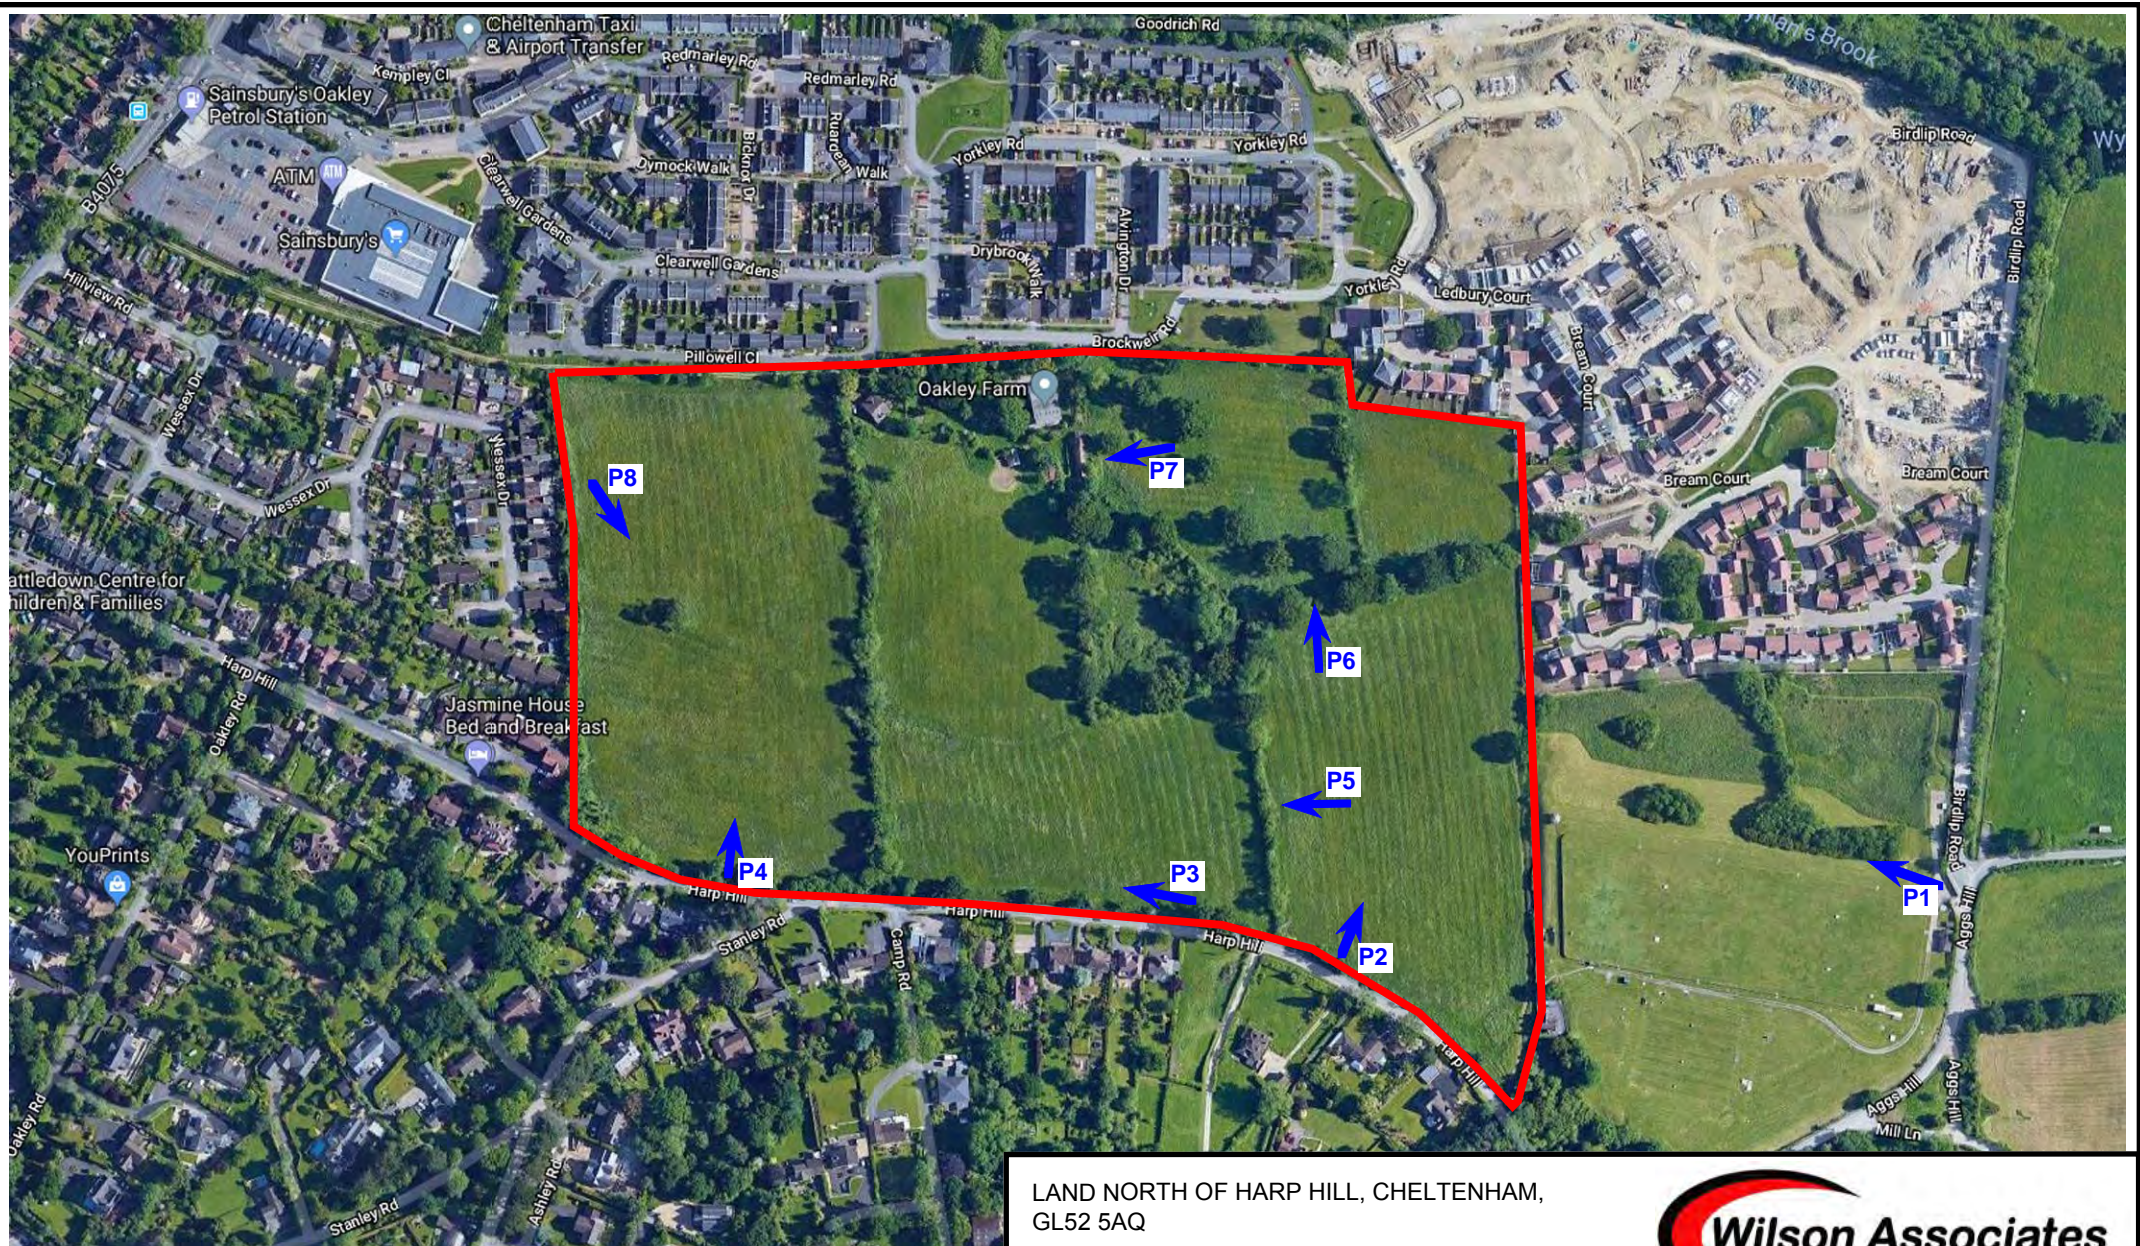
4360/2

P1
Number and direction of photograph (Appendix 2)

EXISTING SITE LAYOUT (based on Aerial Image from Google Maps) SHOWING WALKOVER PHOTO LOCATIONS
