SECTION 3 – UNDERSTANDING THE SITE

3.0 UNDERSTANDING THE SITE

This chapter describes the current condition of the Pittville Park. For ease of reference the site has been divided into character areas. See Fig 1.3

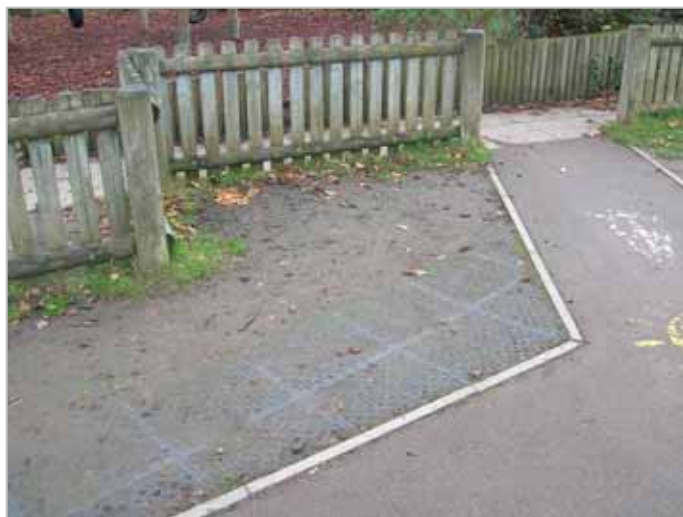
The surfaces within this area, whilst safe are becoming worn and are beginning to deteriorate. Grassed surfaces adjacent to the equipment is wearing, despite the provision of grass-crete.

2007 Worn grass surface in play area

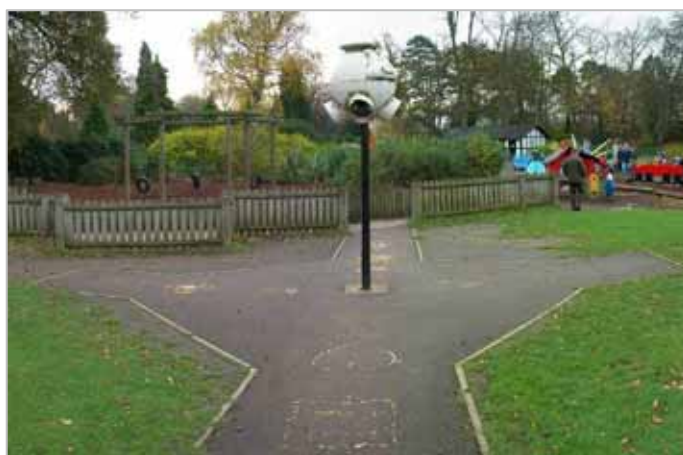
The play area has a bitmac and wet pour surface which is functional and safe but contributes little to the play value for the area. Some of the markings on the surface have become faded and worn so that they can no longer be distinguishable. The fenced area is accessed via two self closing gates; one is located to the south, adjacent to the toilet block and the other to the north west adjacent to the aviaries.

2007 Worn play surface markings

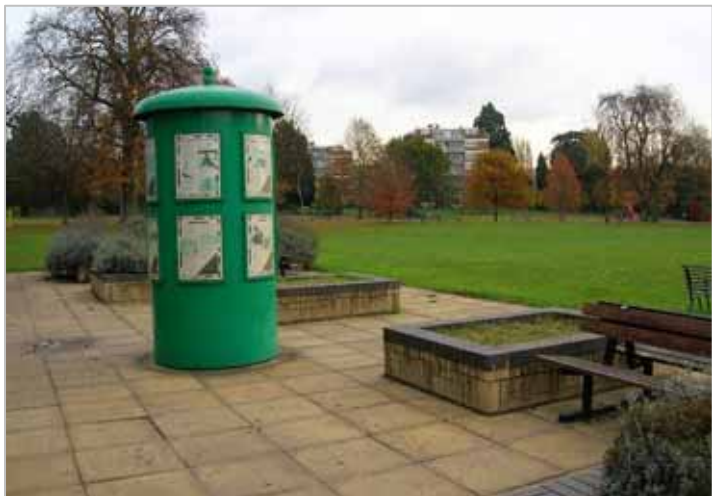
Adjacent to the aviaries is a small garden, Centenary Gardens, built in 2000 to celebrate the 100th birthday of Queen Elizabeth the Queen Mother. The garden is built in a buff coloured artificial stone material with a series of raised planting beds with benches between. The planting here is beginning to become overgrown and neglected with a number of the planting beds with bare soil. Interpretation panels are located on a cylindrical display board. The information is faded and in need of replacement.

2007 Centenary Gardens

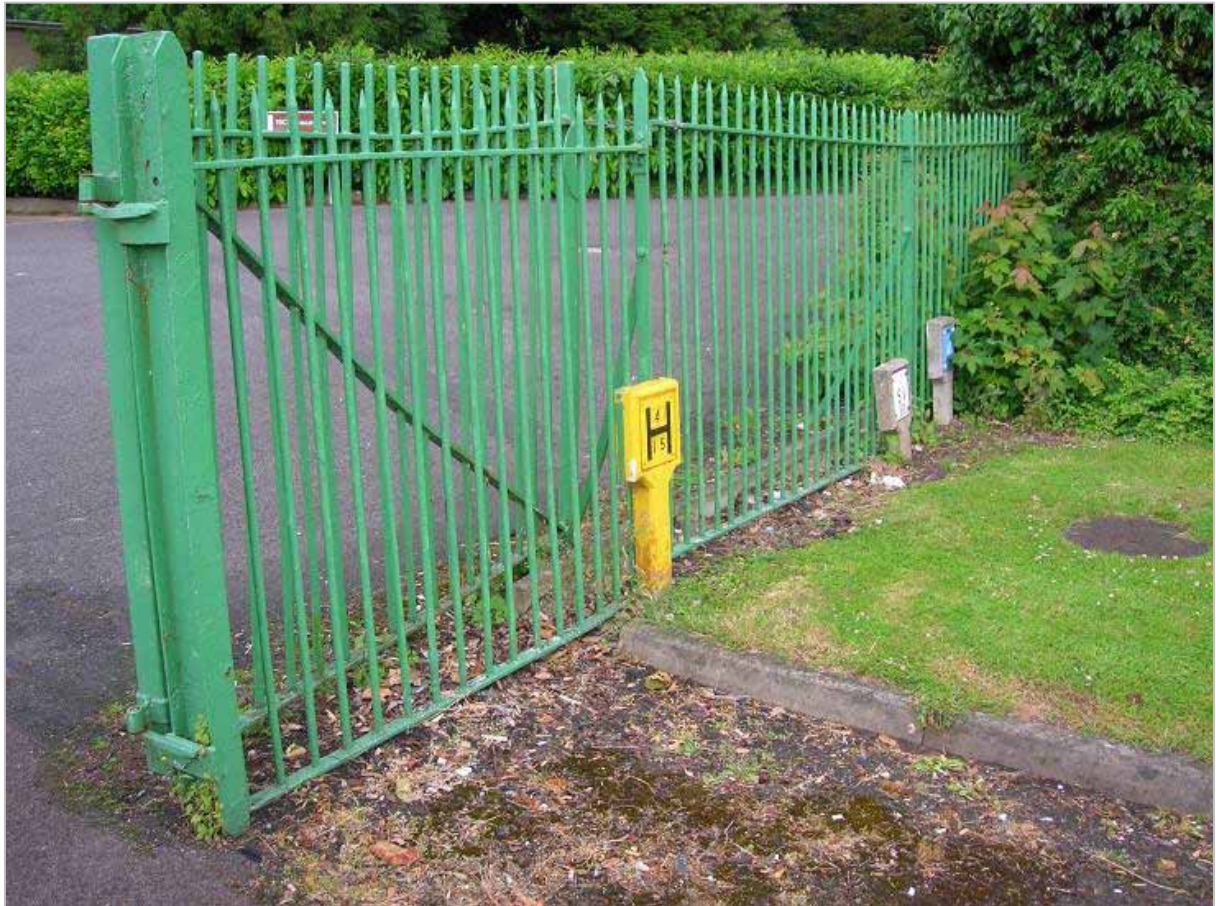
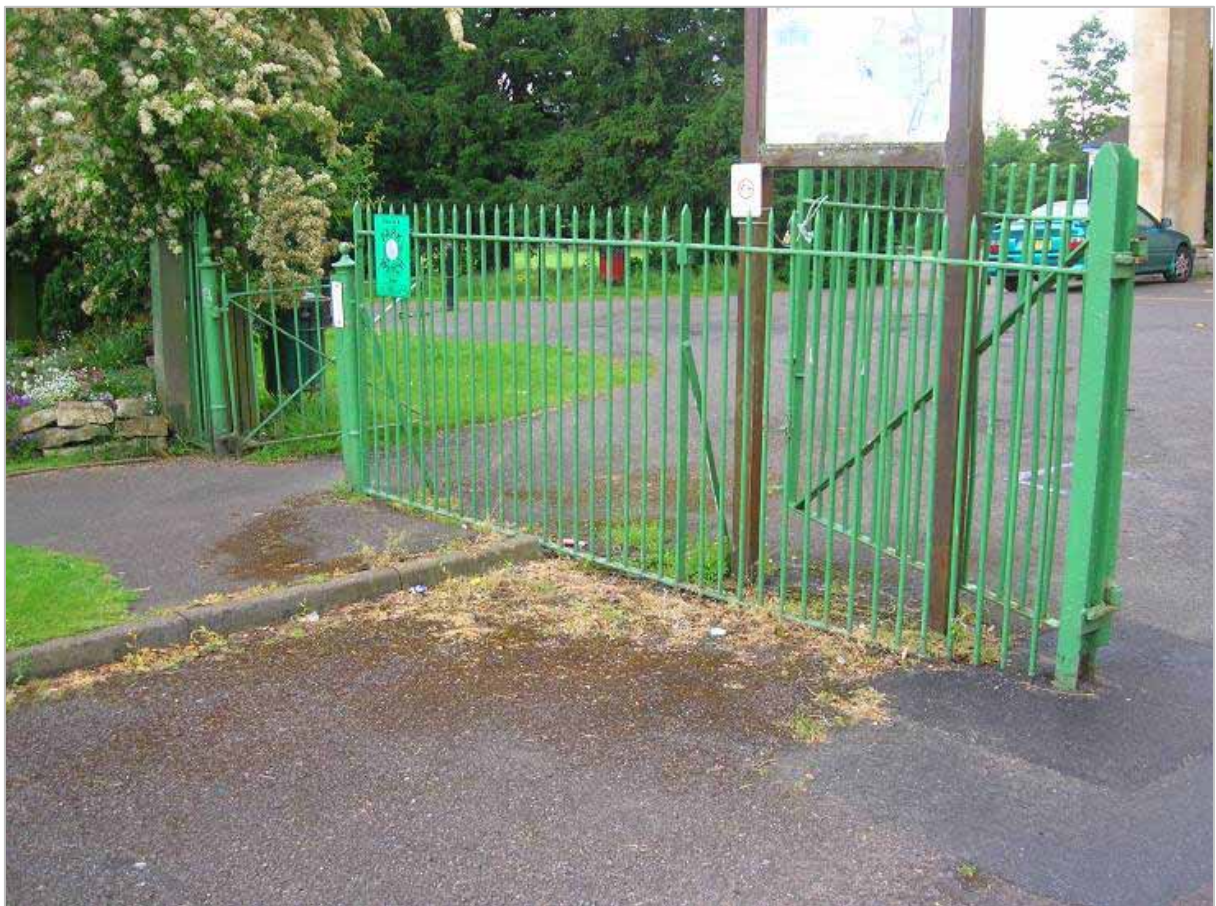
The gateway ironwork is showing signs of deterioration and gives a visual appearance of neglect. To the north and south, the bitmac road surface runs under a section of the ironwork. A lack of pedestrian or vehicular traffic here has enabled the colonisation of moss and weeds which continue to grow unchecked, adding to the visual appearance of neglect.

The bitmac surface between the gates has been repaired and replaced several times and the resulting 'patchwork' of colours again detracts from the visual appearance of this gateway space.

2007 Railings to north (above) and south (below)

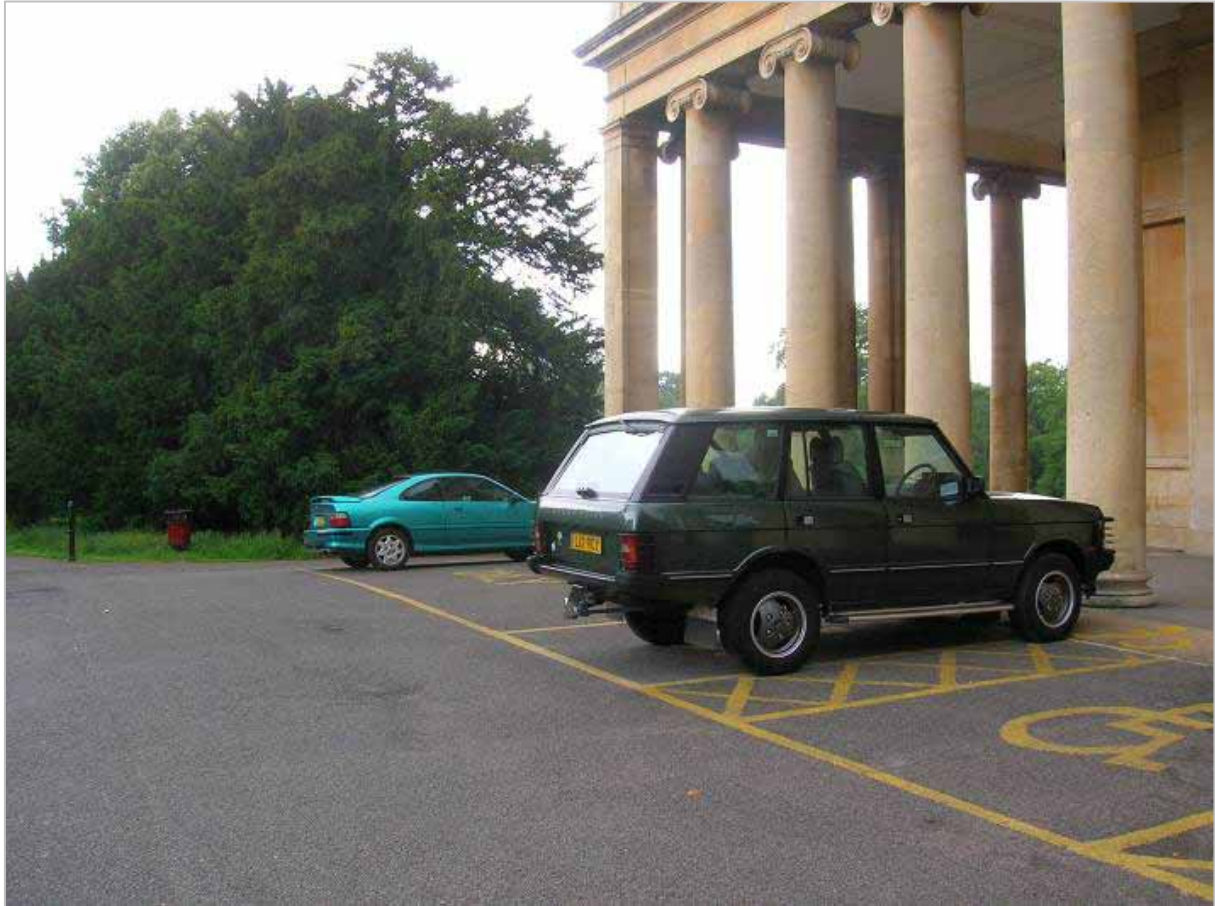
Disabled parking spaces have been provided adjacent to this east colonnade, which detract from the vista between the East Approach Road and the Pump Rooms.

2007 Disabled parking adjacent to the Pump Rooms

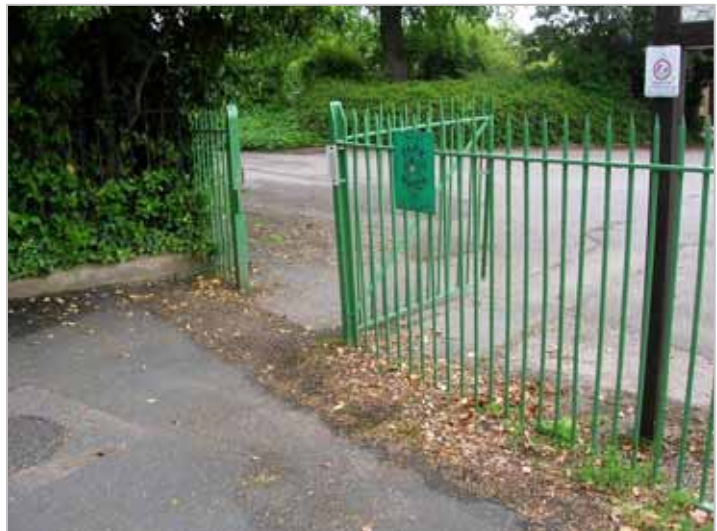
There is a narrow pedestrian gateway to the north of the ironwork which allow direct access off the pedestrian footpath along West Approach Drive.

A collection of signs and notices have been attached to the ironwork which gives a cluttered appearance.

2007 Pedestrian gateway

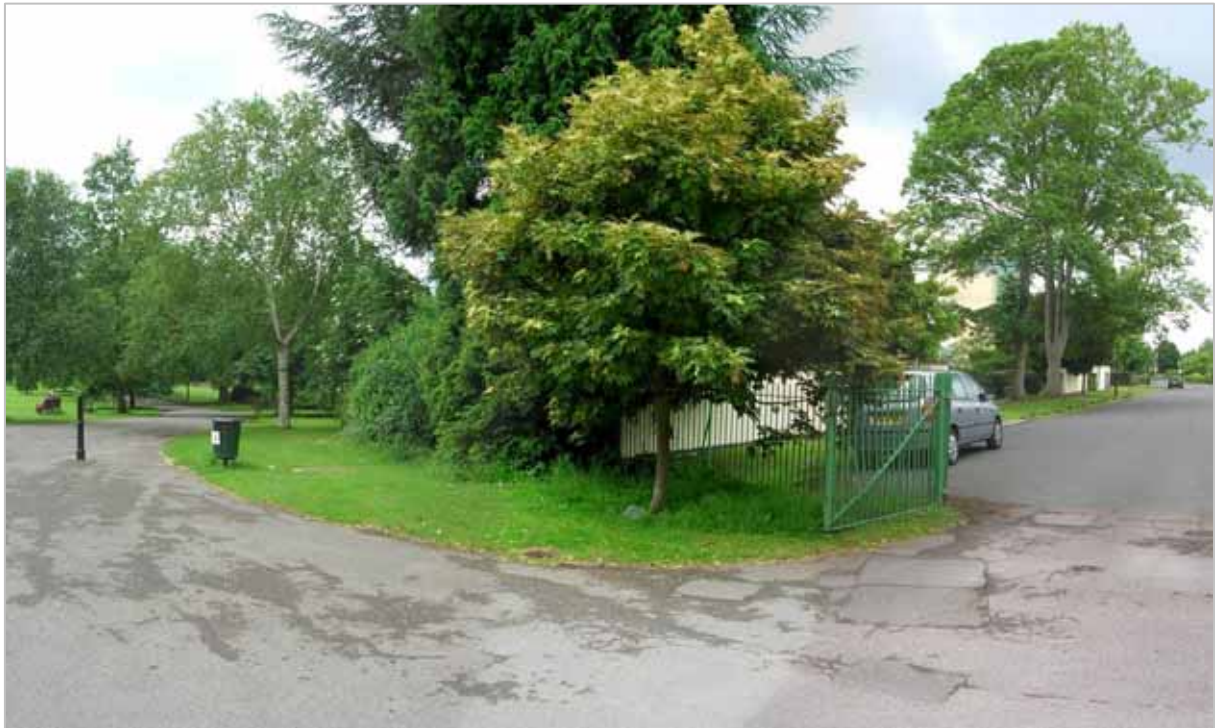
The gateway is defined by green iron railings and gates in the same style as those found throughout Pittville Park. The ironwork is showing signs of deterioration and wear and detracts from the visual qualities of this gateway space.

The hard, bitmac surface runs up to and under the majority of this ironwork and as a result of little wear from pedestrians and vehicles, has been colonised by moss and weeds along with leaves and litter. This adds to the visual appearance of deterioration and neglect.

The hard, bitmac surface level is such that the gates have worn a groove into the surface with the process of opening and closing. The bitmac surface is also showing signs of deterioration and has been removed, repaired or replaced in sections.

2007 Gateway looking south west

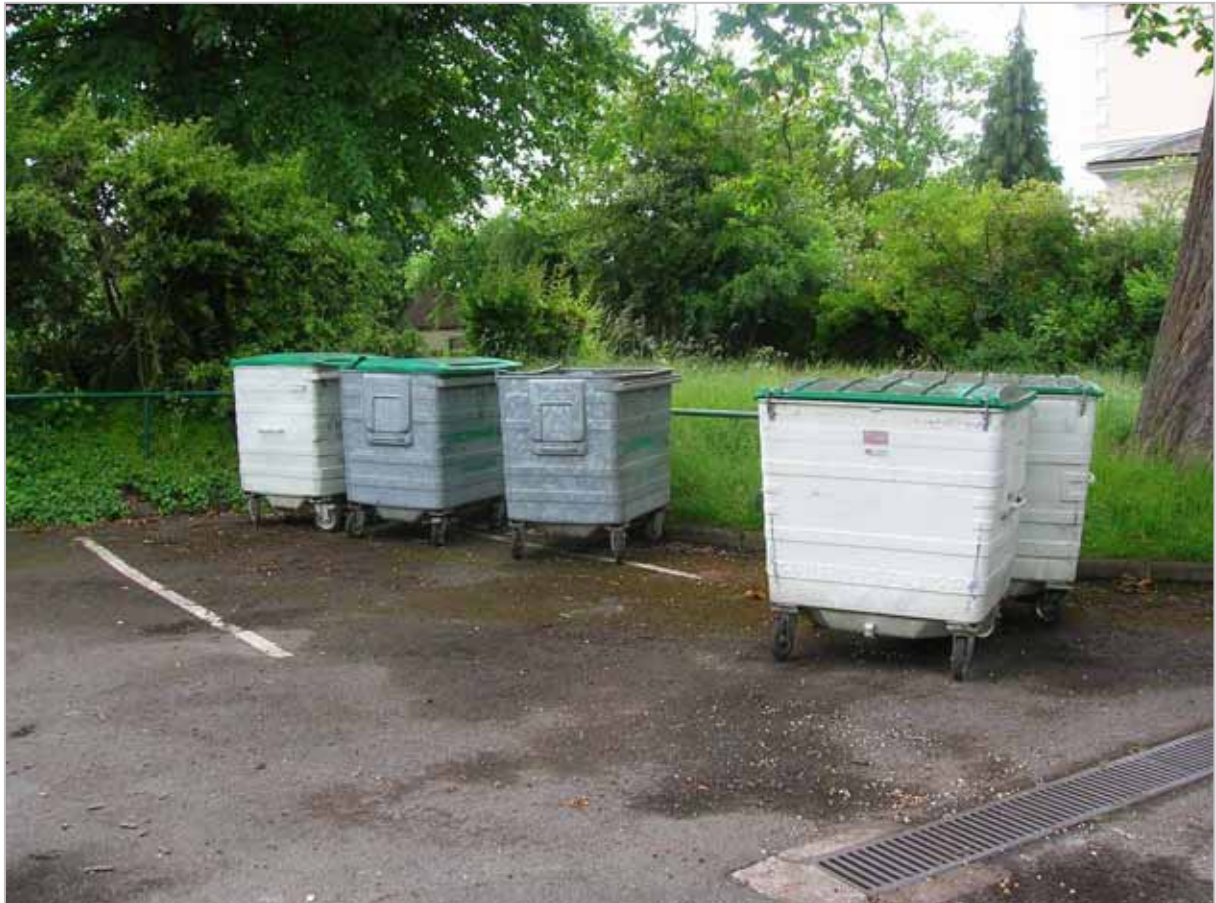
2007 Waste bins

To the south west, the car park contains a selection of waste bins, which appear to be randomly stored away from the main building.

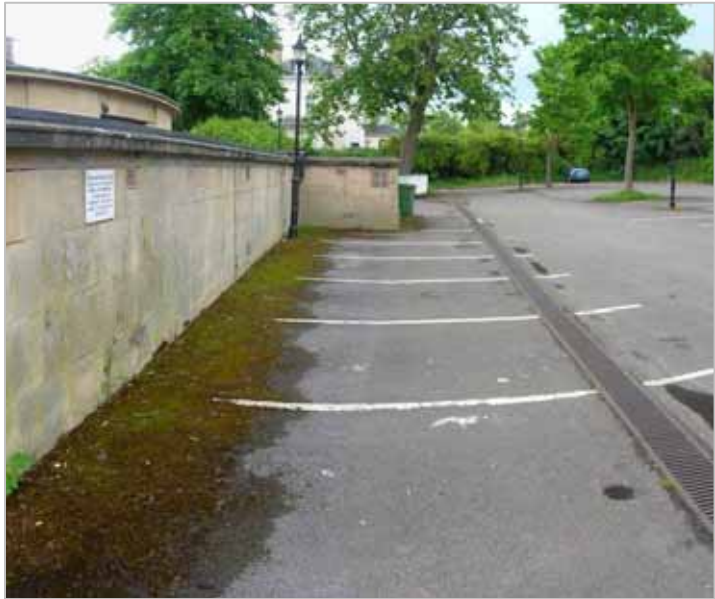
The hard bitmac surface extends to the building wall, with a series of slot drains to intercept surface water which is flowing towards the Pump Rooms. There is a build up of moss along the surface immediately adjacent to the building, which appears to be well established and adds to the general visual appearance of neglect.

2007 Southern extent of car park

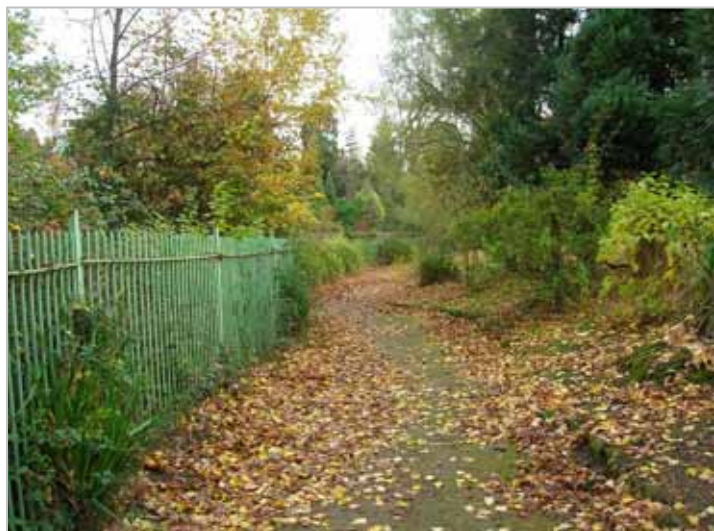
The lake edge is defined by a path which runs around the lake between the two bridges. This informal path is surfaced with compacted gravel to the south and bitmac to the north. The surface condition of the path is deteriorating in places and flood debris from the lake is contributing to this deterioration.

2007 Southern lakeside

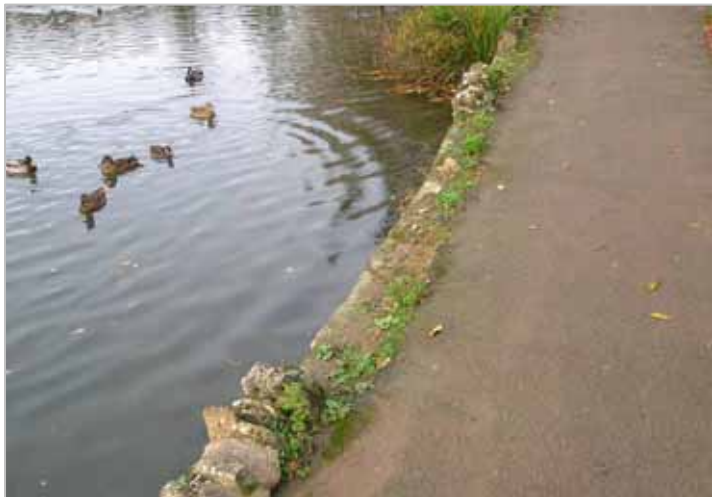
2007 Edging deterioration

To the north the lakeside is open and the hard surfaced path runs parallel with the lakeside. An informal stone edging divides the path from the water and, in places, this has become worn and dislodged. Replacement pieces have been incorporated from a variety of sources which do not maintain visual continuity.

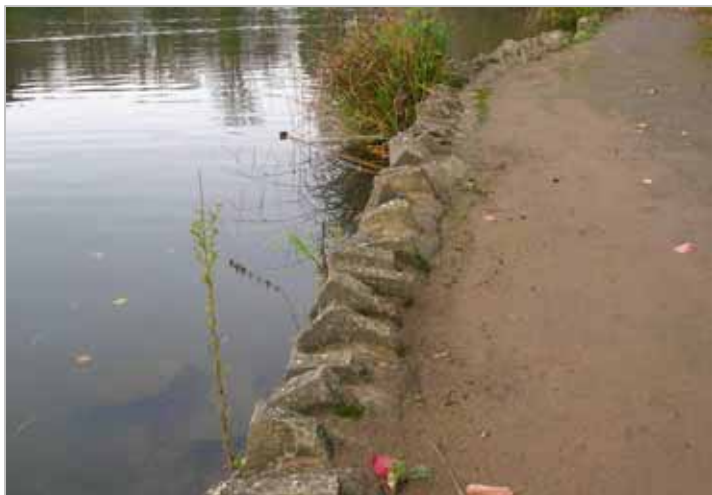
2007 Replacement edging material

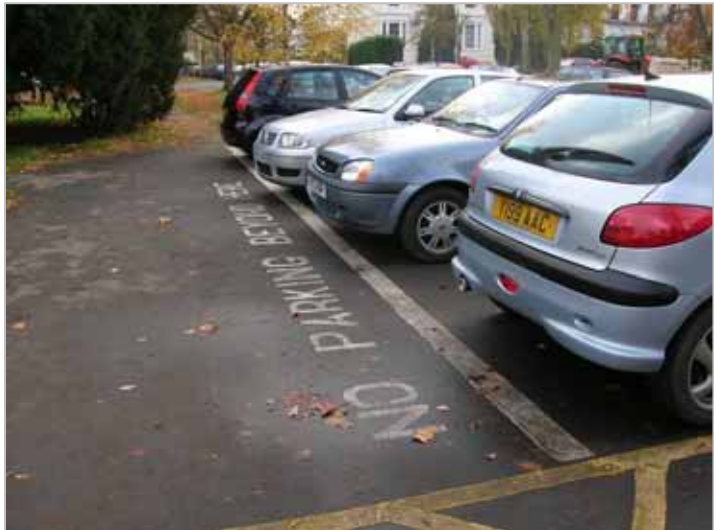
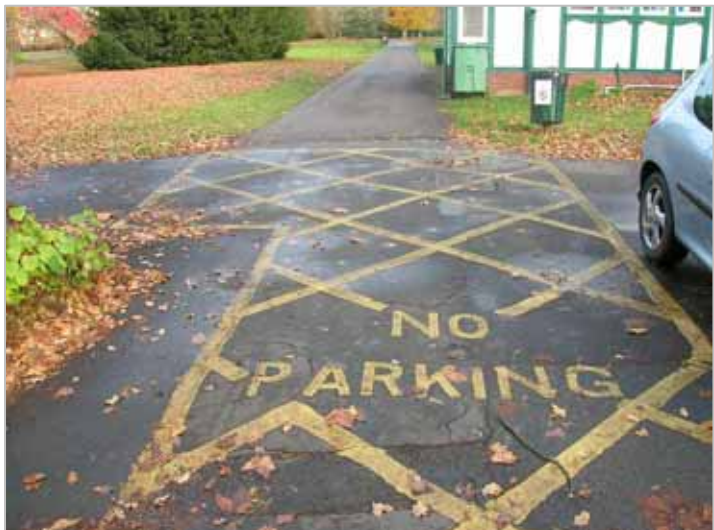
2007 Road and Pavement markings (above and below)

Visually intrusive road markings have been painted onto the pavement adjacent to the Chalet indicating a no parking zone, however, according to park users, this area continues to be blocked on a regular basis.

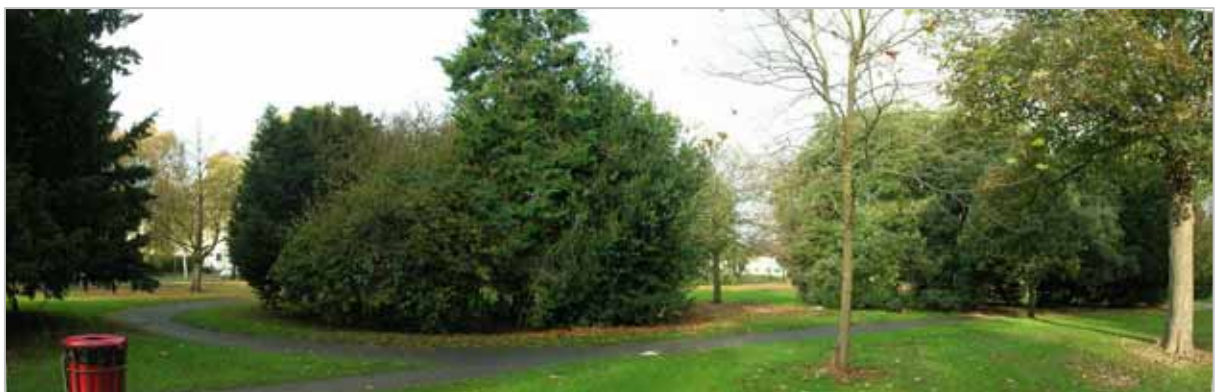
The overall character of the lawn is enhanced by the mature deciduous and evergreen trees, both on the lawns and along the various surrounding roads. On this southern lawn the pattern of planning appears to be more random and views out towards the surrounding residences are blocked by the mature trees and shrubs. Some of the trees and shrubs are in need of maintenance work to check their growth and restore condition. The overgrown nature of some of the trees and shrubs gives an impression of danger and may lead to users becoming uncomfortable using this space.

2007 Mature trees and shrubs block views out of the area

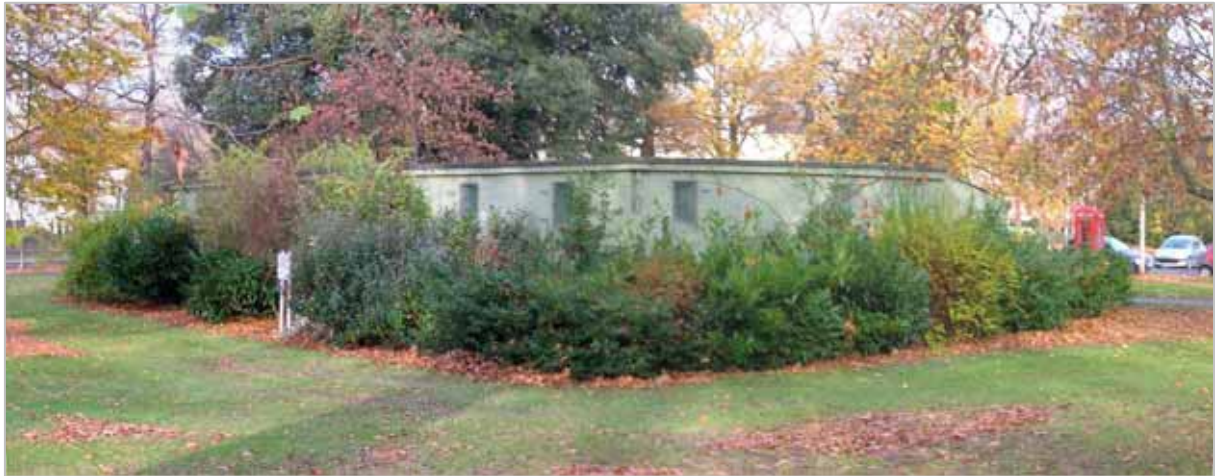
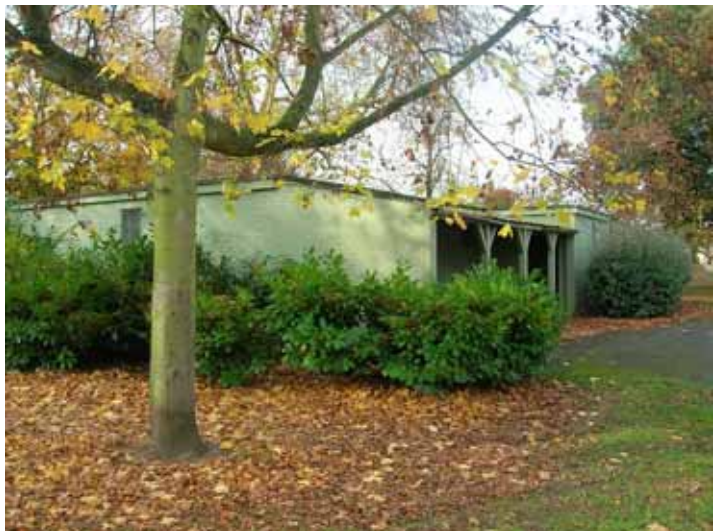
2007 The Scout Hut (above and below)

The building sadly is an eyesore and makes no contribution to the character and setting of the lawns. The building is surrounded by a collection of overgrown shrubs which contribute to the neglected feel of the building.

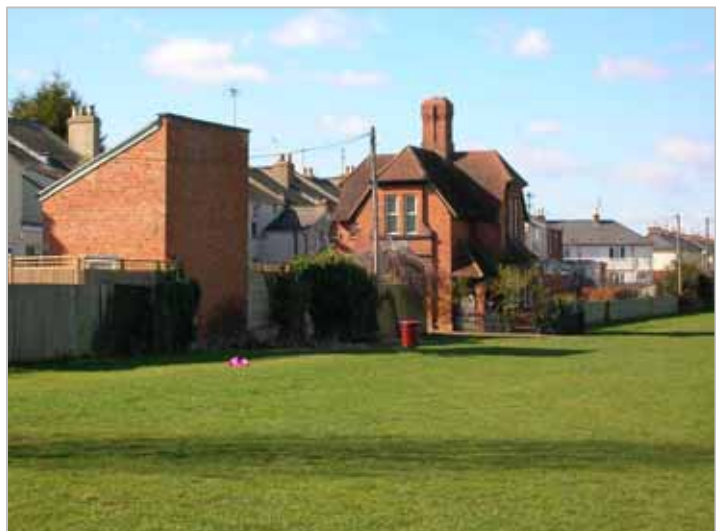
To the south the boundary is formed by the rear garden fences of the St Paul's area, and in places has an un-uniform and messy appearance.

2007 Boundary treatment to the south

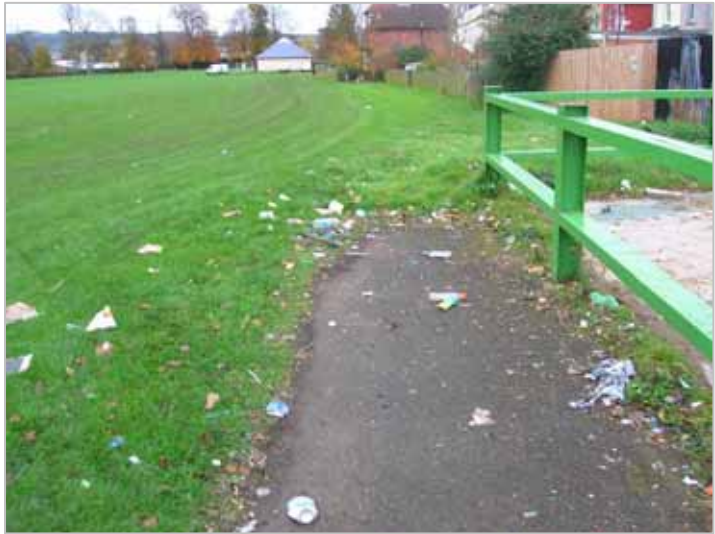
There is an amount of rubbish which accumulates behind the residential houses and particularly around the St Paul's gateway, despite the provision of rubbish bins, which has a detrimental effect on the visual appearance of the park.

2007 The St Paul's gateway

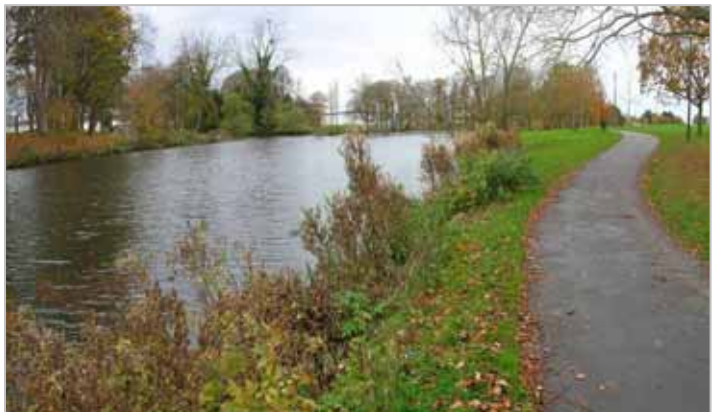
Along the lakeside the vegetation is predominantly water-loving species such as Iris and Carex species. In places these native perennials are growing unchecked and are becoming overgrown. Views of the lakeside are restricted in places because of this growth however along most of the length of the north lakeside planting is in keeping with the setting and provides a valuable habitat for water-loving wildlife.

2007 North lakeside native plants (above) site of Rustic Bridge (below)

In 2004 the bridge was destroyed when it was hit by a stolen car and the only remaining feature of the bridge is the metal footings.

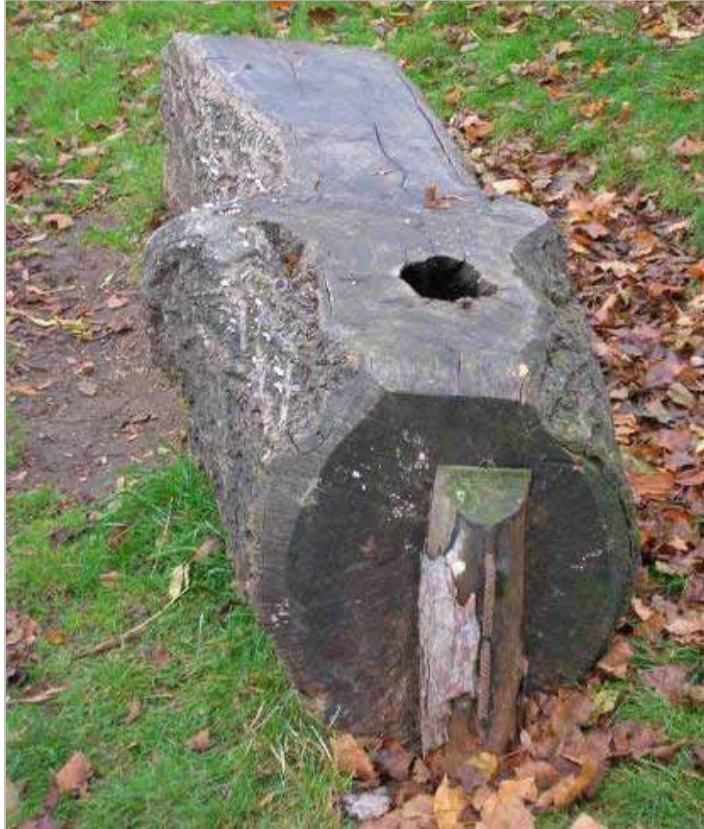
Seating opportunities are however limited and benches and fallen trees tend to be a considerable distance apart and there is a lack of cohesion to style of seating provided on this western side of the Pittville Park.

2007 Sustainable seating (above) and rubbish bins (below)

Rubbish Bins are provided along the northern shoreline but tend to be located in one area rather than spread evenly across the site. Style and colour of the bins varies and there has been some vandalism on these rubbish bins. The prominent location of the bins tends to detract from the outstanding character of this area, whilst the need for rubbish bins is great a style should be chosen that is more in keeping with the surroundings.

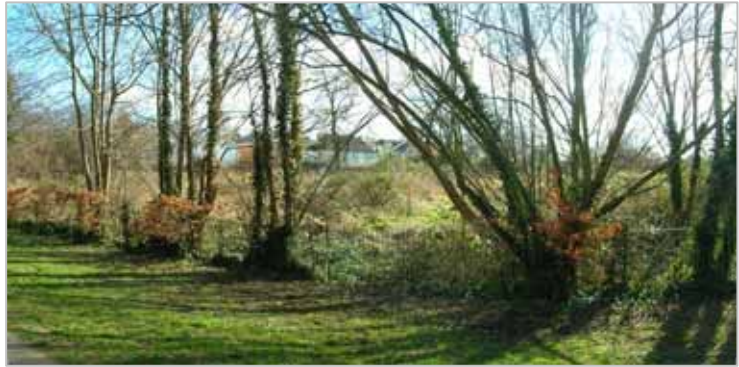
Towards the eastern section of this area, the lakeside is contained within a narrow strip of land. To the south are allotments and Dunalley County Primary School. The boundary is defined by a medium height iron fence with Beech hedging and tree saplings. In places the hedging is in poor condition and is in need of replacement.

2007 Boundary to the south

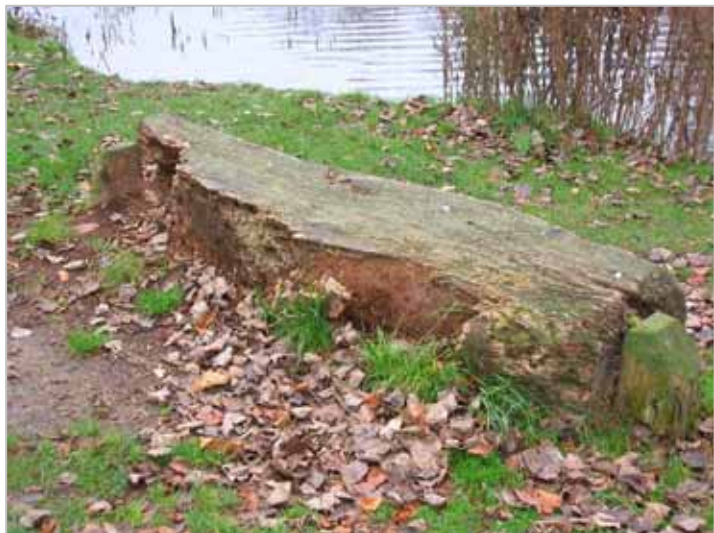
Provision for seating along this southern lakeside is poor with only two benches recorded. One of the benches has been created using the fallen trunk of a tree. This wood appears to be in an advanced state of deterioration and so does not provide a user friendly seating opportunity.

2007 Bench

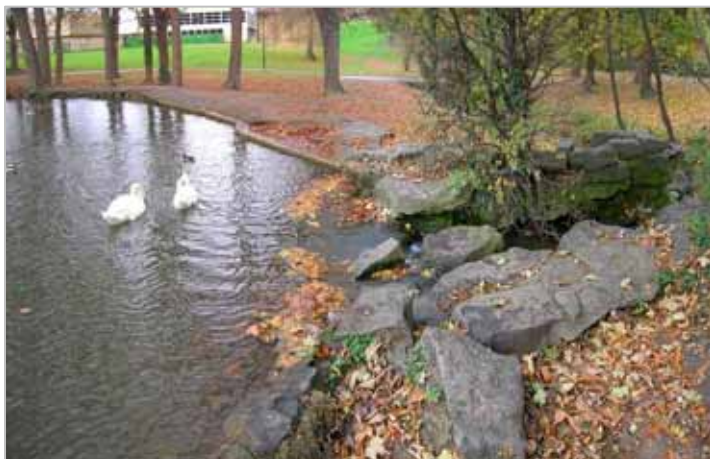
The Weir, at the time of survey, was considered to be in structurally poor condition. Repair work has recently been completed, including the addition of pH neutral boulders.

2007 To the west the Lower Lake runs into Wyman's Brook

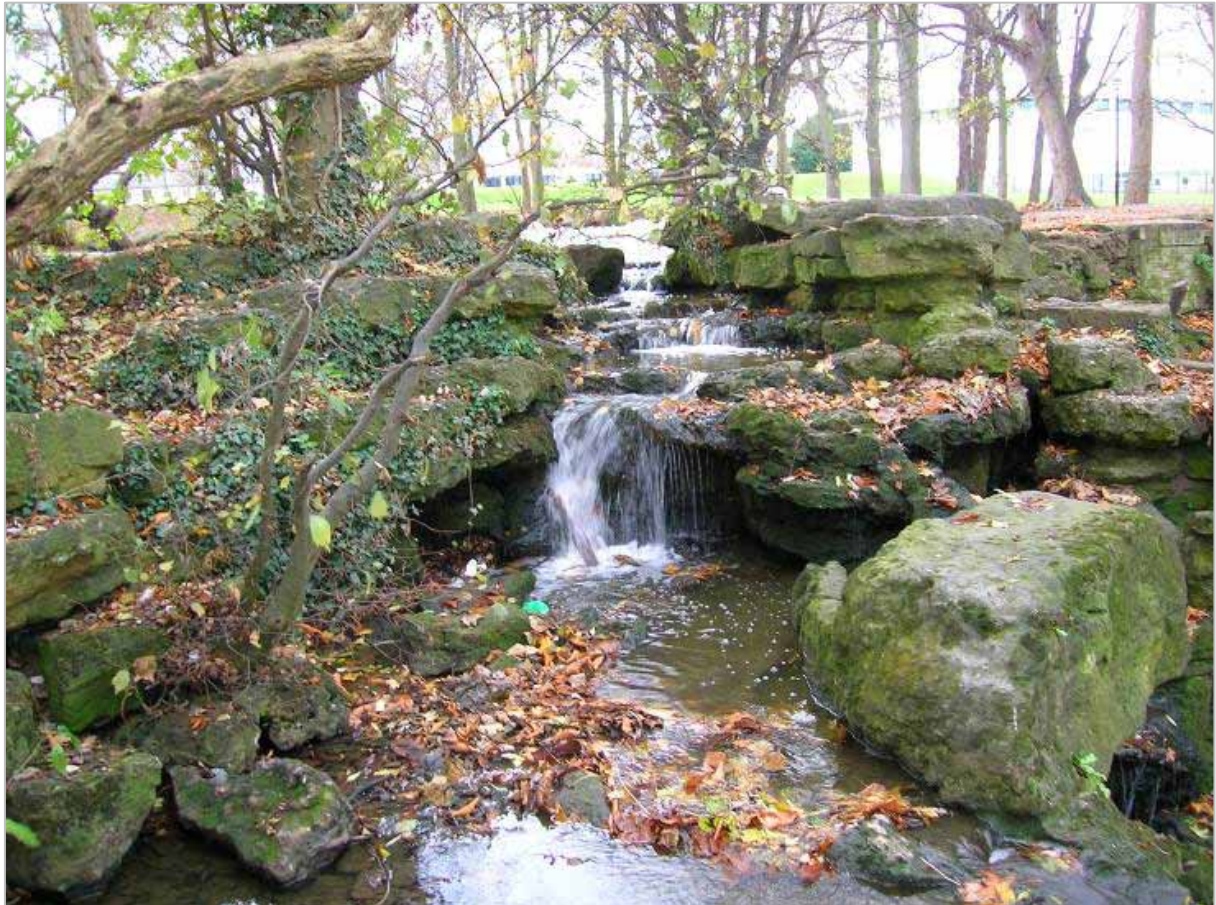
Today the waterfall remains but there is no indication of the Mill House that once stood there. The waterfall is an interesting feature which could be much improved by management and maintenance. Rubbish seems to accumulate within the rocks and is removed on infrequent occasions.

2007 Waterfall (above) Wyman's brook (below)

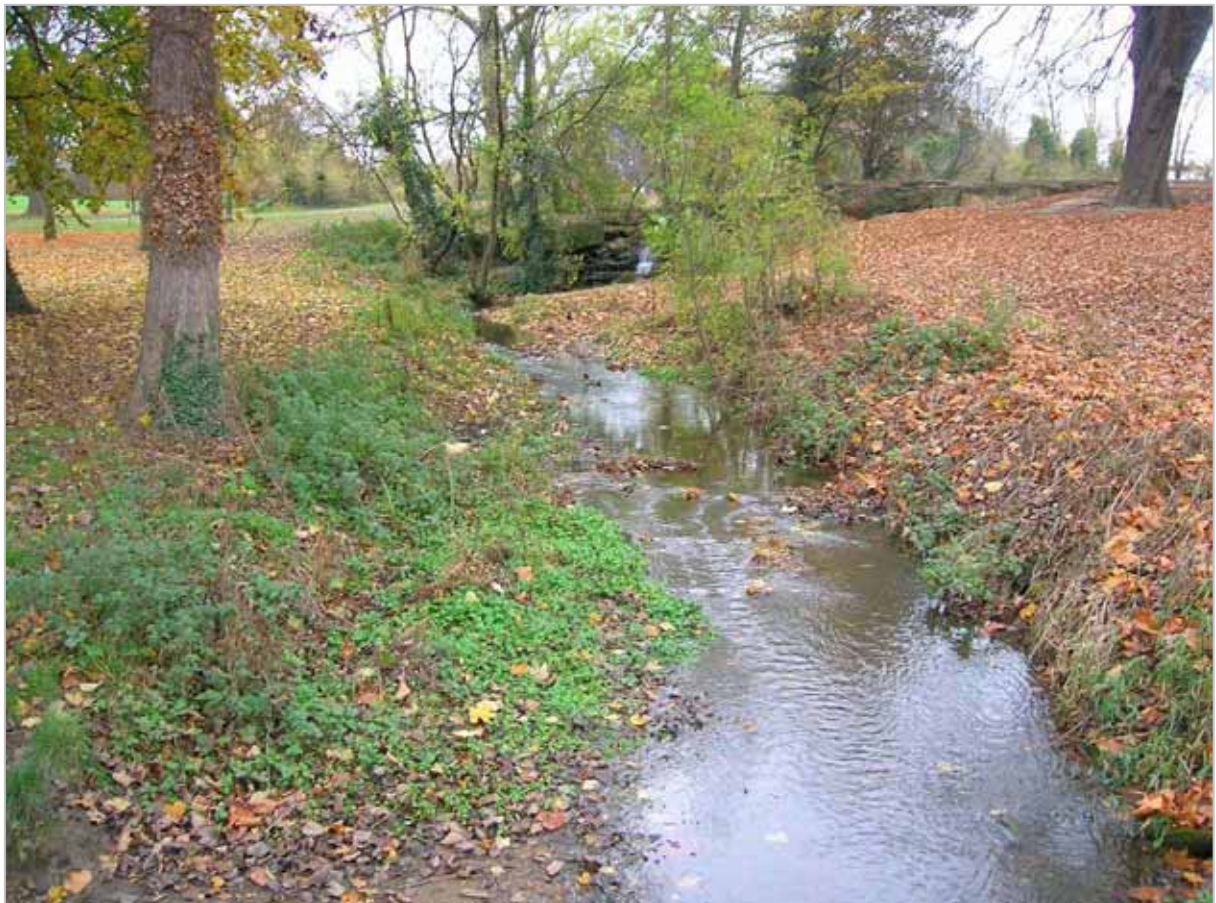
At the foot of the waterfall Wyman's Brook runs west as a small stream. To the south the bank of the stream is steep, rising into mature woodland and to the north there is a gentle gradient to the bank. Wyman's Brook, at the time of writing, was filled with rubbish and gave the appearance of being unmanaged.

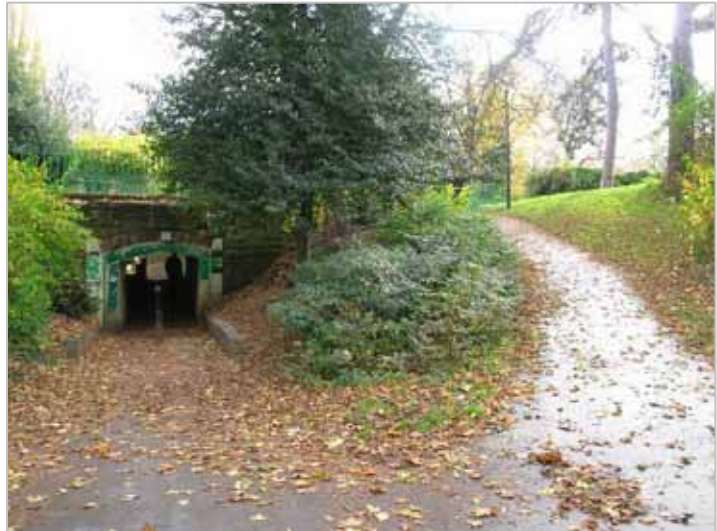
Today the subway is still a very useful means of getting from one side of the park to the other, however a steep slope to the east and poorly lit tunnel make the subway unappealing. To cross the road instead also involves a steep climb up to the road level via a narrow footpath.

2007 Subway entrance beneath the A435 Evesham Road

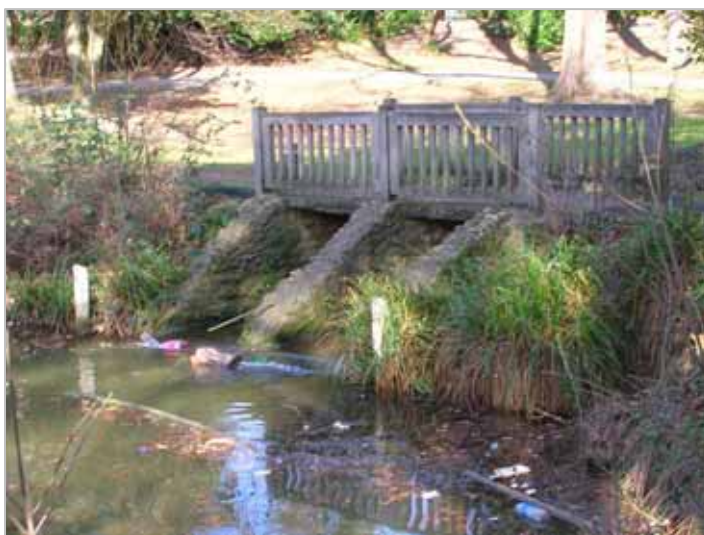
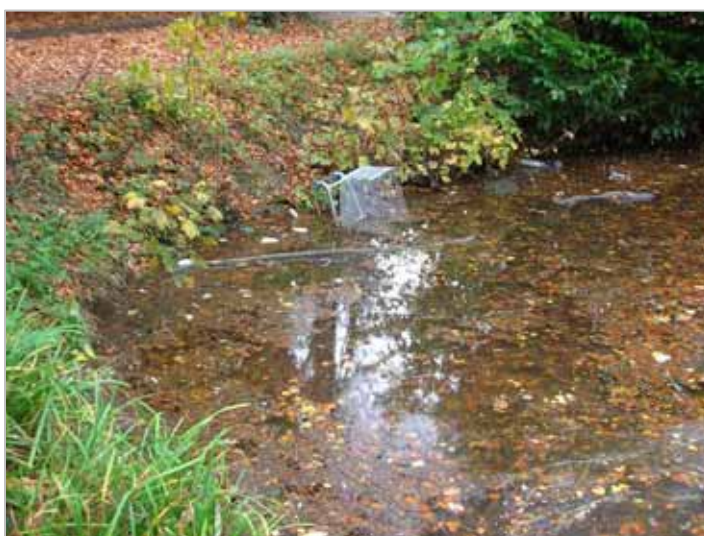
On site visits there was a large amount of rubbish discarded into this section of the lake and on subsequent visits the rubbish had not been cleared.

2007 Rubbish in the Lower Lake (above and below)

Larger items such as shopping trolleys, sign posts and rubber tyres have also been seen in the Lower Lake.

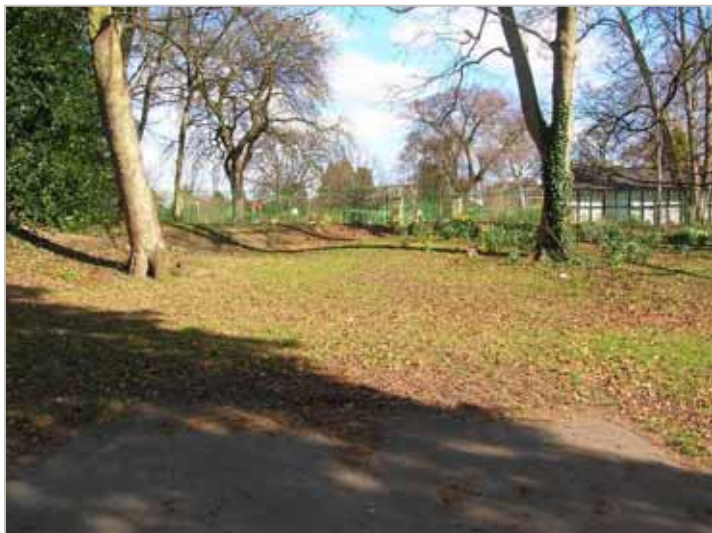
The bitmac surface towards the north has an unusual u shaped addition close to the A435 Evesham Road at the point where the gates into the eastern park stand. This is a very logical point to have the entry gate into the western park but at present this is not in existence.

2007 Bitmac surface ends short of a possible entry point into the western park

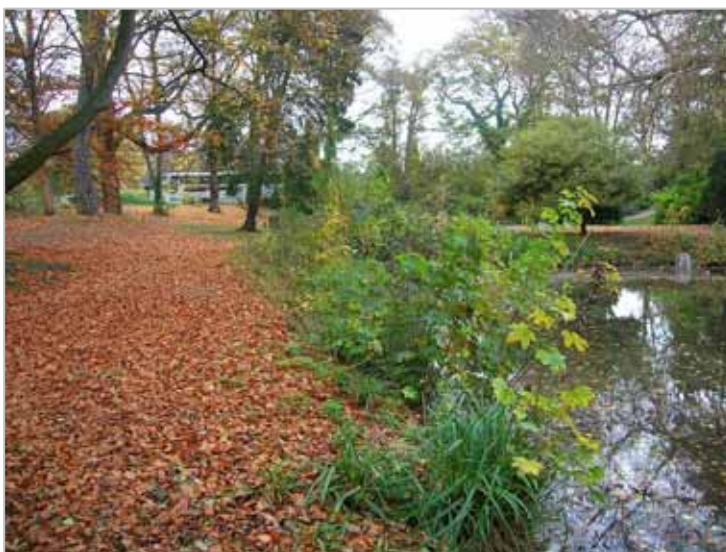
Planting around the lake at this point is, in parts, becoming overgrown and is in need of maintenance to keep it in check.

2007 Planting around the eastern lakeside

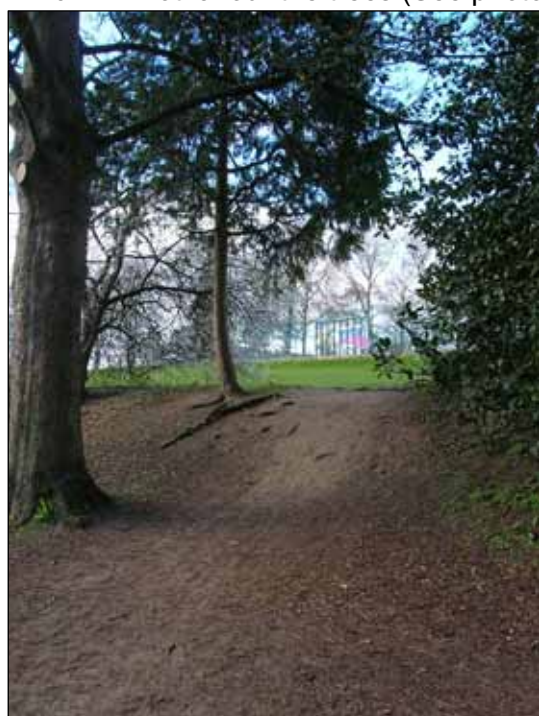
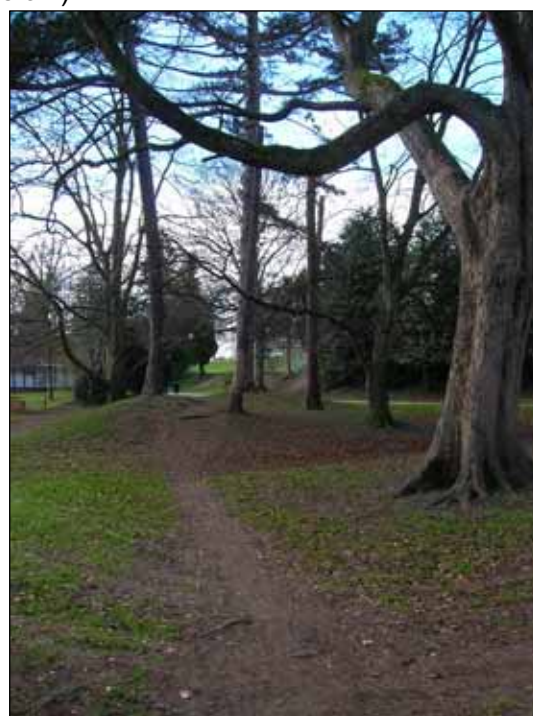
This area encompasses the 'Lower Lake', including the island at its western end, and all the land immediately surrounding it. The banks of the lake are populated by numerous early mature Sycamore, Willow, Birch and a few other broadleaved species, many of which may be self-set, whilst the island is populated by dense trees and shrubs, and largely unmaintained. Further away from the lake there is a more diverse range of planting, including London Plane, Ash, Poplar, Lime, Norway Maple, Pine and yet more Sycamore, most of it early mature to mature. At the extreme eastern end of the lake where it narrows, the planting includes all of the above, but also Cypress, Larch, Holly and ornamental shrubs, particularly around the Rockery at the head of the lake. The ground around the northern end of the lake (where the boathouse is situated) is subject to high levels of occupation, especially during the summer months, and there is much evidence of soil erosion and compaction, a situation which will not favour the trees (See photographs below).

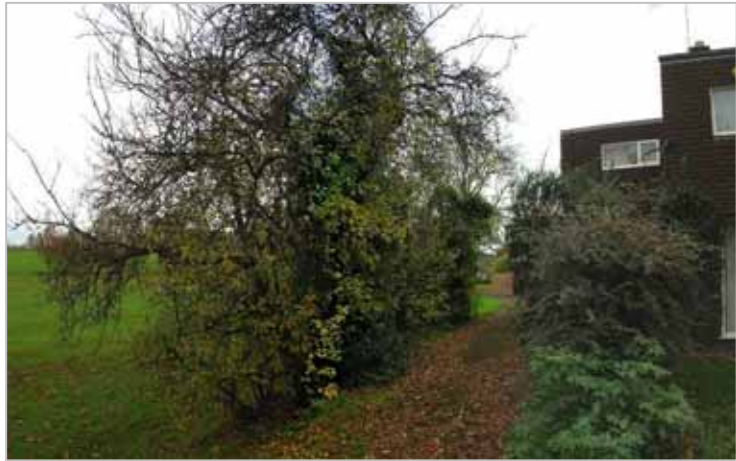
The boundary to the north is defined by a hard, bitmac surfaced narrow path which stands upon the raised platform once occupied by Marle Hill House. Today the platform is occupied by the residential houses of Albermarle Gate. This footpath is not part of Pittville Park but is used by visitors to the park. This northern boundary is lined in places by mature and semi-mature trees and large shrubs which restrict visual access both into the park and to the residential houses.

2007 Overgrown shrubs

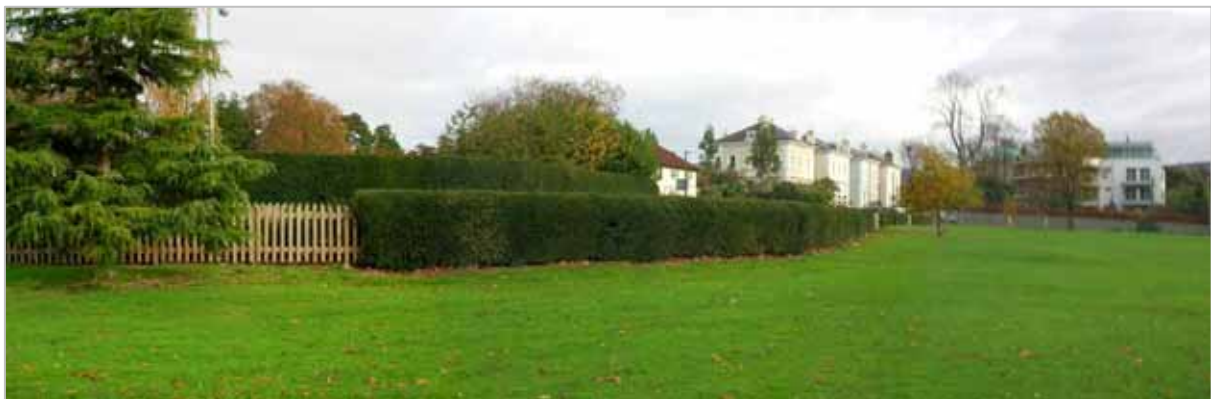
To the north east of the area the boundary is defined by a wooden picket style fence and an evergreen Yew hedge. Sections of the hedge are missing and have been replaced with the wooden fence which, although giving an inharmonious and uncharacteristic feel to the boundary, is well maintained.

2007 North eastern boundary

Some rubbish is accumulating under this boundary hedge, possible blown by the wind from the rubbish bins.

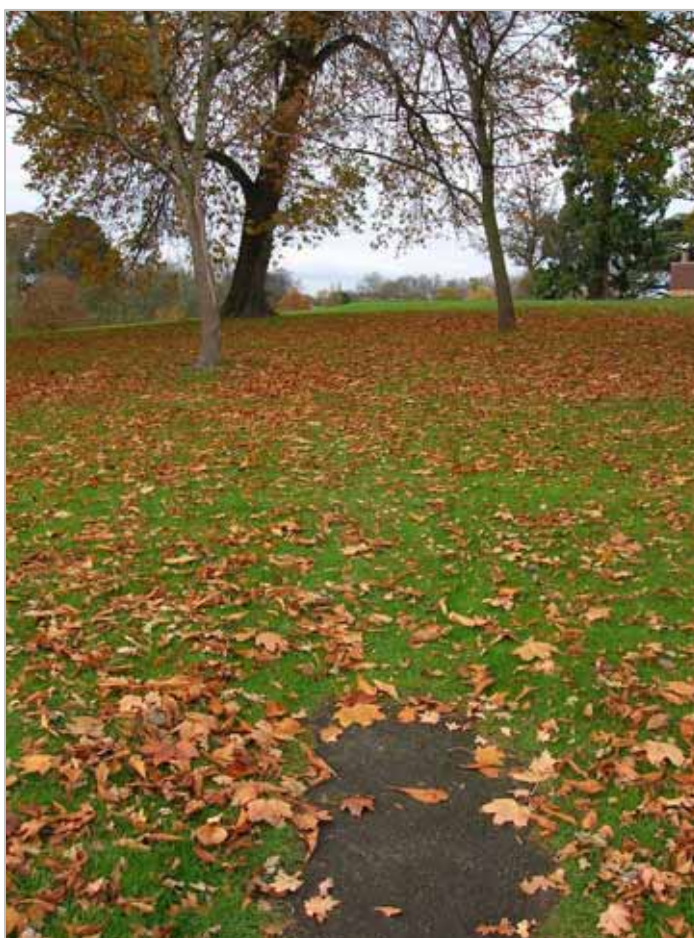
This narrow, hard, bitmac surfaced footpath rises up a gently slope towards the avenue of trees to the west. However it comes to a dead end well in front of the avenue.

2007 Path ends well short of trees
