SECTION 3 – UNDERSTANDING THE SITE

3.0 UNDERSTANDING THE SITE

This chapter describes the current condition of the Pittville Park. For ease of reference the site has been divided into character areas. See Fig 1.3

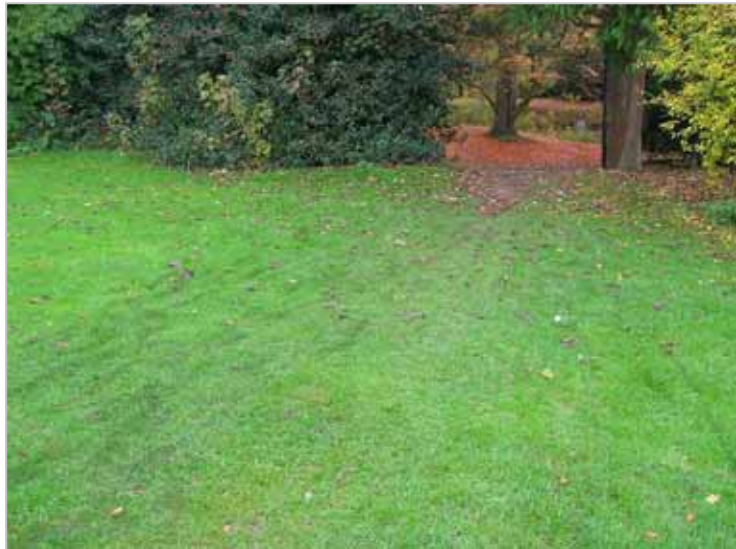
2007 Desire lines in the grass beyond the tennis courts and skateboard park

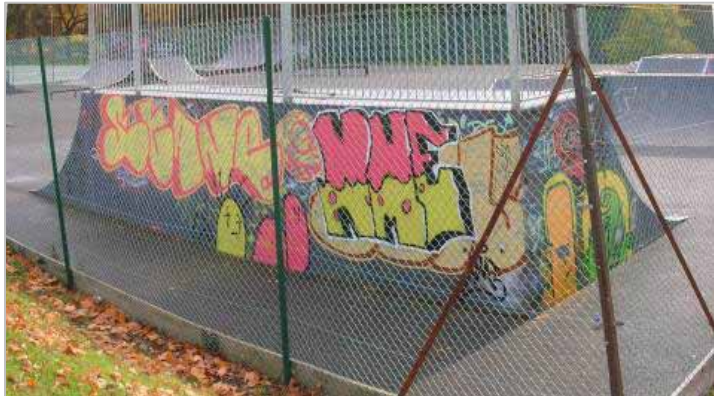
There is graffiti on many of the pieces of equipment within this skateboard park and much of it is clearly visible from distances away within the wider parkland. This graffiti has a detrimental affect on the visual character of the park.

2007 Graffiti

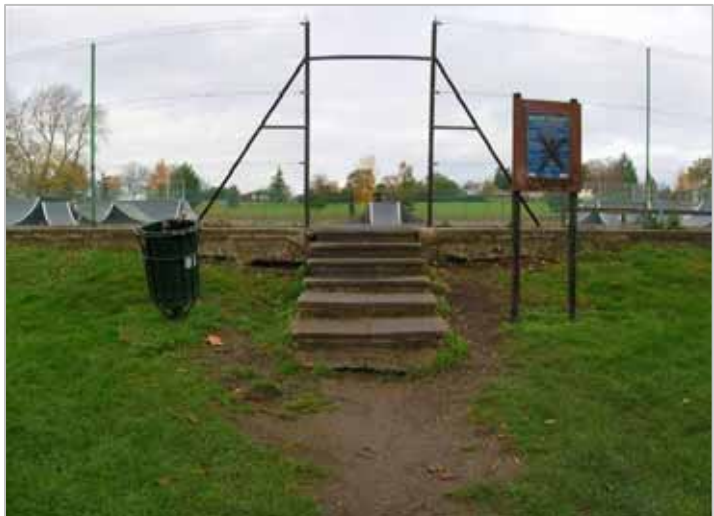
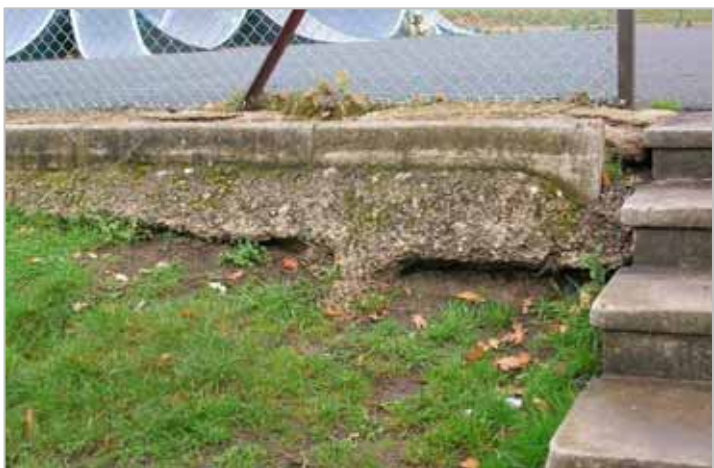
There are two entrances to the skateboard park, one to the north and one to the south. As the terrain slopes gently to the south, there are steps leading down from the southern entrance directly onto the grass below. No footpath has been provided to lead to and from the skateboard area and as a consequence of popular use, the grass is now worn away. This wear is visually intrusive and combined with the poor condition of the steps and concrete footings to the skateboard area gives the appearance of neglect and decay.

2007 South entrance to skateboard park (above and below)

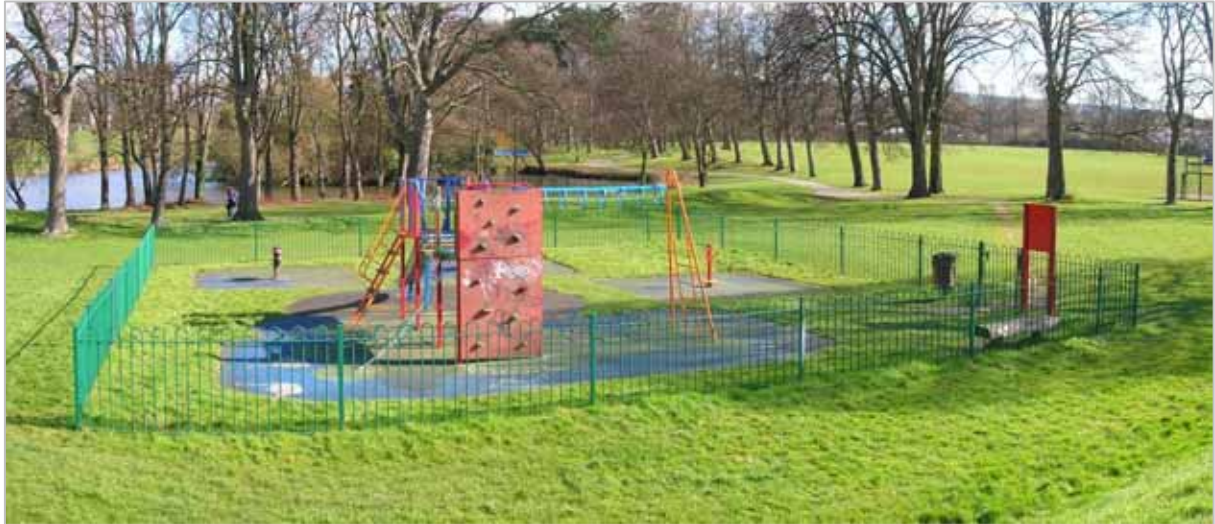
Immediately to the west of the Sycamore avenue is a very small children's play area. This fenced area contains a limited amount of equipment which has a very low play value, only offering opportunities for physical play. The current equipment is beginning to look tired and neglected.

2007 Children's Play area

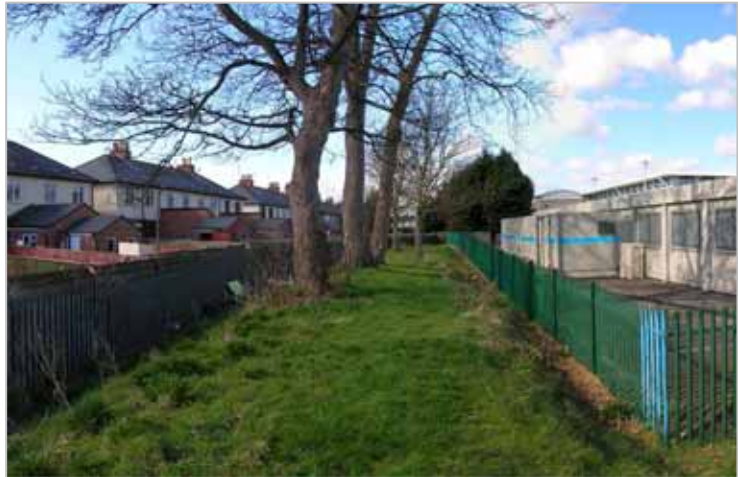
There is a large amount of rubbish within this strip of land, which appears to originate from the houses beyond.

2007 Southern boundary

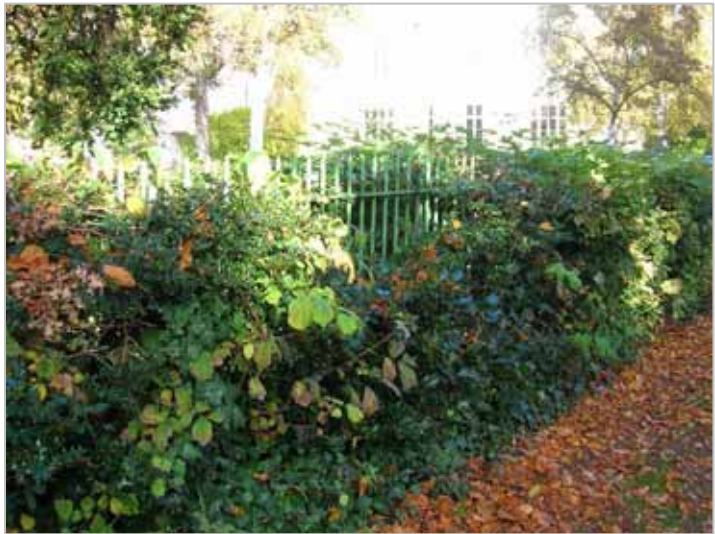
Boundary treatment surrounding the square is predominantly a high Holly hedge, interspersed in places by surviving sections of iron railing, along with random sections of wooden fence and chestnut pailing. This treatment, although successful in defining the space, gives the appearance of neglect.

2007 Iron railings visible within the hedge

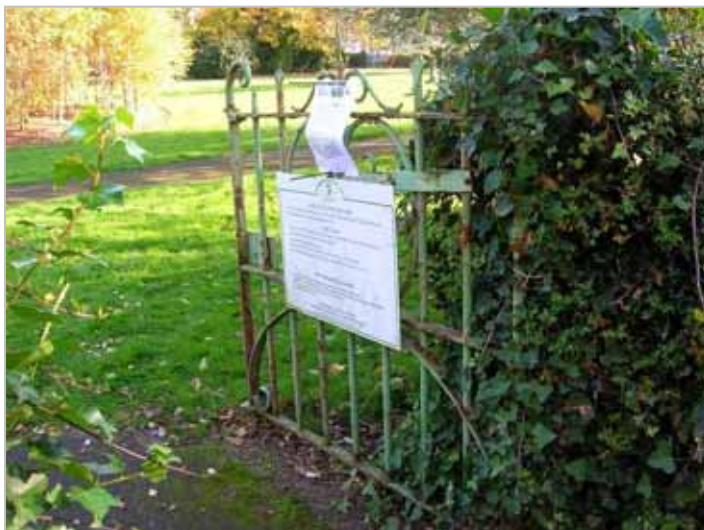
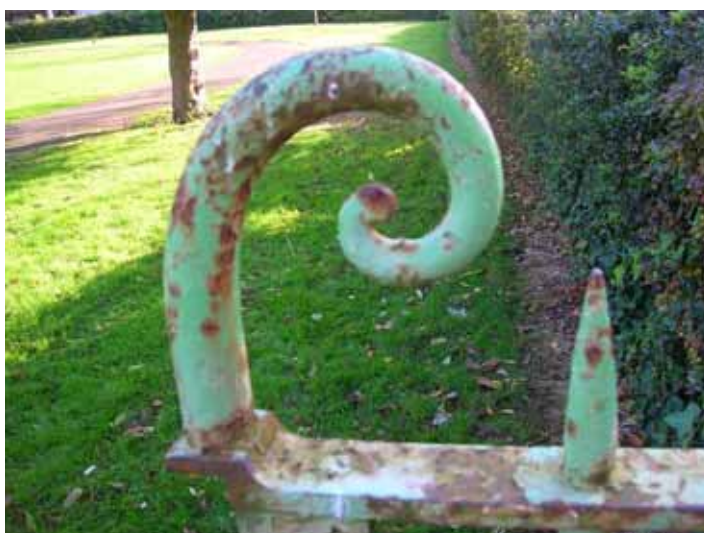
Access into Wellington Square is via gateways to the north, south, east and west sides. The gateways are defined by open sections of the hedge, by iron railings with gate missing and iron gates. The ironwork is in decline and is in need of renovation or replacement. The lack of unity in the gateway treatment also adds to the appearance of neglect.

2007 Gate (above and below)

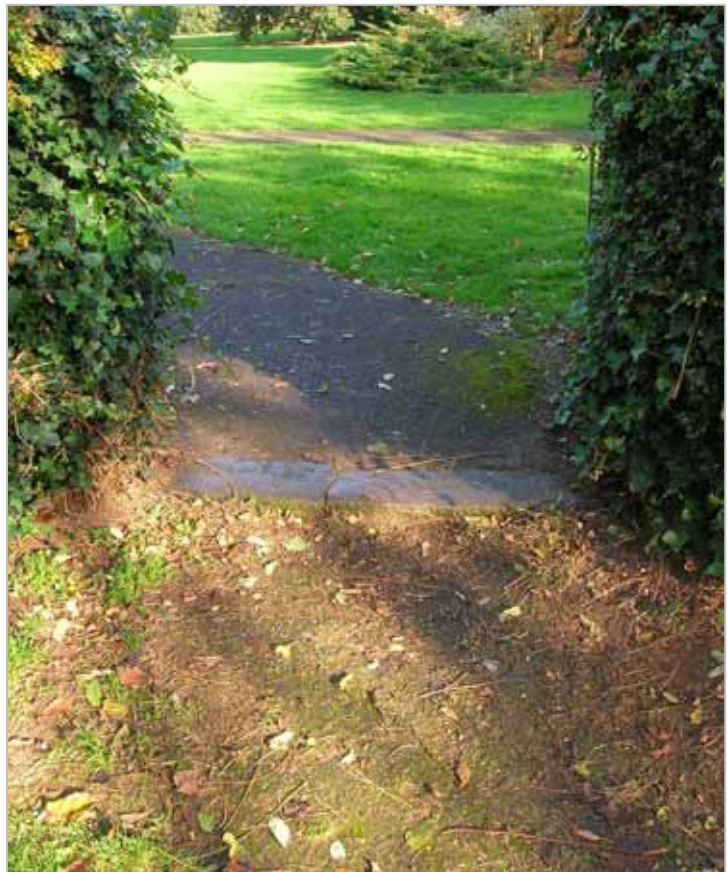
There is however, in places, no footpath along the verge, which now displays clear desire lines indicating the amount of foot traffic. This lack of footpath also continues around the gateway to the west of the square, where foot traffic has worn away the grass.

2007 Gateway to the west with worn grass verge

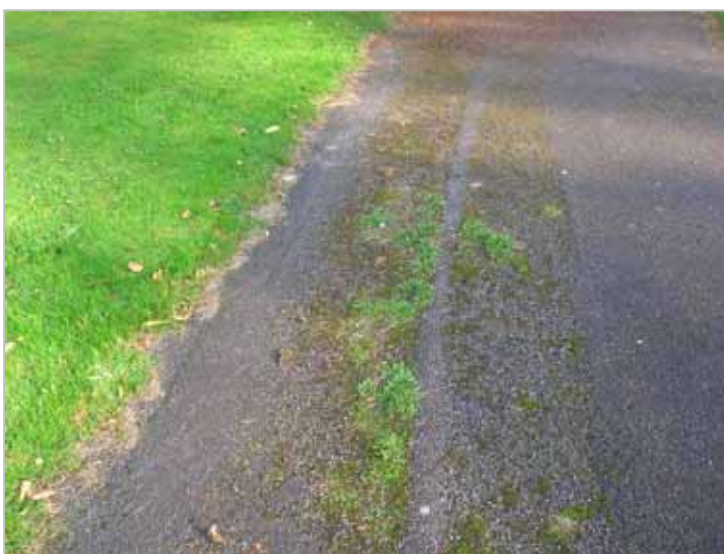
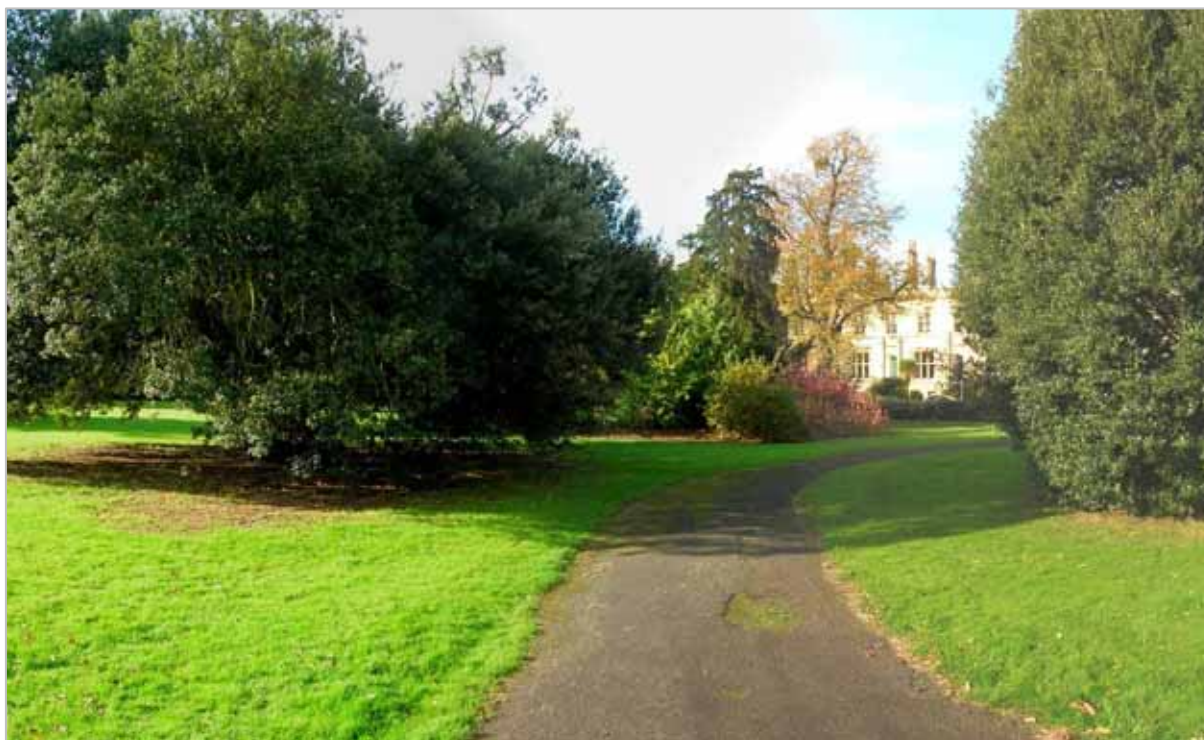
Within the boundary of the hedge, Wellington Square is a mature green space filled with collection of trees and shrubs. The footpath leads from each gateway towards a path which encircles the square. This hard, bitmac surfaced path is in generally good condition although there are isolated sections which are becoming worn or being colonized by moss.

2007 Path surface (above and below)

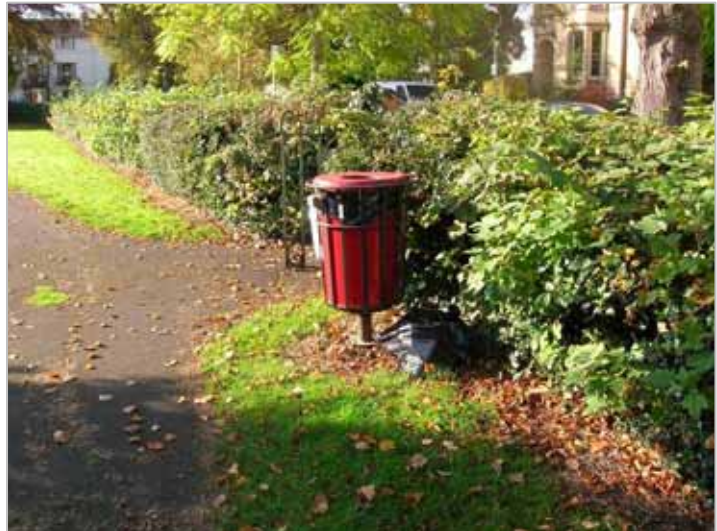
There is also equally poor provision of rubbish bins, the only bins within the square located adjacent to two gateways and on the occasion of site visits, appeared to be full with rubbish accumulating around the base of the bins.

2007 Wellington Square rubbish bin

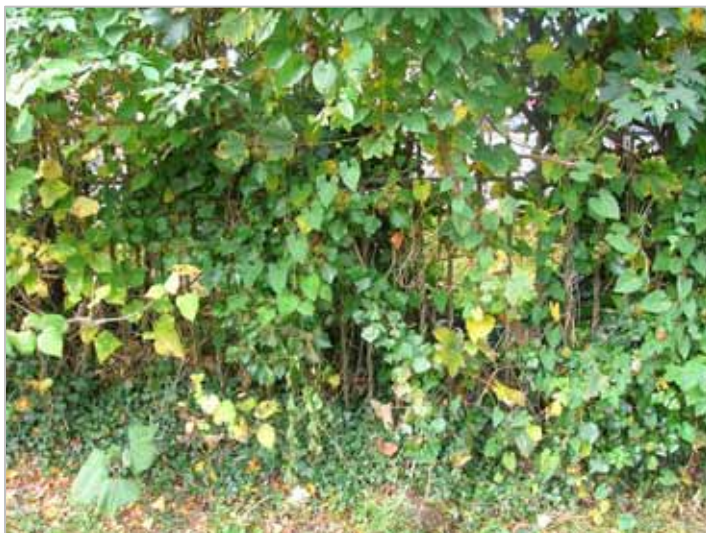
The hedge is dissected in places by iron railings in varying degrees of repair, which contribute to a sense of neglect.

2007 Iron railings within the hedge

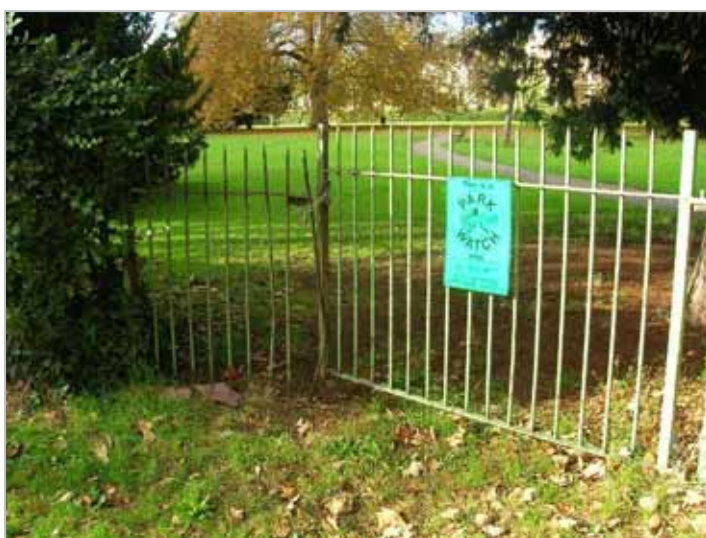
2007 Clarence Square East railings

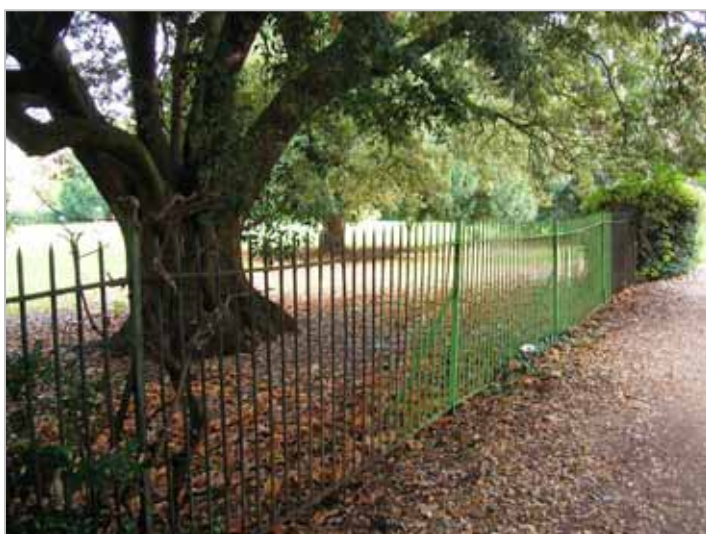
2007 Clarence Square South railings

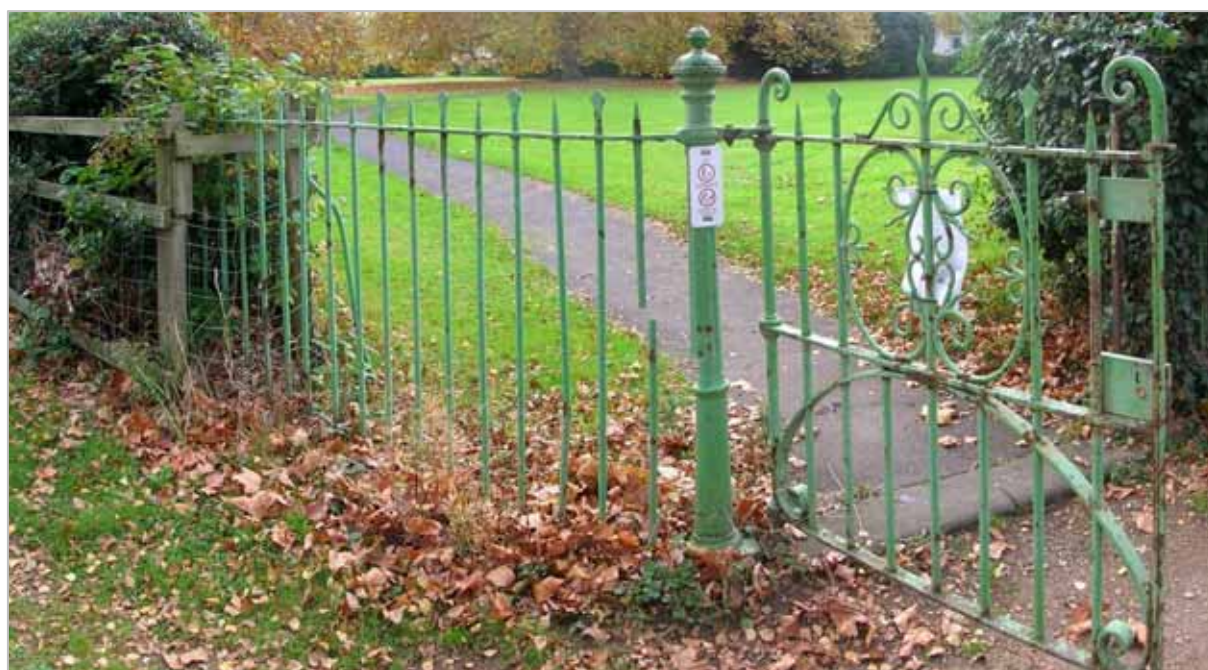
2007 North west gateway

Clarence Square differs from Wellington Square with the gateways positioned to the four corners, north, south, east and west rather than being located along the sides. The gateways are defined with ironwork in varying states of deterioration.

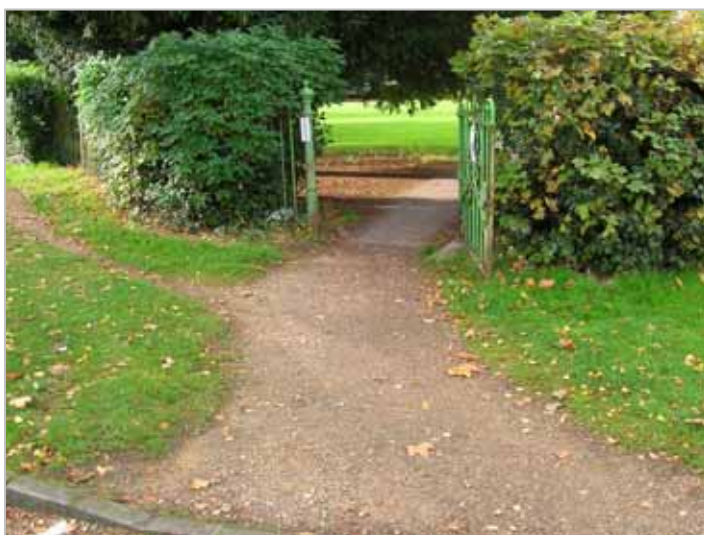
2007 North east gateway

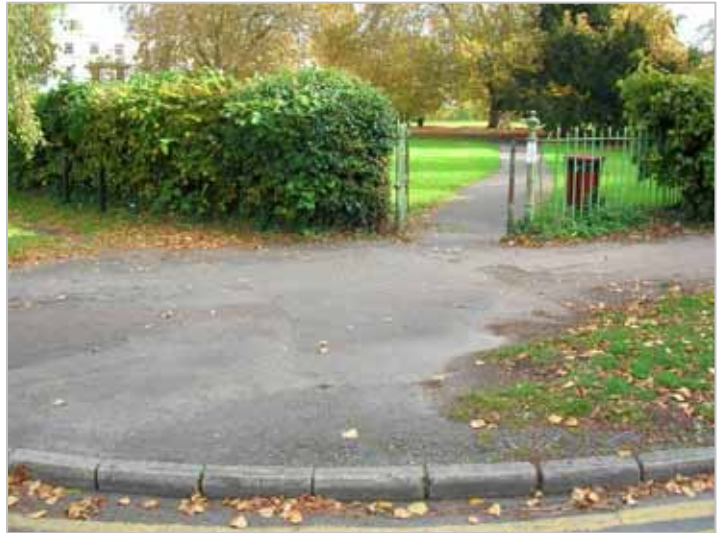
2007 South west gateway

The sense of arrival into the green space varies according to the state of decay and surface treatment at each gateway. To the south west there is a hard surfaced bitmac path which leads into the square and surrounds the gateway to the south west corner, which enhances the sense of arrival and leads the visitor into the square. However, to the right, alongside Clarence Road, this hard surface soon gives way to a compacted gravel and dirt surface. To the left along Clarence Square West the hard surfaced path stops abruptly and the grass verge has no footpath. Clear desire lines within the grass indicate the amount of foot traffic along this verge and the clear need for a footpath.

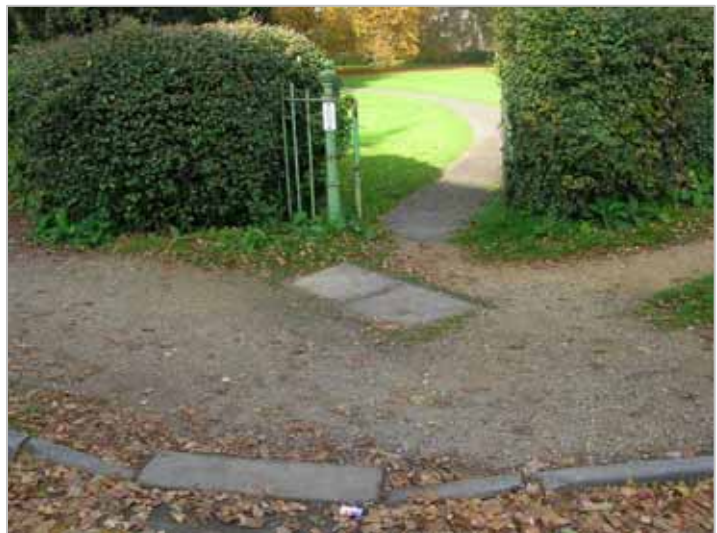
2007 South east gateway

Despite the ironwork and gates at each of the gateways, the general appearance is that of neglect and deterioration.

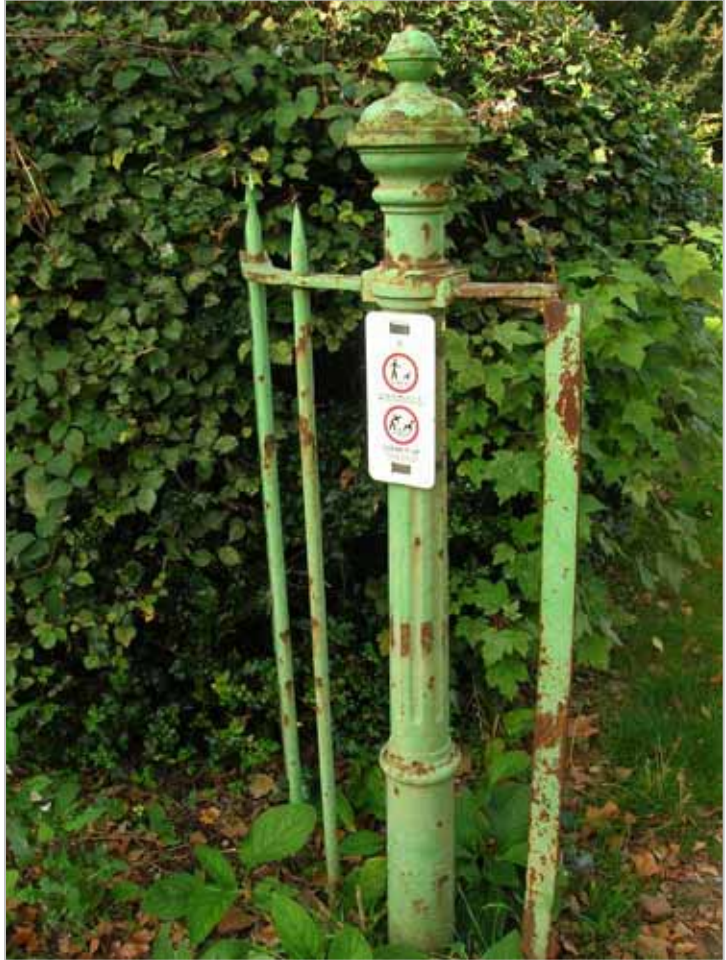
2007 Ironwork

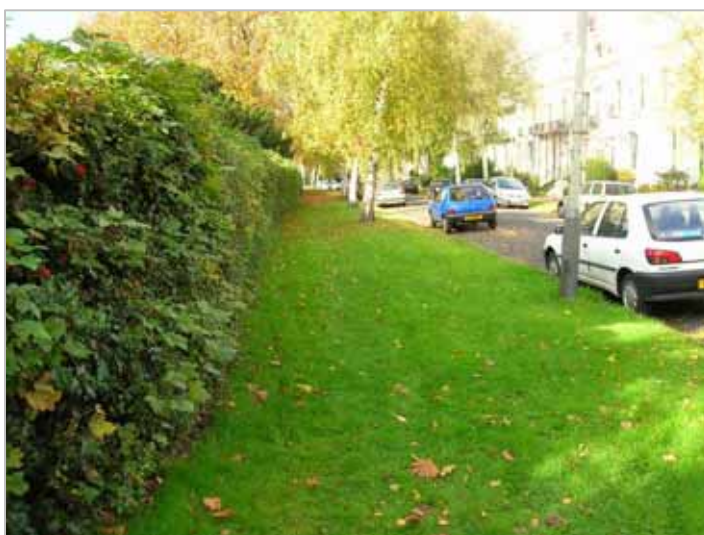
There is no footpath beyond the northern boundary however, well worn desire lines in the grass are an indication of the amount of foot traffic this strip of grass receives.

2007 Clarence Square North

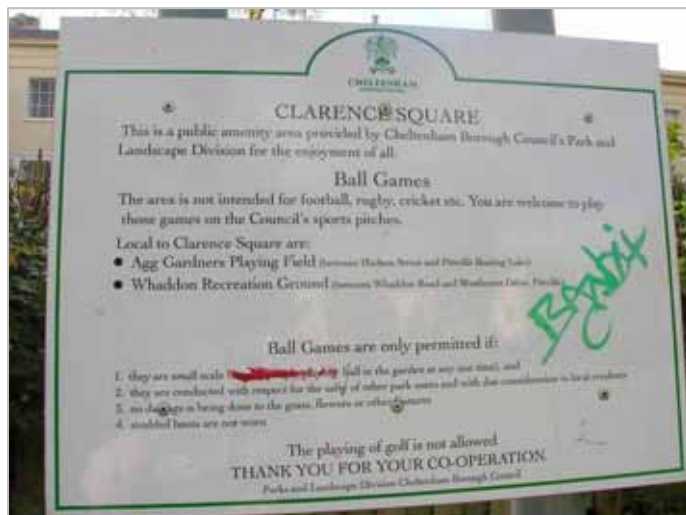
It is disappointing to note that seating opportunities are not adequately provided for within this square. Rubbish bins are provided adjacent to entrance gateways only and they, along with signage in the square are covered with graffiti.

2007 Graffiti

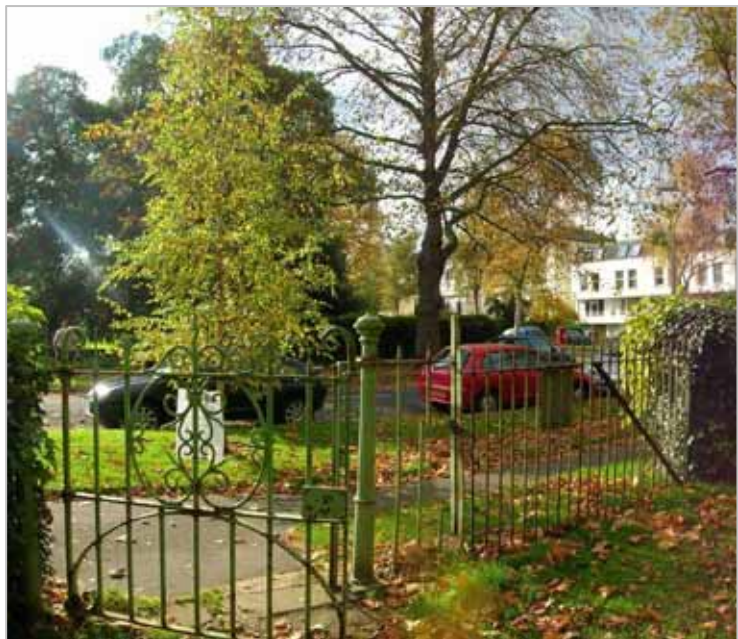
Access into Pittville Crescent north is via a single gated entrance to the south adjacent to Central Cross Drive. The ironwork is in the same style as Pittville Park and shows the same degree of deterioration and feeling of neglect.

The gateway opens into the grassed crescent without a hard surfaced path. The result is a dirt covered entrance which detracts from the historic importance, character and setting of this space.

2007 Gateway into Pittville Crescent north

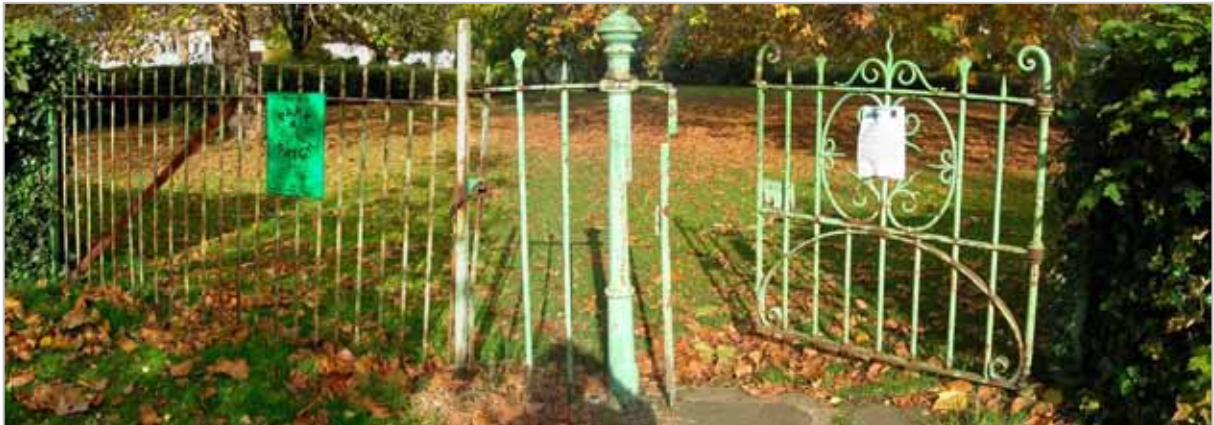
2007 Pittville Crescent north ironwork

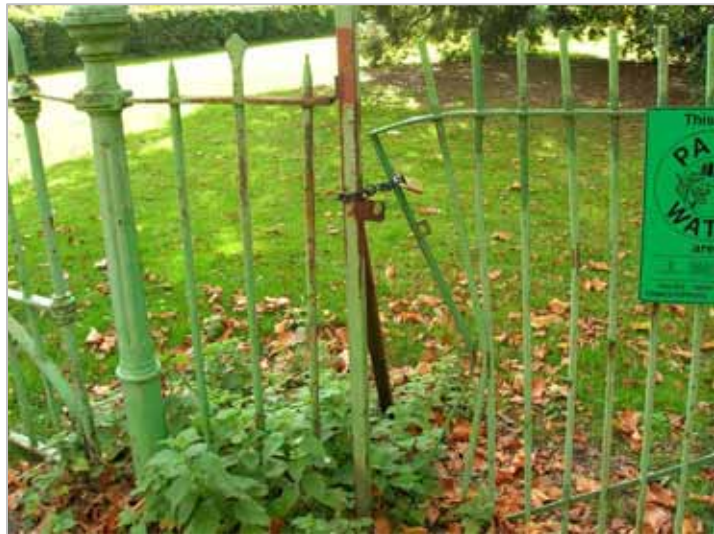
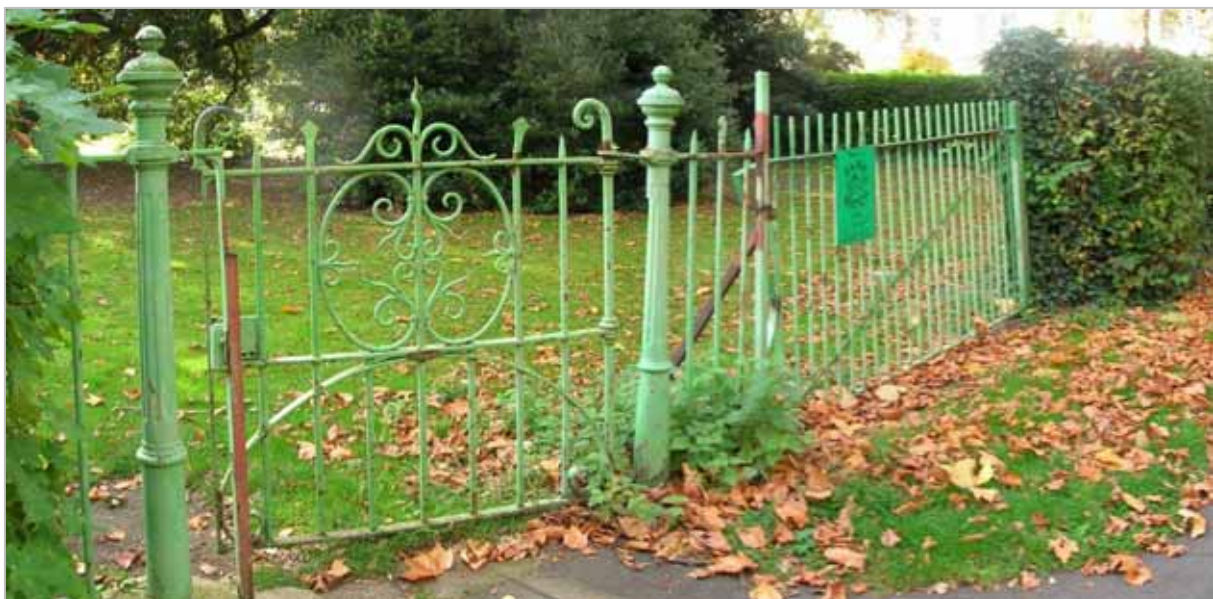
The gateway into Pittville Crescent south is via a gateway through ironwork adjacent to Central Cross Drive. The ironwork is in the same style as Pittville Park and is showing the same deterioration and sense of neglect.

2007 Pittville Crescent south gateway (above and below)

The gateway opens directly onto the grass of the crescent and as a result of the lack of hard surface a dirt track has been worn into the grass which detracts from the character and setting of this historic crescent.

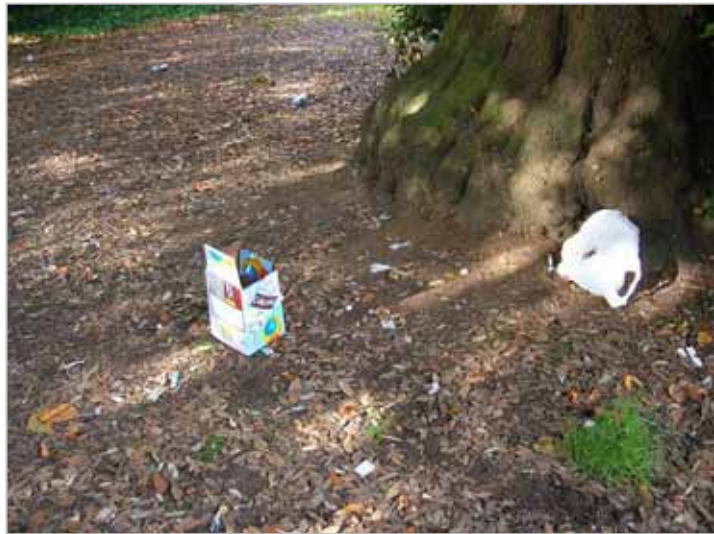
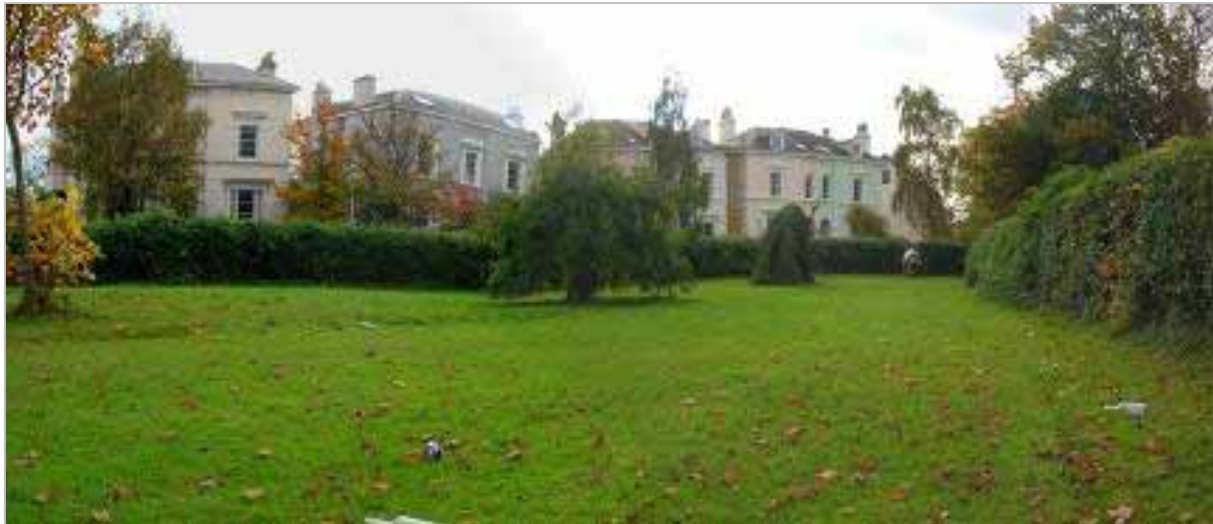
Within the crescent, the grassed area contains mature and semi mature tree species, which are largely located to the centre of the space. The high nature of the boundary hedge creates an enclosed and secluded space which is clearly being used in inappropriate ways, presumably by local young people. There was, on the occasions of site visits, a large amount of rubbish, including empty alcohol bottles and cans, littering the grass surrounding the base of the mature Holm Oak (*Quercus ilex*)

2007 Litter in Pittville Crescent south (above and below)

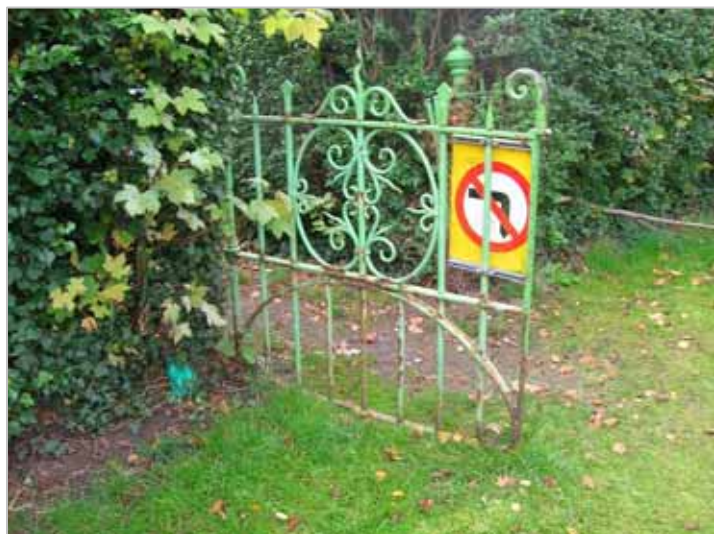
A sign attached to the gate has been constructed from a previous road sign and gives a conflicting message when viewed from inside the crescent. (See Section 5.5)

2007 Gateway signage

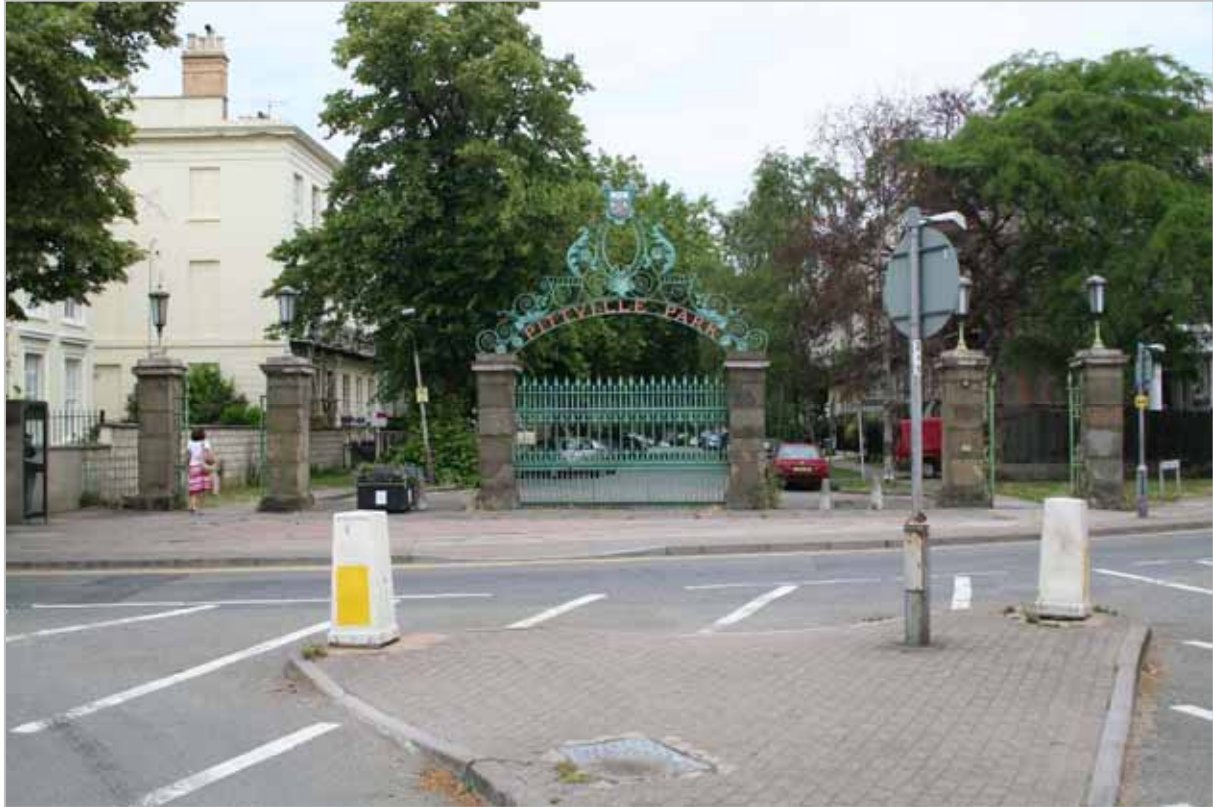
Pittville Lawn to the north of the gates is not open to vehicles from the south. The gates stand back from the road beyond a wide paved area adjacent to the highway footpath. The paving looks faded and its style not compatible with such an important historic feature. The pavement dips adjacent to the gates to allow access across the road to a traffic island. There are numerous traffic signs and bollards which clutter the street scene at this point and detract from the magnificent gates.

2007 Pittville Gates from Winchcombe Street

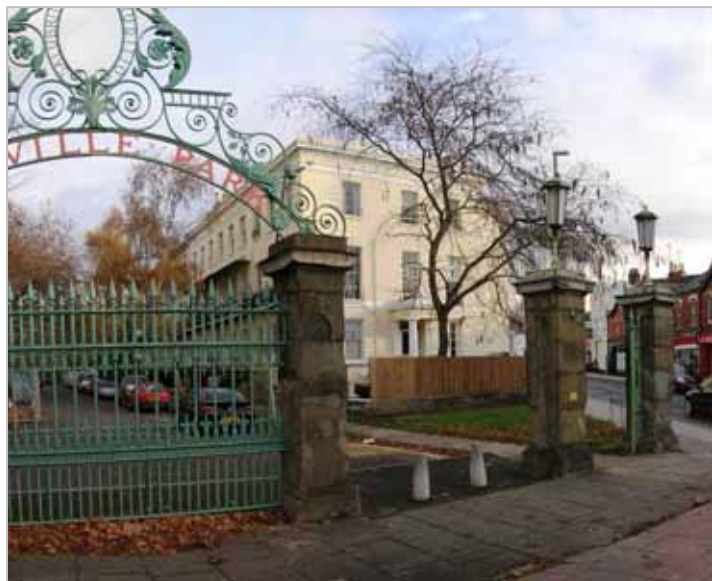
2007 Concrete bollards

The two internal openings now have concrete bollards to restrict vehicular access. These bollards do not compliment the character and setting of the gates

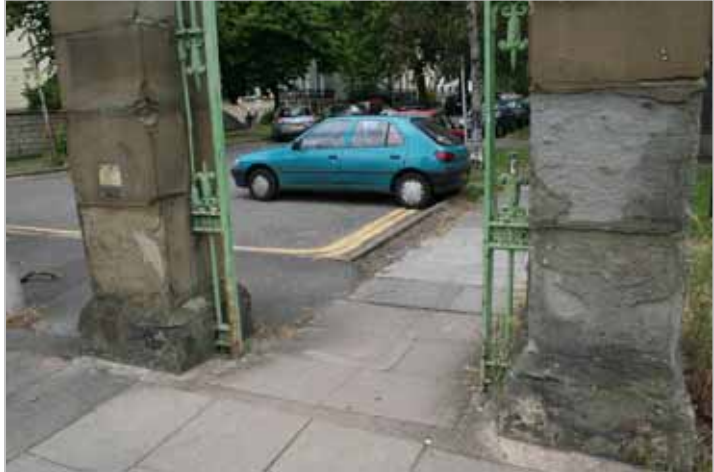
To the north of the gates road markings signal a no parking area and areas of bitmac have been replaced to form a patchwork of surfaces. There is no consistency in the surface detail of this important area.

2007 Stonework

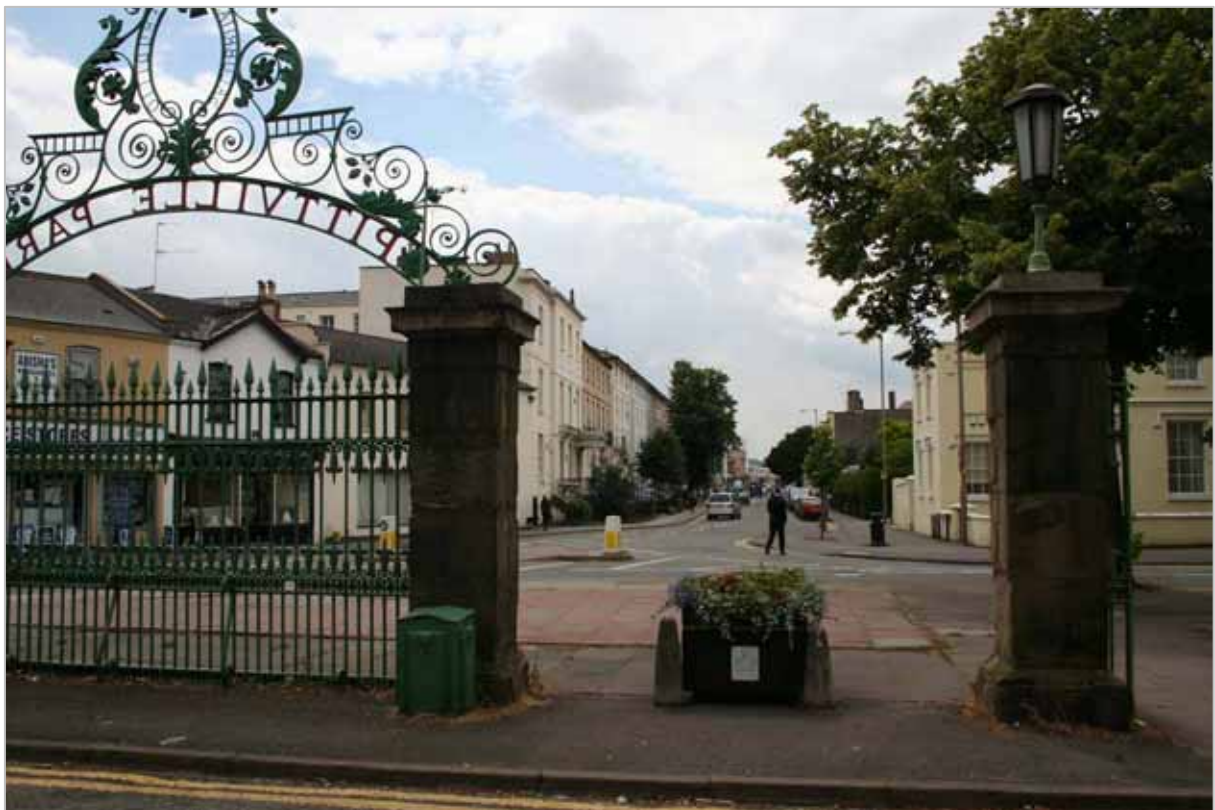
The ironwork of the gates is beginning to look tired and in need of renovation.

One box planter has been added between the wider of the western openings. There is a lack of symmetry with this single planter and whilst the plants contained within seem well maintained, the planter itself does not compliment the character and setting of the Pittville Gates.

2007 Pittville Gates looking south

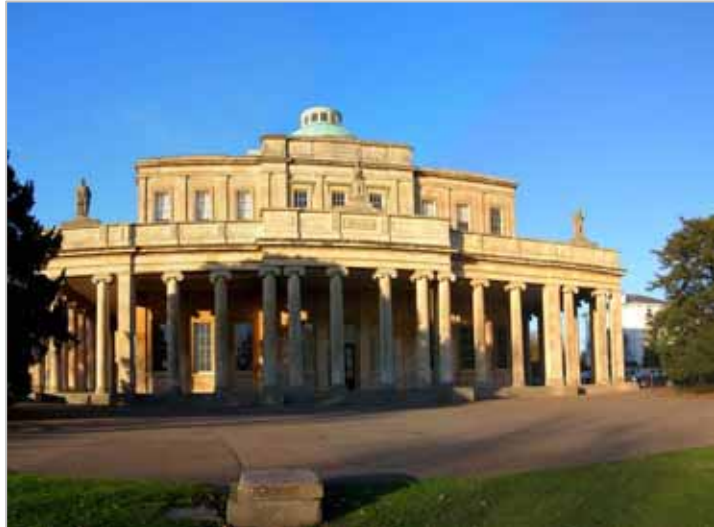
2007 Pittville Pump Rooms

Its construction is brick with an Ashlar surface cover and to the west, south and east an impressive colonnade provides focal interest. A balcony looks out across Pittville lawns to the south, which is accessible from within the building, although structural problems are now restricting access.

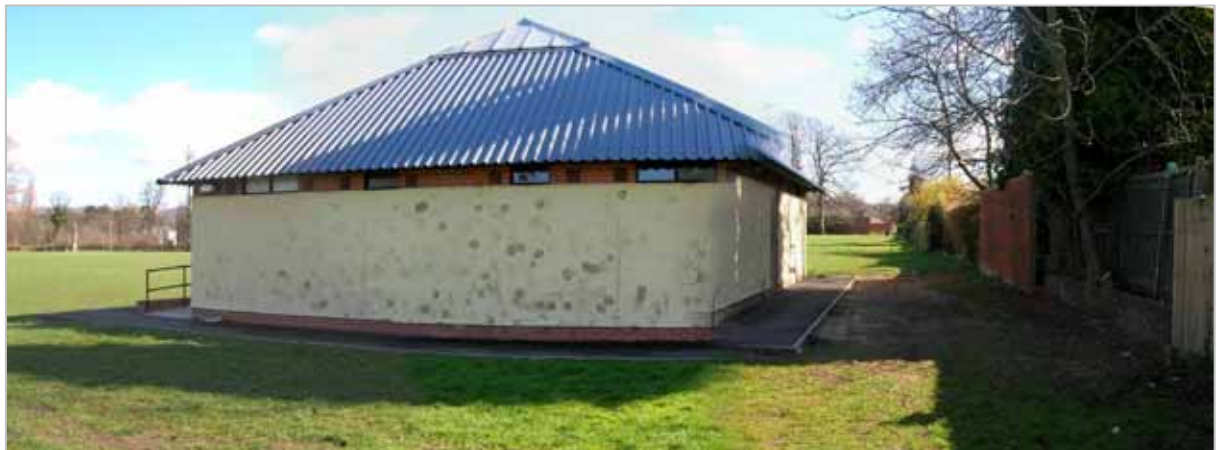
2007 Agg Gardner Pavilion

There are no hard surface footpaths leading to and from this pavilion, which results in users of the pavilions walking over grass. As a result, the surrounding grass has become worn away.
